**Ref: 238 London Road Early Reading**

I undertook a bat scoping assessment at this property on the 24<sup>th</sup> of August 2021 at the request of the owner of the property. This assessment was undertaken further to the proposal for a loft conversion to expand internal living space. The survey was undertaken according to best practice guidance as detailed by the Bat Conservation Trust (BCT)<sup>1</sup>.

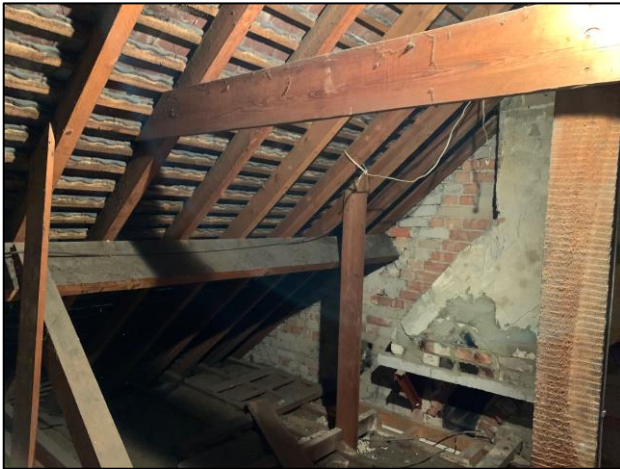
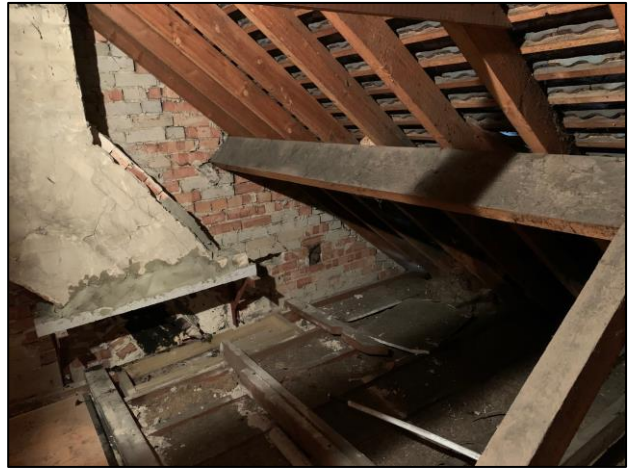
**Photograph 1 and 2.** The internal aspects of the void, showing the lack of bitumen lining and the rockwool insulation.

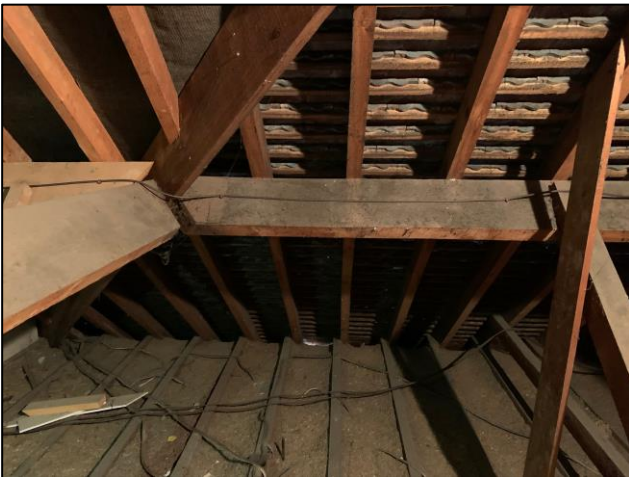
**Photograph 3 (left).** An example of a small gap the eaves. **Photograph 4 (right).** Clay roof tiles with a number of gaps that could potentially be used by crevice roosting bat species.

Overall, the building is considered to support low potential for both hibernating bats and summer roosting bats within the gaps within the soffits. No further bat surveys are considered necessary in this instance. However, a precautionary approach should be undertaken, whereby the clay roof tiles should be hand stripped one by one from the roof under the direct supervision of a licenced bat ecologist. In the unlikely event that bats, or evidence of bats are found at this stage, the potential for impacts and need for EPS licencing will be reassessed.

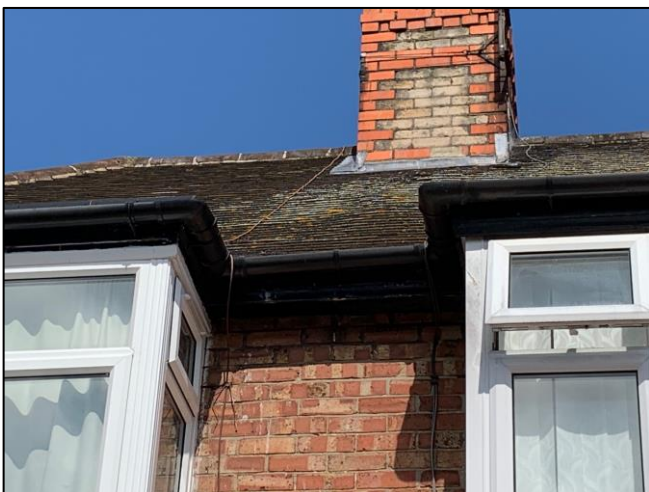
**Photograph 5 (left).** Well-sealed lead flashing around the chimney base. **Photograph 6 (right).** Fascia boards well sealed and hanging tiles that are not be impacted.
