# REPORT ON A SITE INVESTIGATION

**LINDISFARNE,  
HENLEY ROAD, WARGRAVE,  
BERKSHIRE RG10 8PE**

**25/13185/GO**

## **ALBURY S.I. LTD**

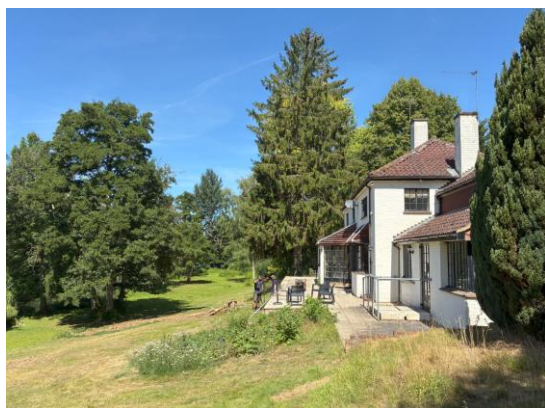
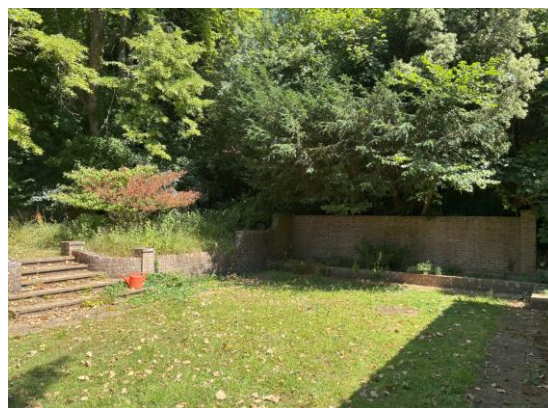
The site comprises a residential dwelling known as Lindisfarne, located at Ordnance Survey National Grid Reference 478121, 180887. Photographs which give a general impression of the site at the time of the fieldworks are included below.
