**Land to the Rear of 20 & 22 Station Road  
Twyford**

**Report for:**  
Citroemec Limited  
Unit 3  
East Heath Avenue  
Wokingham  
Berkshire  
RG41 2PR

### Site Description (Photographs 1-4)

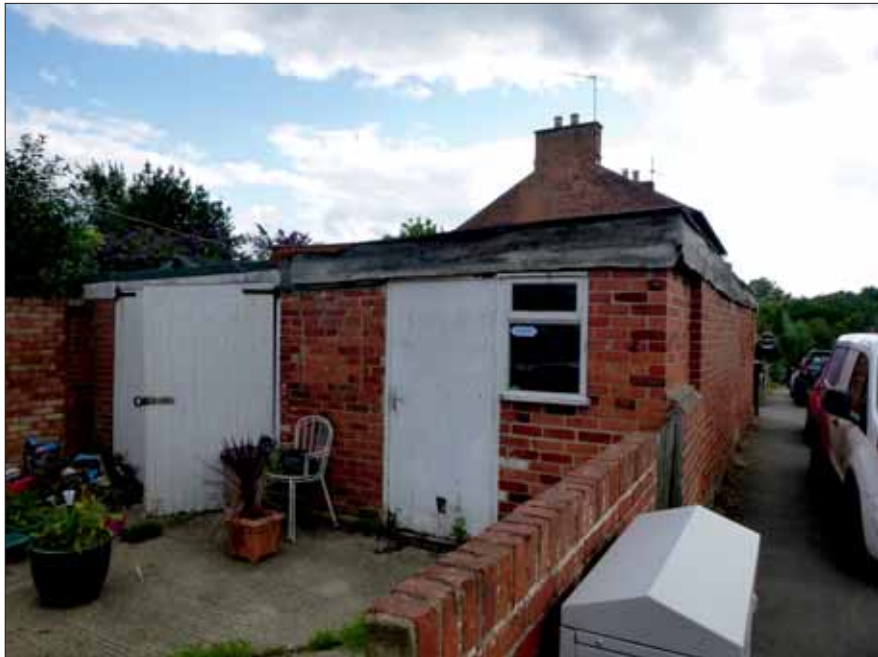
The site conditions remained the same as previously recorded, with no significant changes. The building was a single-storey, block and masonry constructed workshop, with the low single pitched roof. The workshop appeared to be originally two separate buildings with one roof covered with bitumen felt and the other with corrugated metal sheets. Timber barge boards were present at each elevation, with a timber framed window at the front of the workshop. Internally, there was no separate roof void present with the roof unlined and uninsulated, with expanding foam used to seal any gaps between roof and wall.

Photograph 1: Showing the front and side elevations of the workshop.

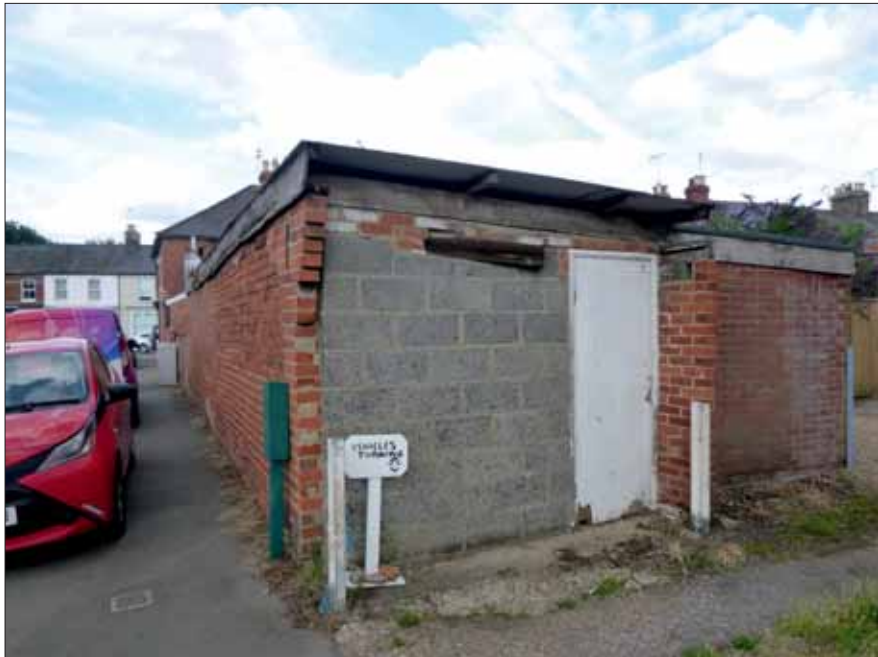
Photograph 2: Showing the rear elevation of the workshop.

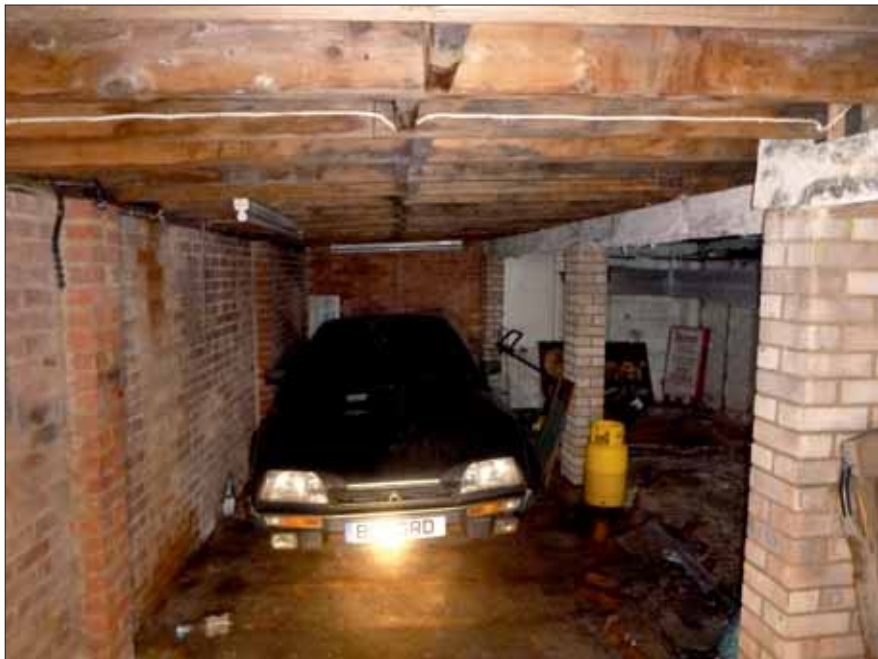
During the follow-up internal and external visual inspection of the workshop, no evidence of bats was recorded, with the building conditions having remained unchanged during the intervening period. The building due to construction type and condition (lacking any roof voids/spaces and/or suitable crevice dwelling opportunities) was assessed to provide **negligible** roosting opportunities for bats.

Photograph 3: Showing the interior of the workshop, with an unlined roof.

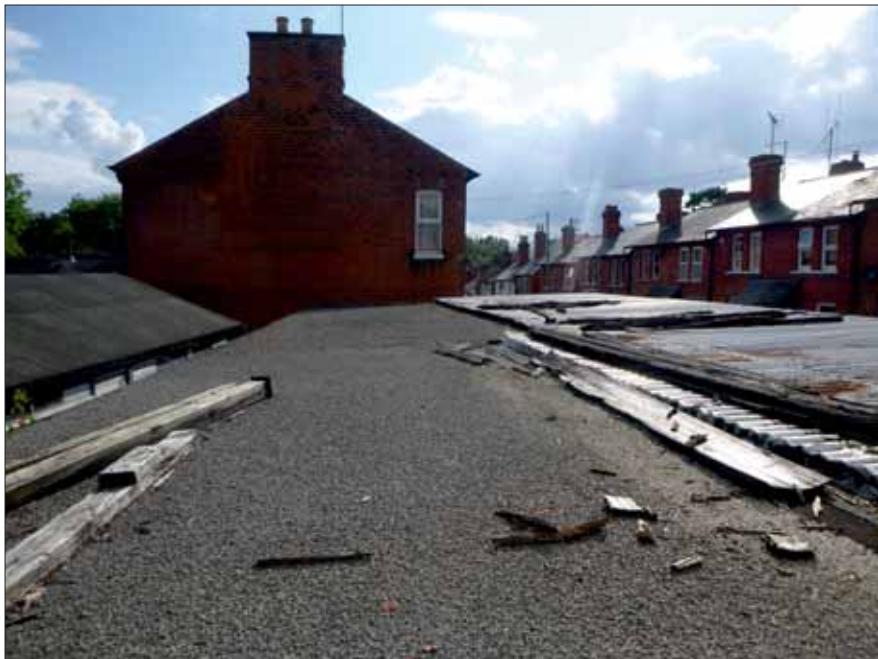
Photograph 4: Showing the flat roof of the workshop.
