## East Court, Finchampstead RG40 3SD

### 2024 Final Bat Survey Report

| Document title | Updated Final Bat Survey Report, East Court, Finchampstead_2024 |

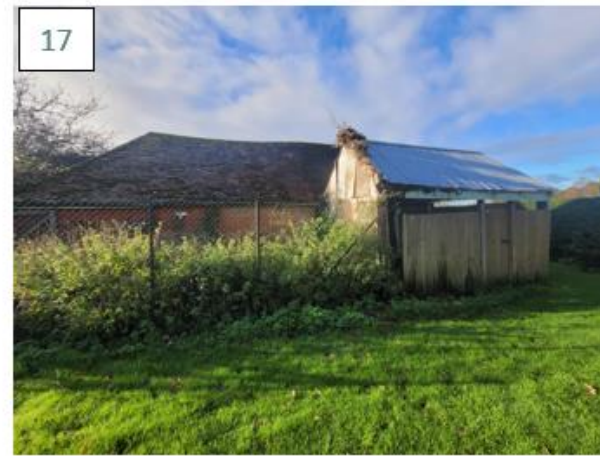
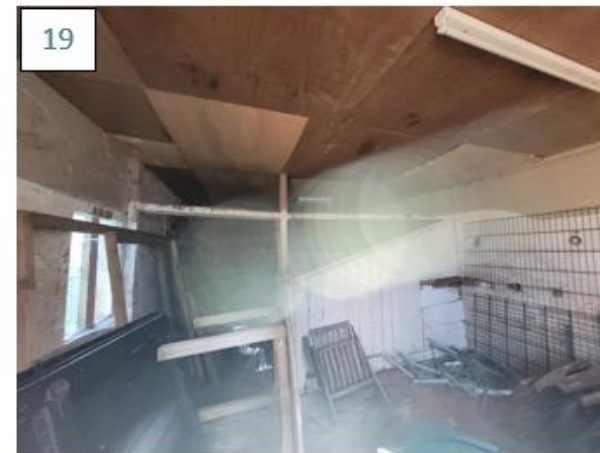
**Detached outbuilding:** This outbuilding is mainly constructed of red brick with a small section of shiplap. It has two double garage sections with a stable section. The eaves are open but have been historically blocked off with chicken wire. The roof above the garage doors is starting to bow and, in this area, there are raised roof tiles. To the rear there is one metal roofed disused chicken coop and a fenced off chicken run. The chicken coop walls are constructed from fence panels which do not meet the roof above.

**Detached outbuilding:** The majority of this building (stable and one garage section) has a false ceiling comprising wooden boards with a roof void present but no internal access. Between the stable and garage there is a wall of wooden shiplap from floor to apex. These areas are currently used to store wood and garden supplies. The second garage section and potting shed are open from floor to unlined roof above. Areas of the roof have had chicken wire added above the potting shed. No evidence of bats was found internally.

16: External view of the detached garage, black circle to show where the roof is bowing. 17: Rear elevation showing disused chicken coop and run.  
18: Eaves of the building. 19: Internal view of the stable area with false ceiling.

In terms of mitigation on site, this outbuilding will also be subject to a supervised soft strip to safeguard any bats present. Given that the tiles will be replaced on a like-for-like basis, there will be numerous cavities available for bat roosting under tiles on the new roofs, and therefore no impact on the favourable conservation status of any species found present.
