## **Preliminary Bat Roost Assessment**

John Cooper  
1 Orchard Place  
Rectory Road  
Wokingham  
RG40 1DW

Reference: Q19062

Date: February 2026

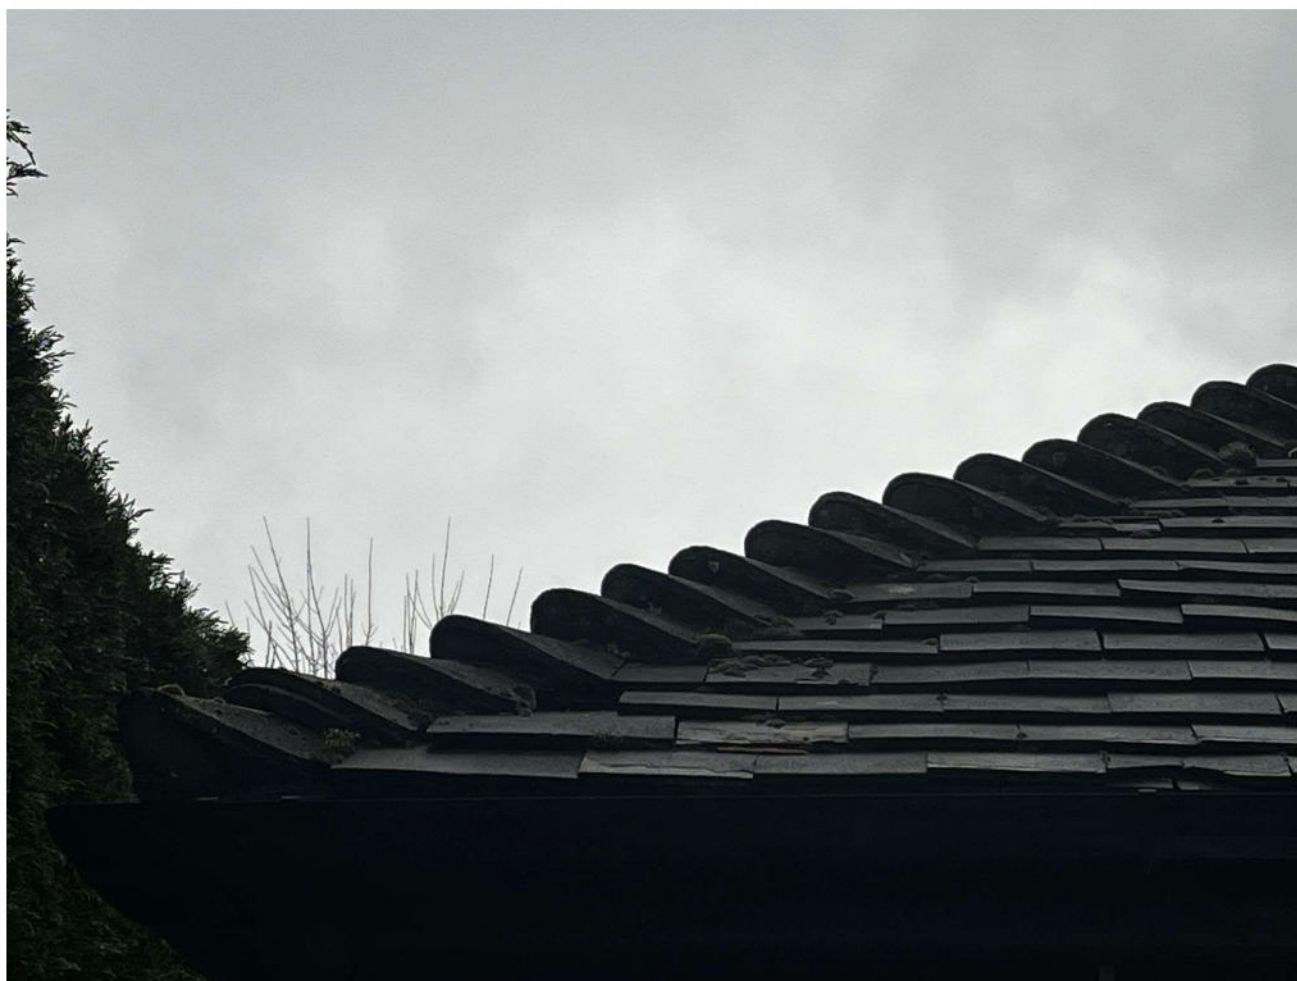
The building has some potential access points which are visible in the figures above, in the form of several slightly raised tiles on the roof. The most viable roosting locations are the slightly shifted tiles on the pitched and hipped slate-tiled roof. However, these raised tiles do not provide sufficient space to function as suitable roosting features.

Due to the limited nature and size of the slightly raised tiles, it is unlikely that any crevices present are sufficient to support a maternity roost. The attached garage has no loft space and is therefore considered to have negligible potential for supporting roosting bats. Additionally, while Confederate jasmine is present on the front elevation, it is not dense enough to provide suitable roosting habitat.

*Image 3 – Lifted roof tiles – not a big enough gap to be a potential roosting feature*

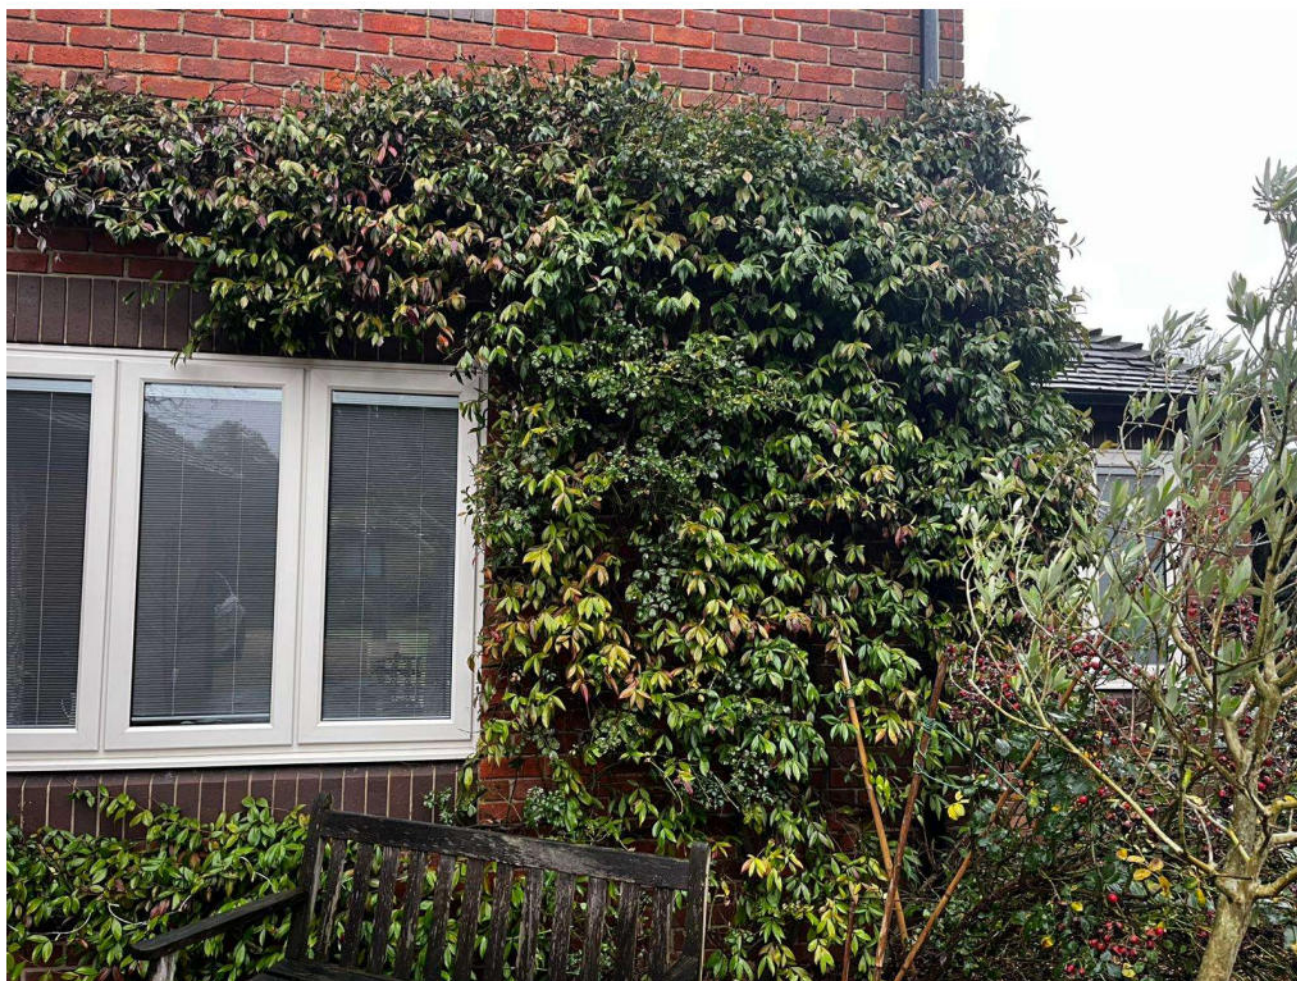
*Image 4 – Jasmine on the front aspect of the property – not dense enough to be a potential roosting feature*
