**31 Allnatt Avenue,  
Winnersh,  
RG41 5AU.**

**PHASE 1 BAT SURVEY  
(Provisional roost assessment)**

**September 2025**

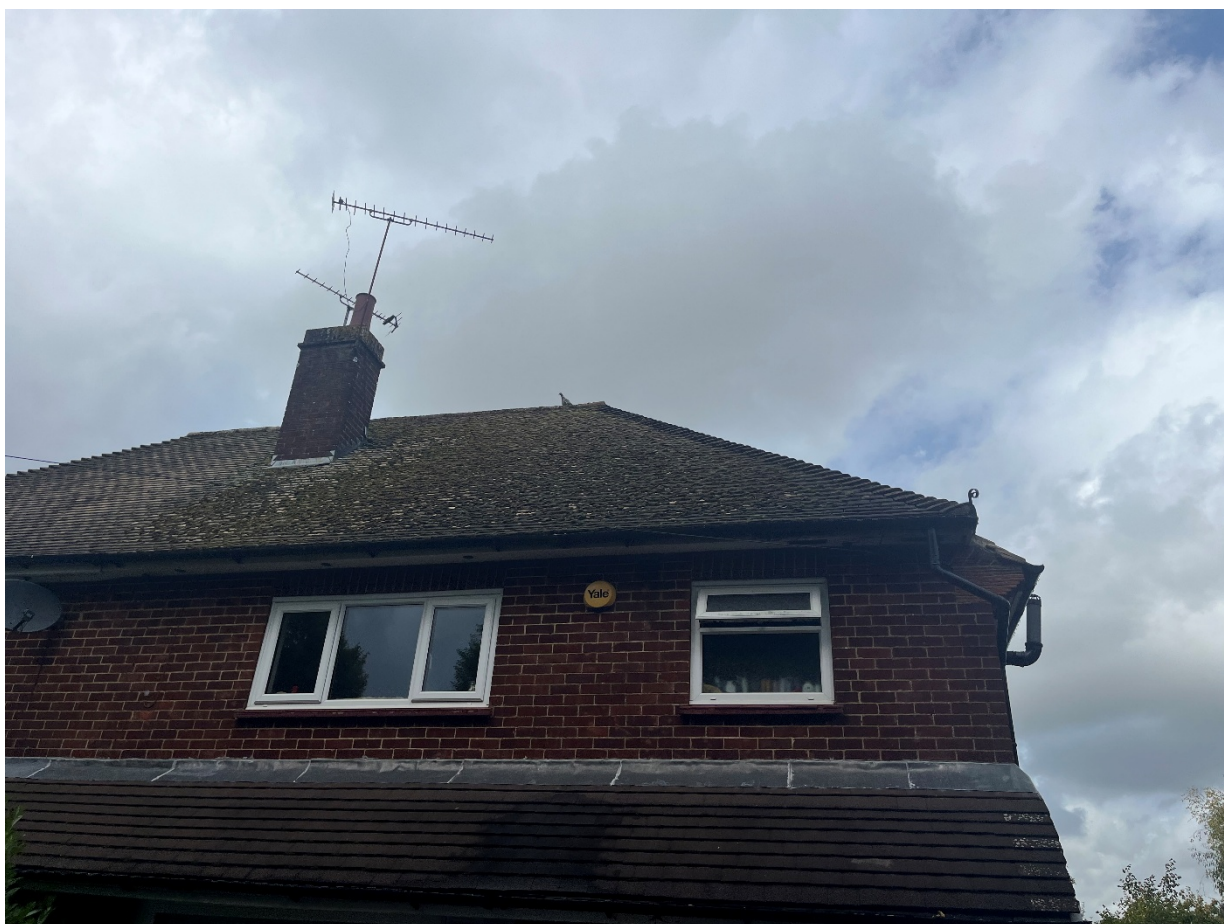
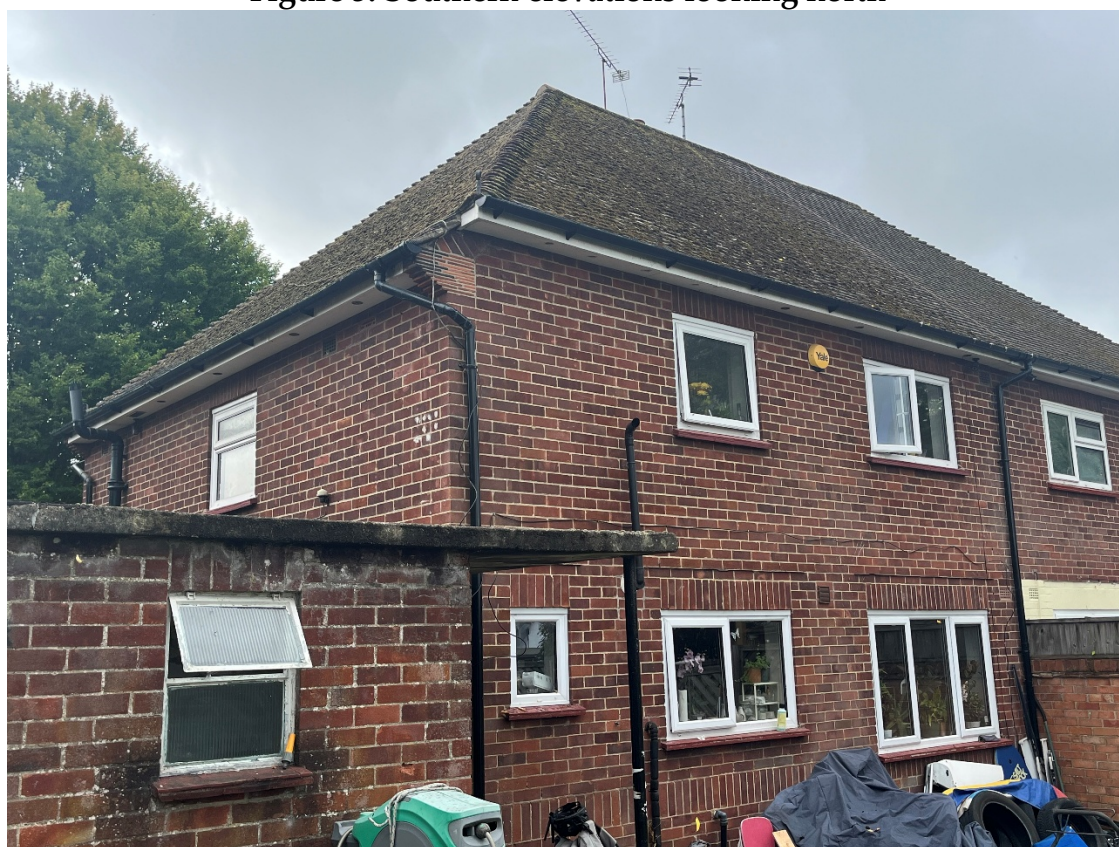
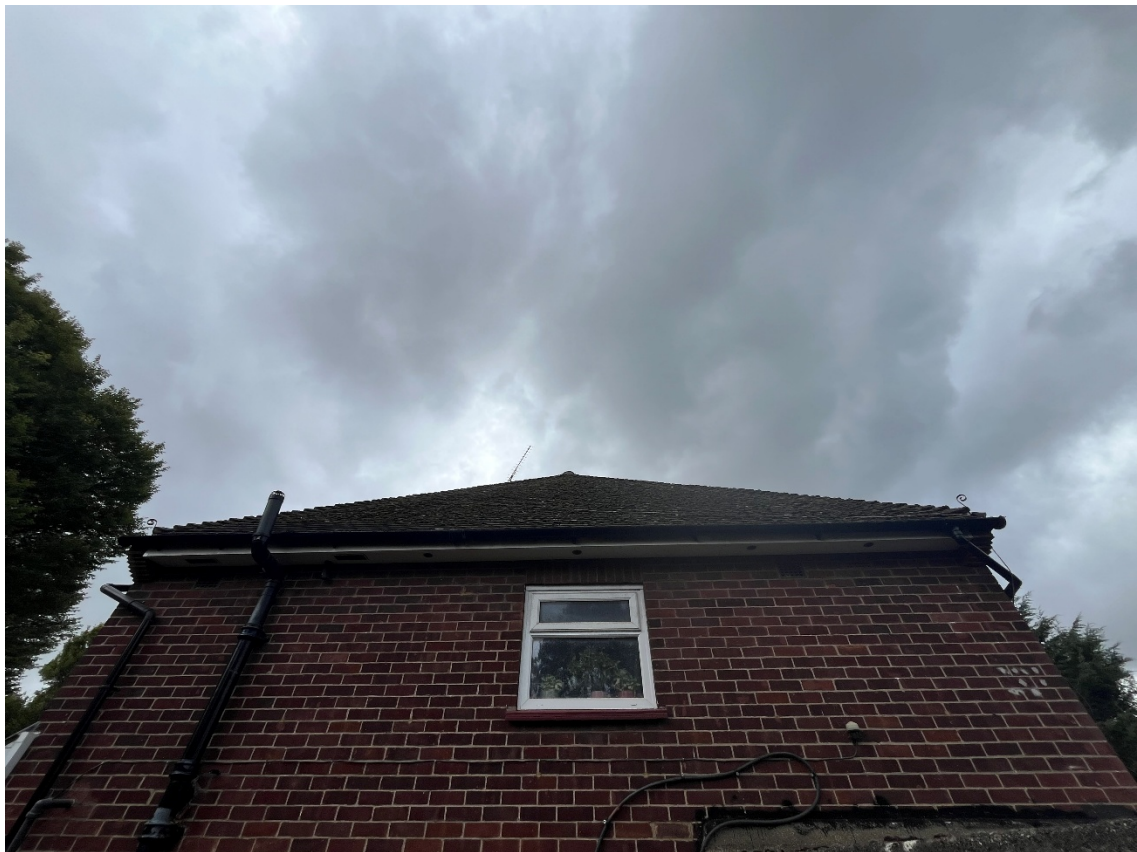
The property is a semi-detached house dating to the mid 20<sup>th</sup> Century, with plain brick walls and cement tiled roof clay tiles (see figures 3-5). The hipped roof has close fitting tiles and these and the leading and ridge tiles are in good order with no gaps. The eaves are closed off with modern uPVC soffits which are closed off leaving no gaps.

**Figure 3. Southern elevations looking north**

**Figure 4. Northern and eastern elevations looking southwest**

**Figure 5. North gable and roof hip looking west**

There was no sign of any bat activity within the house and the roof and fascias are all closed off. Therefore, the property has negligible potential for bats, and a Phase 2 bat survey is not recommended.

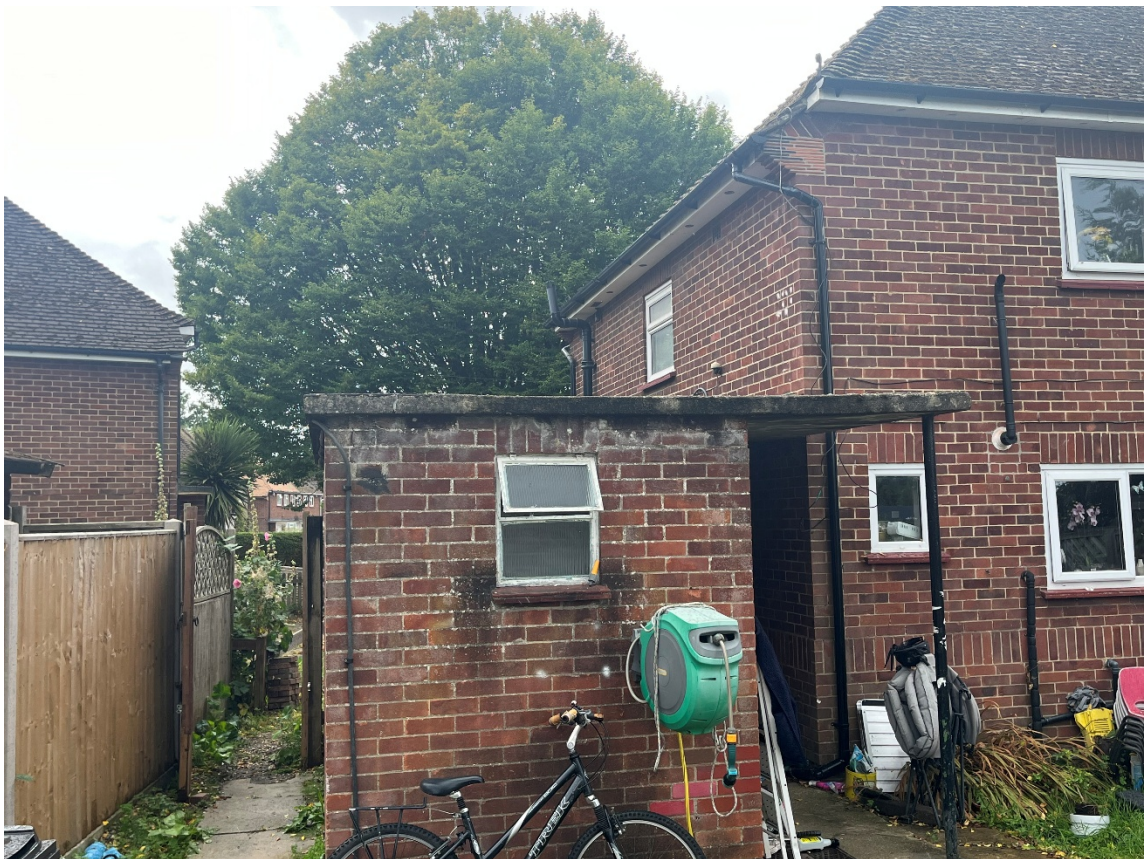
The attached utility room has a flat roof faced with concrete slabs and has an anterior permanently illuminated via sidelights and has negligible potential for bats (see figure 6).

**Figure 6. Utility room looking south**

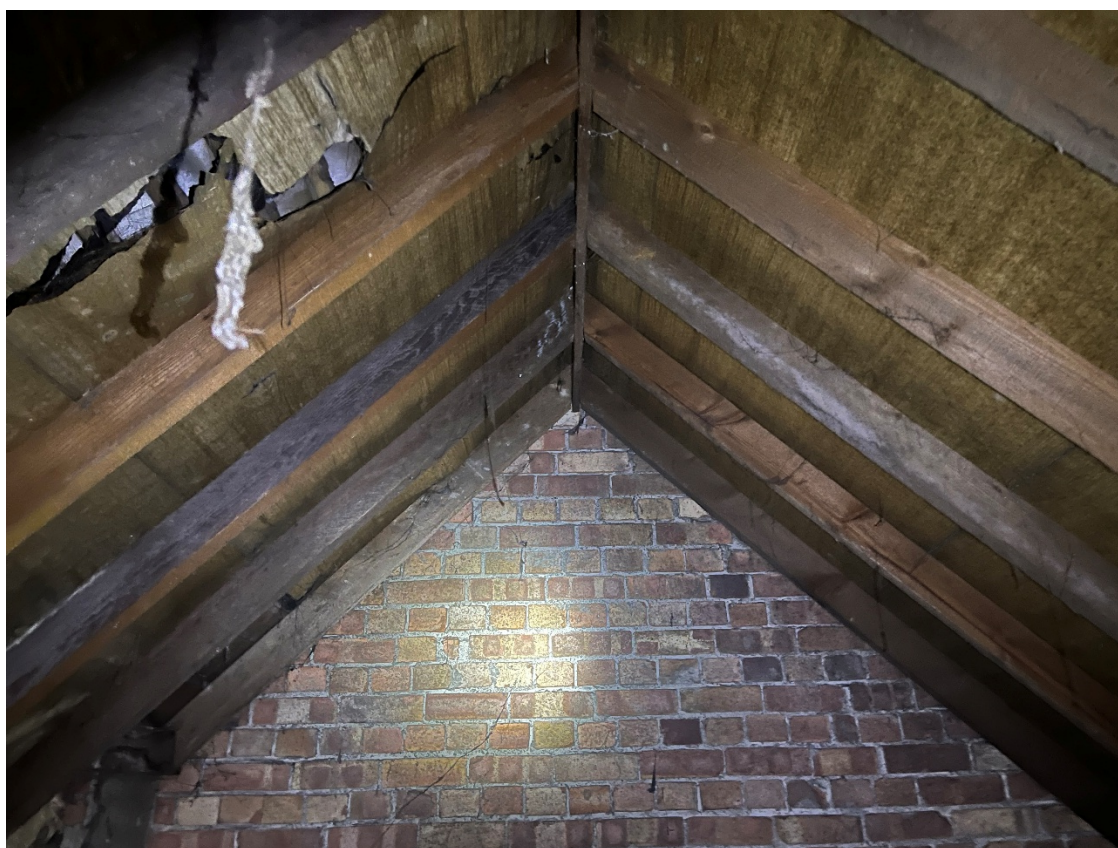
The loft was accessed via a hatch on the landing, and the roof space is open with the roof lined with waxed felting which is in poor order with a few areas where the lining has failed and the tiles visible from within. There were no signs of any bat activity within (see figure 7)

**Figure 7. House loft looking west**
