# Preliminary Roost Assessment

80 Arbor Ln, Winnersh, Wokingham RG41 5JD

This report is prepared to inform a planning application with Wokingham Borough Council. This proposal can be described as "a single storey rear extension and a two storey front extension".

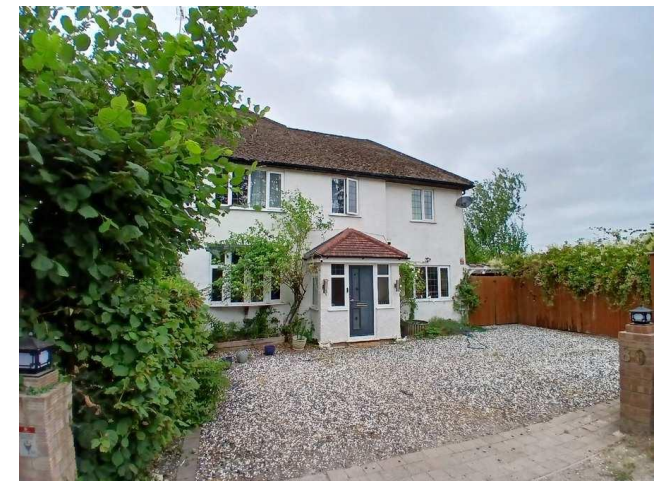
B1 is a two-storey residential dwelling constructed with brick walls and a clay tile roof. The walls are in good condition with no discernible gaps or cracks, and the roof tiles and verges are tightly fitted, presenting no obvious roosting features or access points. Similarly, the timber eaves are in good condition and lack any gaps. Whilst the internal lining of the loft void was in poor condition, no light spill was identified indicating an absence of access points. No bat roosting features, access points, or evidence of bat activity were identified during the survey.

In line with Good Practice Guidelines (Collins, J (Ed) 2023), B1 is assessed to have **negligible** habitat value for roosting bats.

*Eastern elevation of B1.*

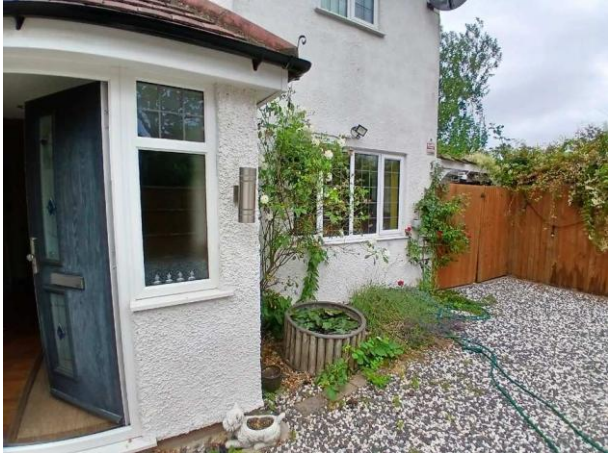
| Feature | Materials/Details | Condition / description / suitability | Photograph |
|---|---|---|---|
| Walls | Brick | <p><b>Condition/description</b><br/>The walls of B1 are in good condition with no gaps or cracks.</p> <p><b>Suitability/access/evidence of bats</b><br/>No bat roosting features or access points were identified.</p> | <p>Eastern elevation walls.</p> |

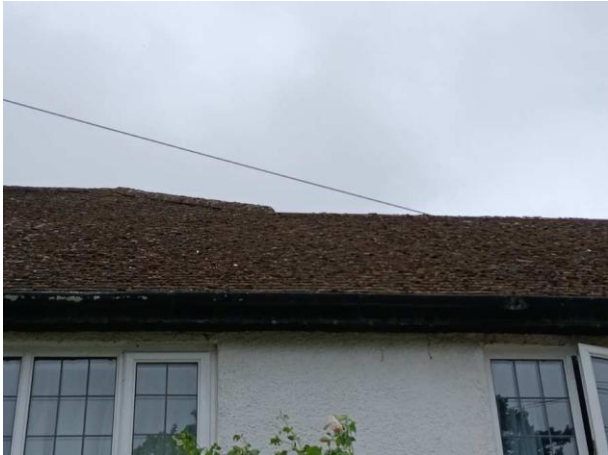
| Feature | Materials/Details | Condition / description / suitability | Photograph |
|---|---|---|---|
| Roof | Clay tiles | <p><b>Condition/description</b><br/>The main roof tiles, ridge tiles and roof verges are tight-fitting.</p> <p><b>Suitability/access/evidence of bats</b><br/>No bat roosting features or access points were identified.</p> | <p>Eastern elevation roof.</p> |

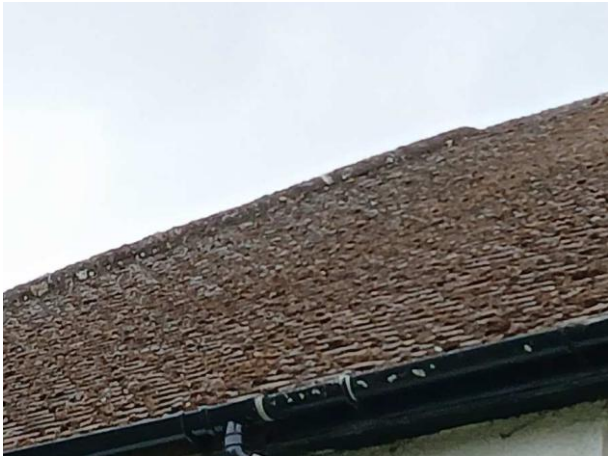
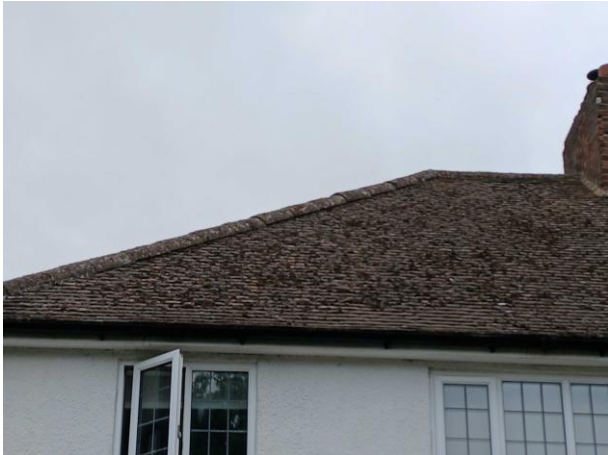
| | | | <div><p><i>Tiles in good condition on the eastern elevation.</i></p><p><i>Western elevation roof of B1.</i></p></div> |

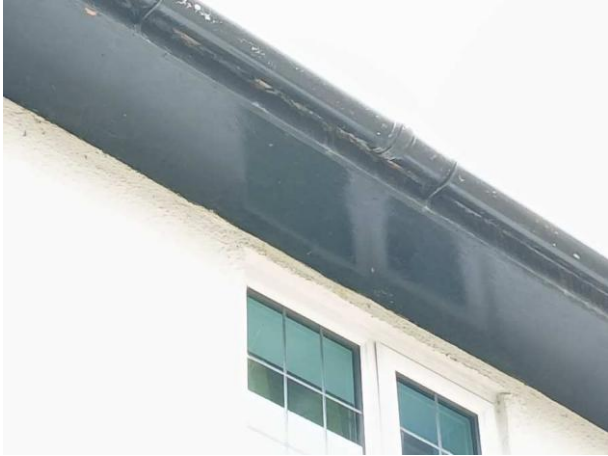
| Eaves | Timber board | <p><b>Condition/description</b><br/>The eaves of B1 are in good condition with no gaps.</p> <p><b>Suitability/access/evidence of bats</b><br/>No bat roosting features or access points were identified.</p> | <p><i>Timber board on the eastern elevation.</i></p> |

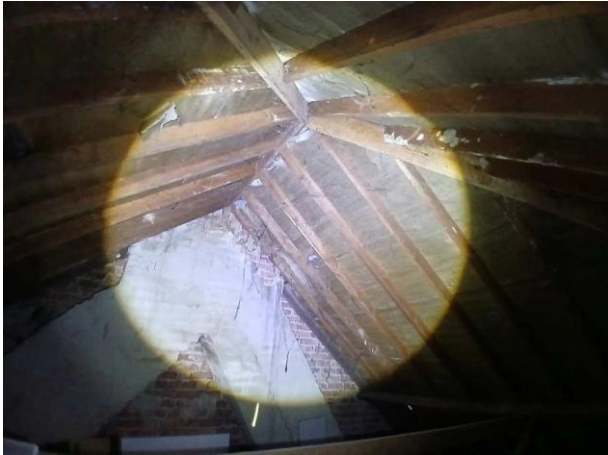
| Internal void | Bitumen felt lining | <p><b>Condition/description</b><br/>The loft void of B1 is ~5m long, ~6m wide and ~3m tall.</p> <p>Whilst the internal lining of the loft void was in poor condition with several tears, no light spill was identified indicating an absence of access points.</p> <p>The flooring of the loft void is partially covered in plywood allowing access to all areas.</p> <p>No rodent droppings were identified within the loft void.</p> <p>No evidence of roosting bats was identified within this void.</p> | <p><i>Internal void facing south.</i></p> |

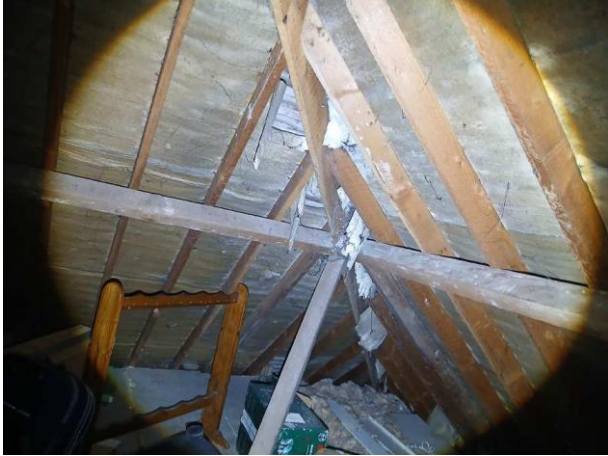
| | | <b>Suitability/access/evidence of bats</b><br>None | <p><i>Internal lining in poor condition.</i></p> |

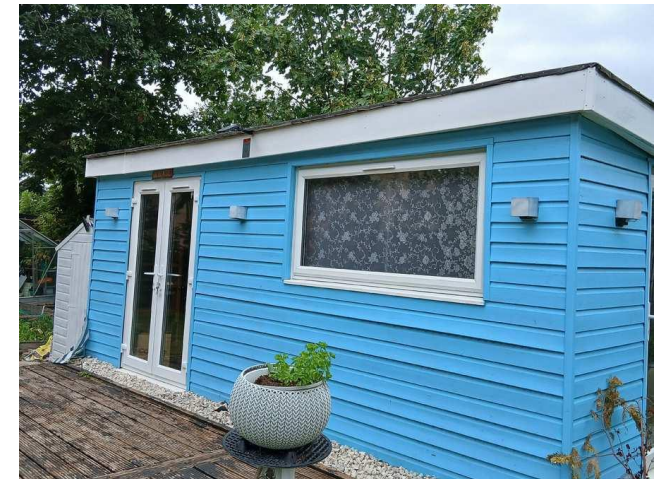
B2 is a detached, single-storey timber-framed outbuilding with a flat roof clad in bitumen felt. The structure is single-skinned, and the internal space is well sealed, with no gaps, cracks or access points identified that would allow bats to enter the building or access any internal voids. No evidence of bats (e.g. droppings, staining or feeding remains) was recorded during the inspection.

B2 also contains large windows, which allow high levels of natural light into the internal space. In addition, the single-skinned timber construction provides little thermal insulation, resulting in significant temperature fluctuations throughout the day and night. These conditions create a bright, exposed and thermally unstable environment, which is unsuitable for roosting bats, as bats typically favour dark, sheltered spaces with relatively stable microclimatic conditions.

In line with Bat Conservation Trust Good Practice Guidelines (Collins, J (Ed) 2023), B2 is assessed to have **negligible** habitat value for roosting bats, as no features likely to be used by bats at any time of the year were identified.

*Southern elevation of B2.*

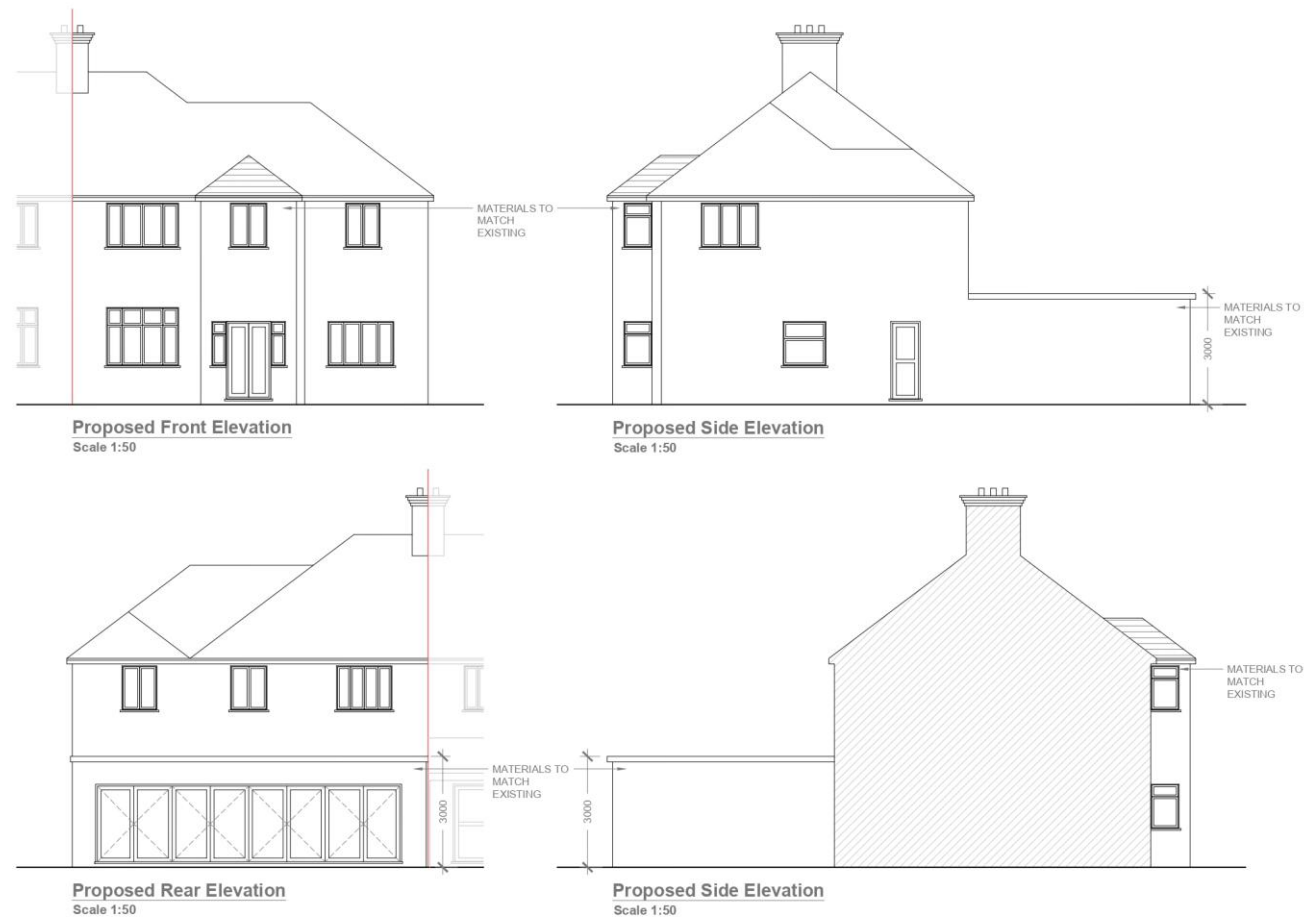
APPENDIX 3: PROPOSED PLAN

| <p>Notes:</p> <p>All plans, sections &amp; elevations are based on measured readings and scaled dimensions.</p> <p>Any discrepancies be reported immediately.</p> <p>To be read in conjunction with Structural Engineers' drawings and Mechanical and Electrical drawings.</p> <p>All Materials To Match Existing</p> | Revisions | Drawing name:<br>Proposed - Elevations | | Drawing no:<br>80 HH 08 | Rev |
