**156 London Road  
Ruscombe  
Twyford  
Reading  
RG10 9HJ**

**ECOLOGICAL SURVEY REPORT (BATS)**  
**(Preliminary Roost Assessment/DBW)**

**Prepared for:  
Mr W. CLARKE  
Date: 28/7/25.  
Ref: NWP/ESR-28/7/25.**

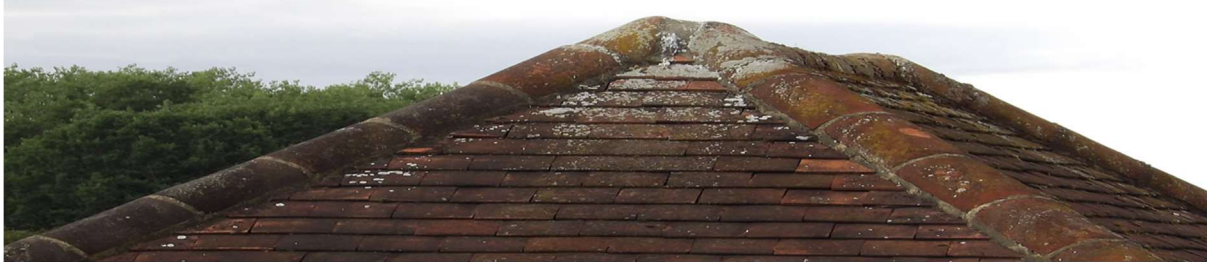
Figure 1. Example of ridge and hip tiles-main dwelling

The ridge tiles on the dwelling were in good condition with no significant missing mortar that bats could exploit. Figure 1.

The hip tiles were in good condition with no significant missing mortar that bats could exploit. Figure 1.

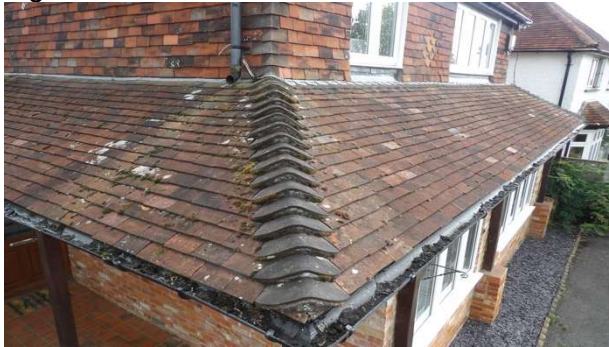
Figure 2.

The tiles covering the roof were in fair condition. Figure 2/3.

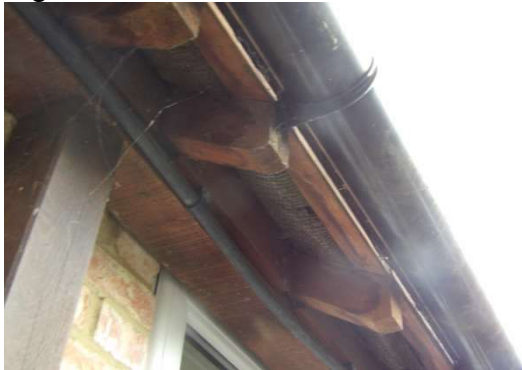
The hanging tiles were not close fitting-there were gaps bats could exploit Figure 5-hatched in red.

No bats or evidence of bats was recorded during the external inspection of the dwelling/extension/garage. There were visible roosting opportunities for bats, under hanging ties, there was no visible access into the building that bats could exploit.

**House-** Informed by the results of the survey and the factors highlighted in Section 6, it is concluded that there is low potential for roosting bats under the hanging tiles affected by the proposed development- Northeastern aspect of the house, if the plans change and any other hanging tiles are touched (front) they would also require further survey effort. Based on recommendations in the Bat Workers Manual and the Bat Surveys Good Practice Guidelines, one further survey effort is required on the tiles hatched in red in Figure 5.

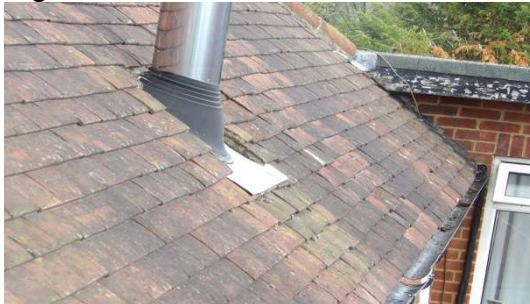
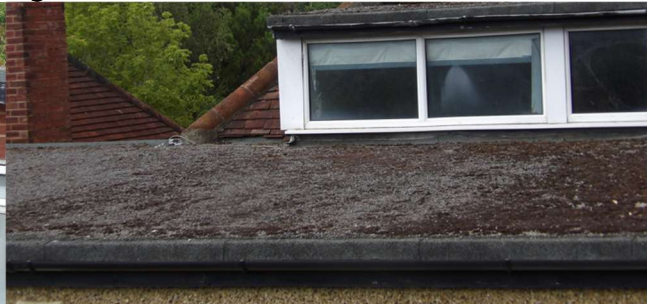
The flat roof was in good condition with no visible gaps that bats could exploit. Figure 7.

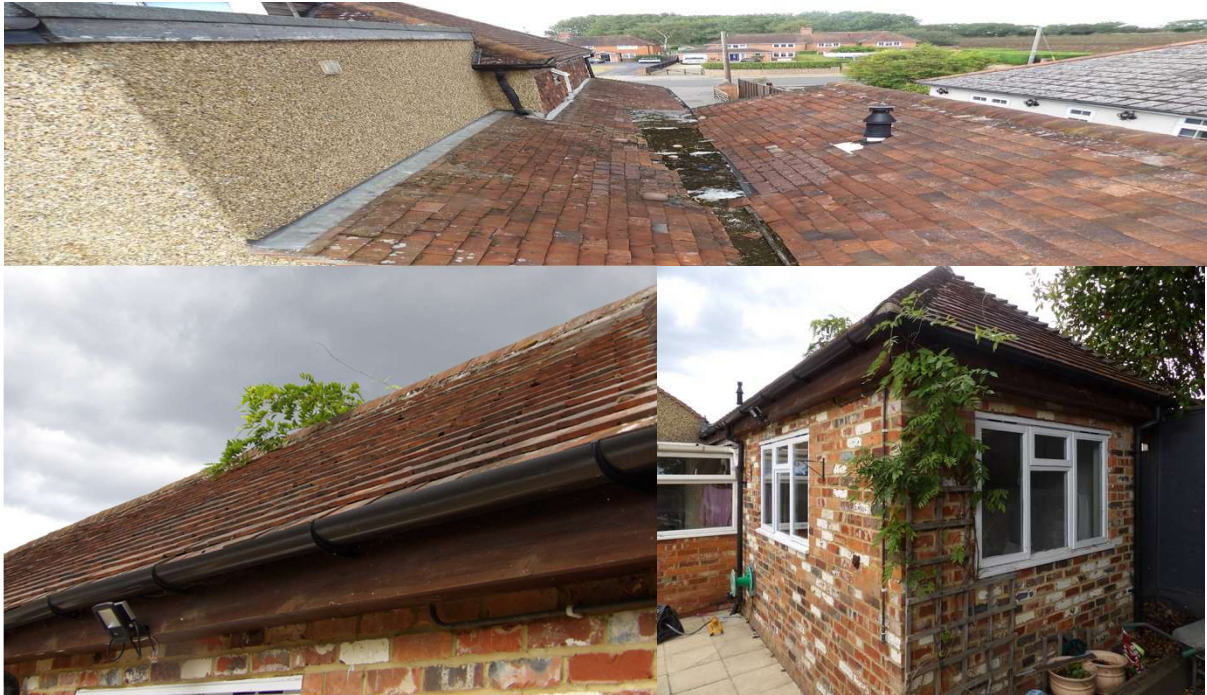
156 LONDON ROAD, RUSCOMBE, TWYFORD, READING RG10 9HJ  
Figure 8/9/10

The ridge tiles on the garage were in good condition with no significant missing mortar that bats could exploit.

The tiles covering the roof were in fair condition, a couple broken however the remainder of the tile appeared to be filling and gap.

The wooden soffits and fascia were all in good condition, close fitting to the walls with no splits or significant openings.

The leadwork around the vent pipe and being used as flashing to seal tiles against the main dwelling was in good condition, close fitting with no significant gaps that bats could exploit.

Figure 8/9/10 show the external area of the garage.

**Garage-** Informed by the results of the survey and the factors highlighted in Section 6, it is concluded that there is negligible potential for roosting bats within the garage, based on recommendations in the Bat Workers Manual and the Bat Surveys Good Practice Guidelines, no further survey effort is required.

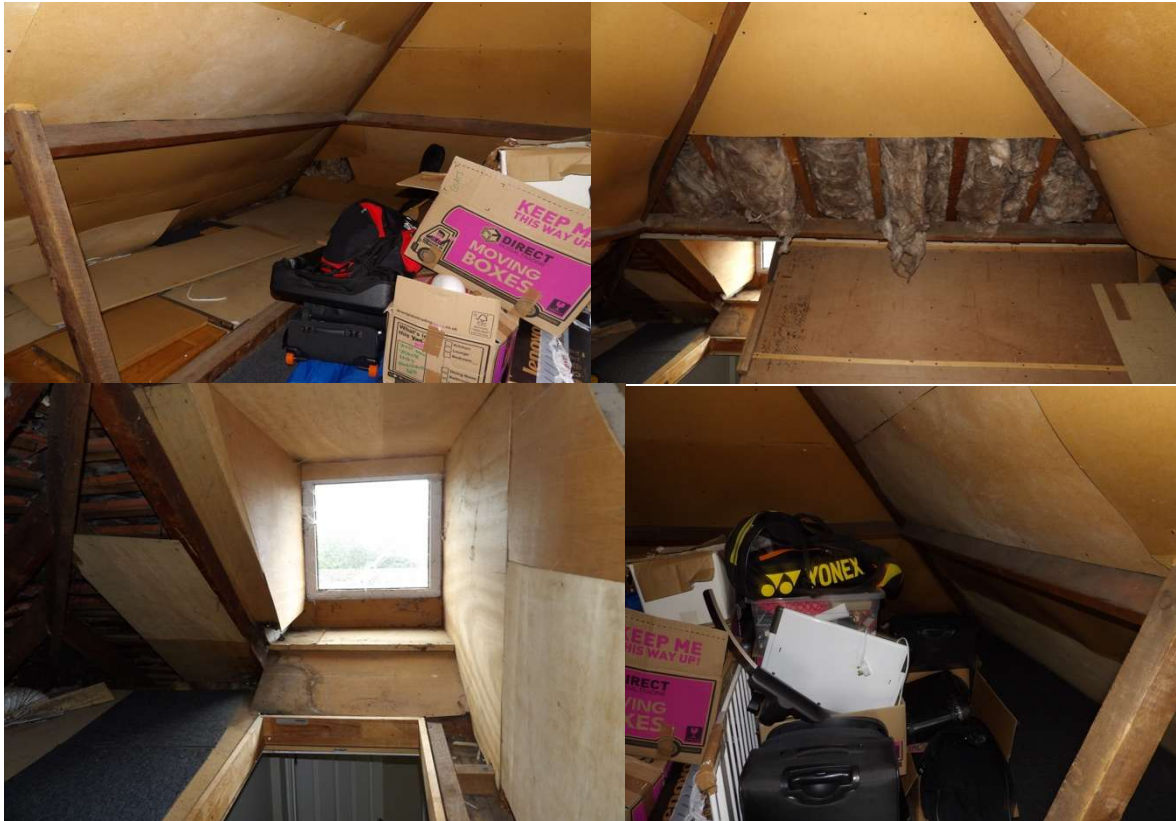
Figure 1/2/3/4.

The roof void in the main dwelling was accessed via steps, it was being used to store some possessions.

There was light ingress due to a window.

The loft area was boarded and insulated.

The tiles were lined with fibre wool insulation held in place with a sheet material.

Figure 1/2/3/4 show general structure and condition of the loft over the main dwelling.

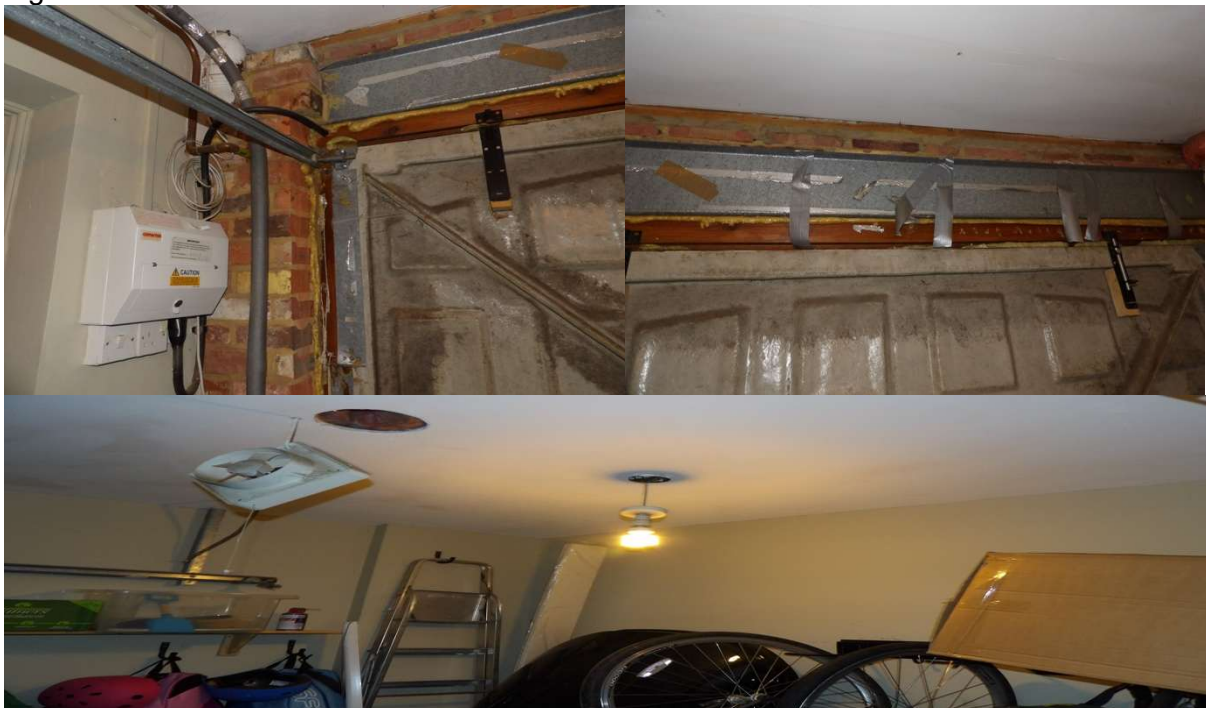
Figure 5/6/7.

The garage had a lined ceiling.

The floor was concrete.

There was no light ingress.

Figure 5/6/7 show internal condition of the garage.
