# **M100.01 Arborfield STW Growth & WINEP**

Arboricultural Constraints Report

November 2025

**Document reference:** M100.01-DN-ARBOS1ZZ-100-AS-EN-0002

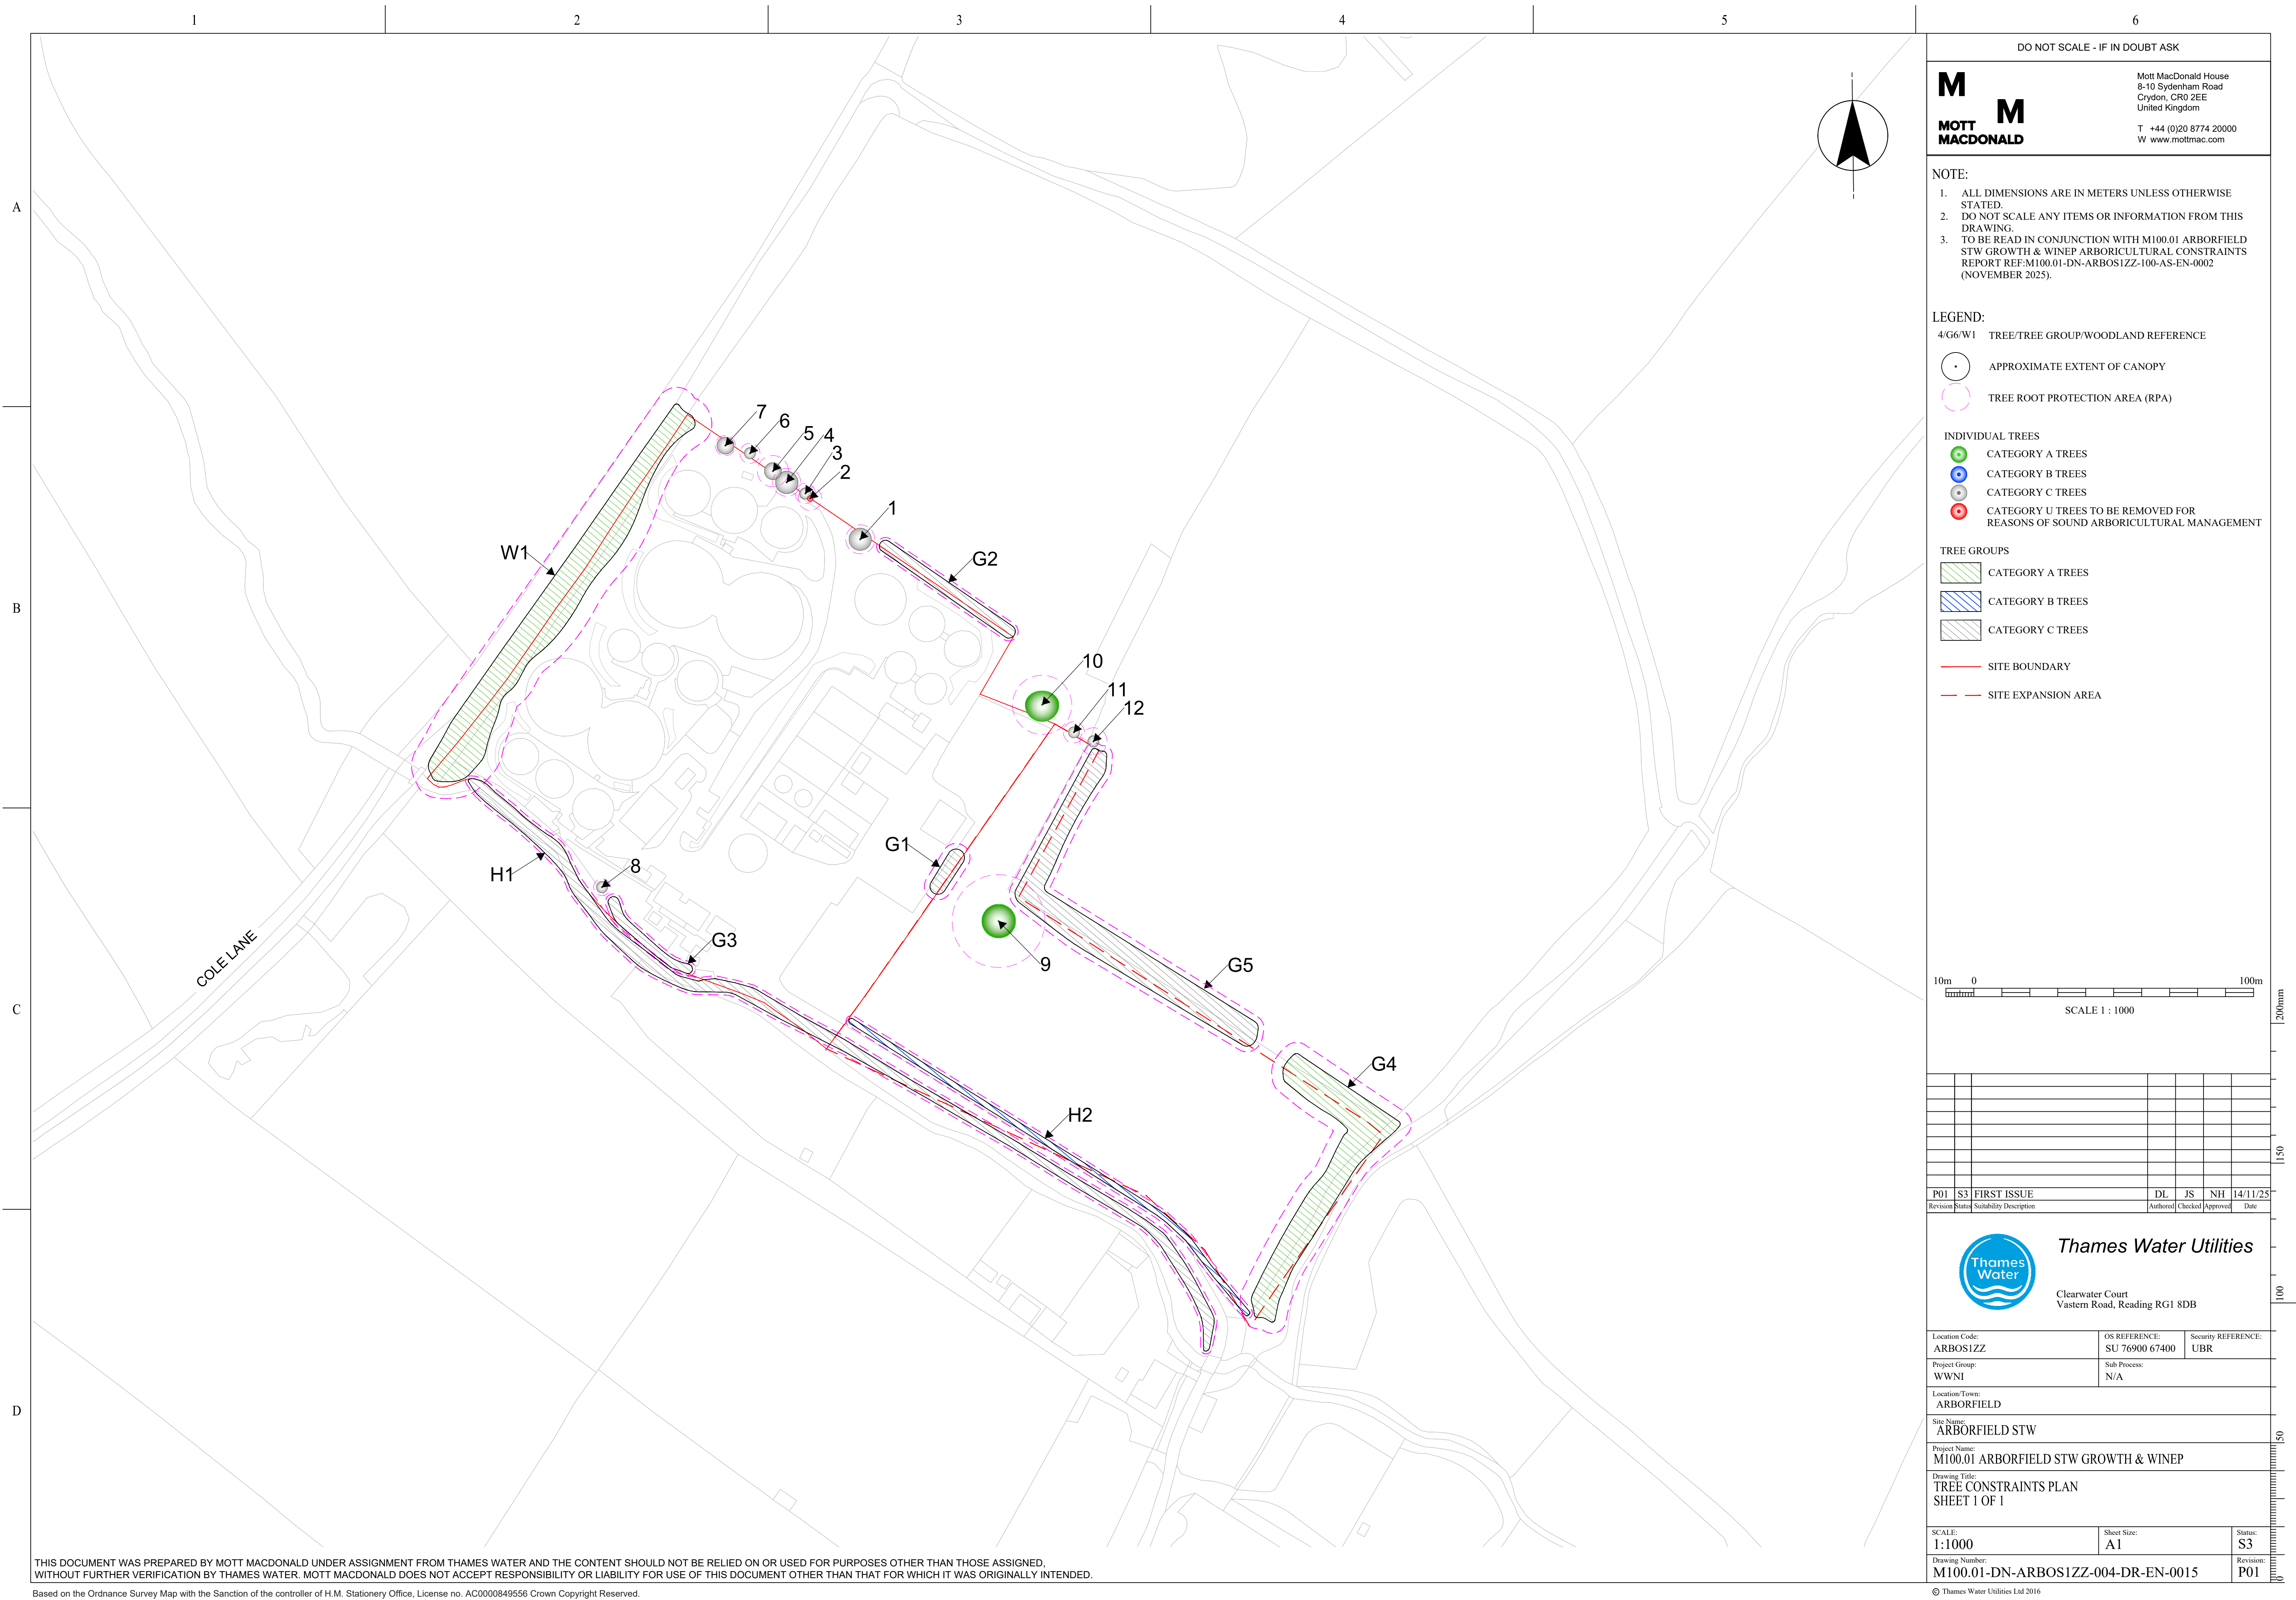
- M100.01-DN-ARBOS1ZZ-004-DR-EN-0016

### C.1 Tree constraints plan

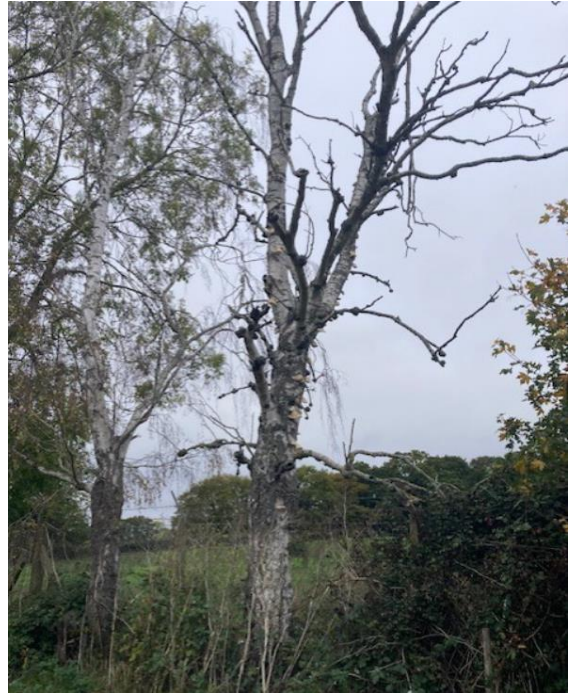
**Figure G.2 Tree 2, taken facing west.**

- 3.2.19 One tree (Tree 2) has been identified as Category U i.e., recommended for removal for arboricultural reasons, in this case the tree is dead.

- 5.1.4 Site specific recommendations include:
- Tree 2 should be removed regardless of any future works as it is dead and poses a risk to operatives on site.

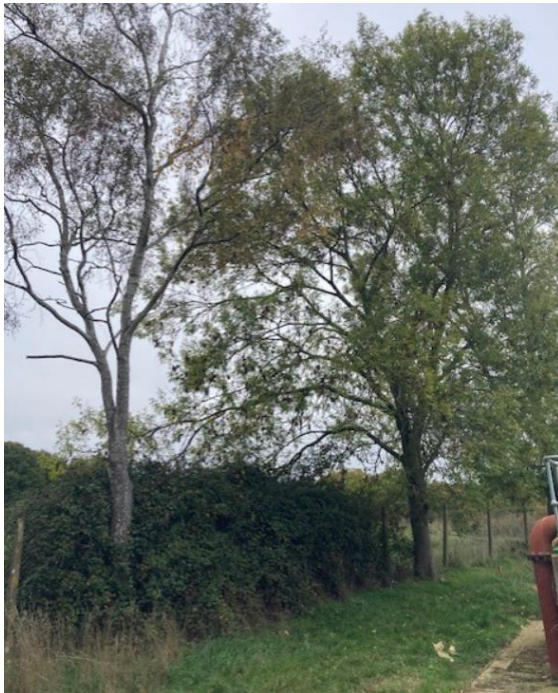
**Figure G.3: Trees 5 and 6, taken facing south west.**

- 3.2.16 Trees 1, 3 to 8, 11 and 12 have been assessed as Category C. These trees are primarily semi mature, generally in good condition, and are located around the perimeter of the Site.

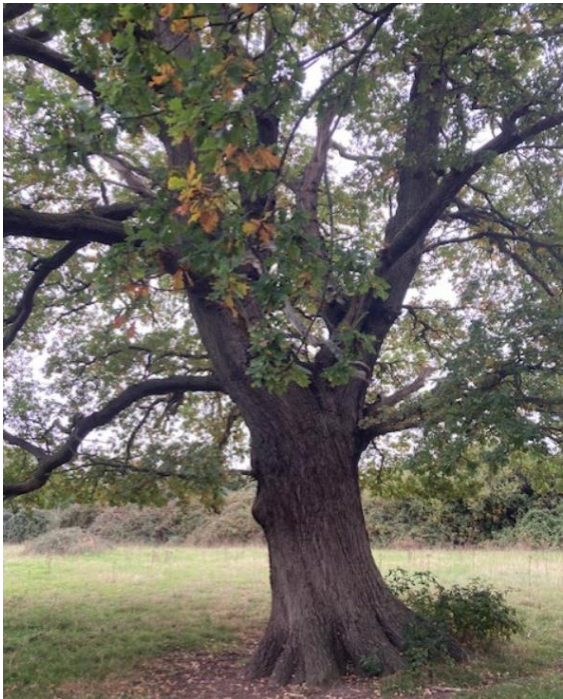
**Figure G.6: Tree 9 taken facing north.**

3.1.3.1 A check has been also undertaken using the Woodland Trust's Ancient Tree Inventory (ATI)<sup>7</sup> and has confirmed that there is one veteran tree (Tree 9) within the survey area, one veteran tree within woodland W1 and one notable tree within woodland W1 (**Appendix F**).

| Tree ref | Tree Type | Life Stage | Height (m) | Av Crown Spread (m) | | | | Av Crown Height (m) | | | | | No of Stems or trees | Stem Diameter (mm) | Root Protection Area (RPA) | | Condition | | | | BS5837 Category and subcategory | | Estimated remaining contribution (years) | Comment |
|---|---|---|---|---|---|---|---|---|---|---|---|---|---|---|---|---|---|---|---|---|---|---|---|---|
| 9 | Pedunculate Oak | Veteran | 15 | 6 | 6 | 6 | 6 | 2N | 2 | 2 | 2 | 2 | 1 | 1380 | 16.6 | 862 | Good | Good | Good | Good | A | 2 | 40+ | This tree has excellent form and vitality with veteran features including decay, large limbs, and cavities. This tree is the most prominent tree within the locality and is recorded as a veteran tree on the veteran tree register. |

- All works MUST remain outside the RPA of tree 9 as this tree is recorded as a veteran tree. As a veteran tree this is considered irreplaceable habitat and as such there must be no loss or deterioration which may result from indirect works, *for example, the effect of air pollution from development that results in a significant increase in traffic.*

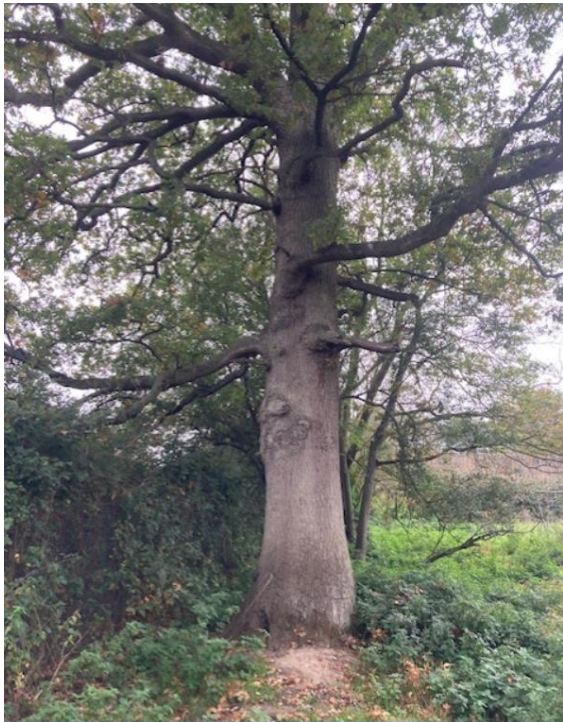
**Figure G.7: Tree 10 taken facing north.**

| Tree ref | Tree Type | Life Stage | Height (m) | Av Crown Spread (m) | | | | Av Crown Height (m) | | | | | No of Stems or trees | Stem Diameter (mm) | Root Protection Area (RPA) | | Condition | | | | BS5837 Category and subcategory | | Estimated remaining contribution (years) | Comment |
|---|---|---|---|---|---|---|---|---|---|---|---|---|---|---|---|---|---|---|---|---|---|---|---|---|
| 10 | Pedunculate Oak | Mature | 18 | 5 | 6 | 6 | 6 | 3N | 3 | 3 | 3 | 3 | 1 | 880 | 10.6 | 350 | Fair | Fair | Fair | Fair | A | 2 | 40+ | Located within farmland, minor basal damage likely due to livestock, slightly sparse crown and low vitality. |

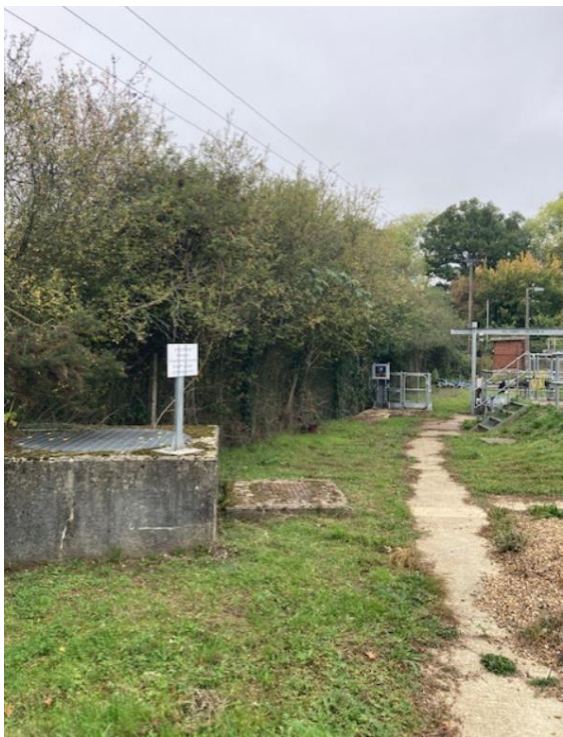
Figure G.7: H1 taken facing north.

- 3.2.17 One hedgerow (H1) has been assessed as Category C i.e. low arboricultural value. This hedgerow is outside the site perimeter fence line and has been pruned back to the fence line. It is sparse and scrubby being made up in parts of bramble.
- 3.2.18 **It is recommended that removals are avoided unless it is integral to facilitate construction, and that any screening functions or amenity value that is lost is reinstated with mitigation planting.**

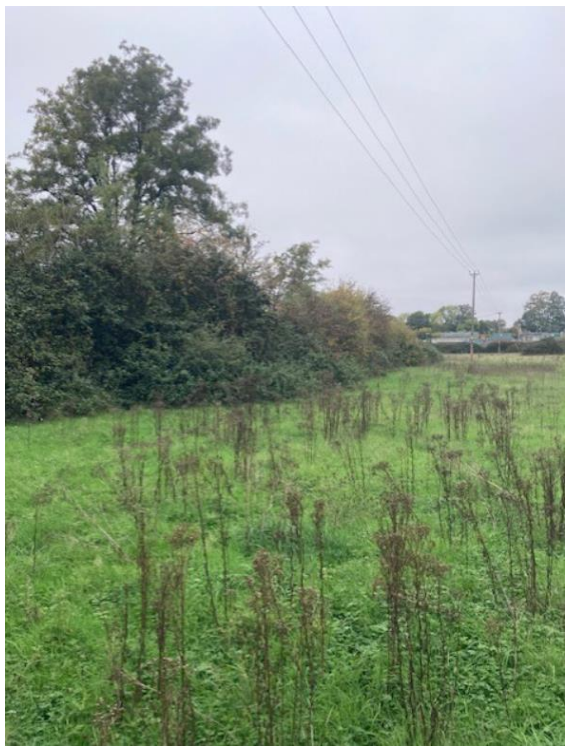
Figure G.8: H2 taken facing north.

- 3.2.14 One hedgerow (H2) has been assessed as Category B i.e., moderate arboricultural value. This hedgerow has high amenity value as part of the wider landscape and high ecological value as it has remained unpruned being allowed to grow to full height forming a very dense hedgerow.
- 3.2.15 **It is recommended that all works remain outside of the RPAs of both Category A and B trees and hedgerows, and that they are retained as valuable landscape features within the Site.**
