# ROAVR | GROUP

**Project:** 25\_PRA\_05\_38  
**Site:** 7 Remenham Hill, Henley-on-Thames RG9 3EE  
**Client:** Hayley Hamilton

| Report Type: | Preliminary Roost Assessment Report [PRA]<br>Daytime Bat Walkover (DBW) |
| Site Address: | 7 Remenham Hill, Henley-on-Thames RG9 3EE |

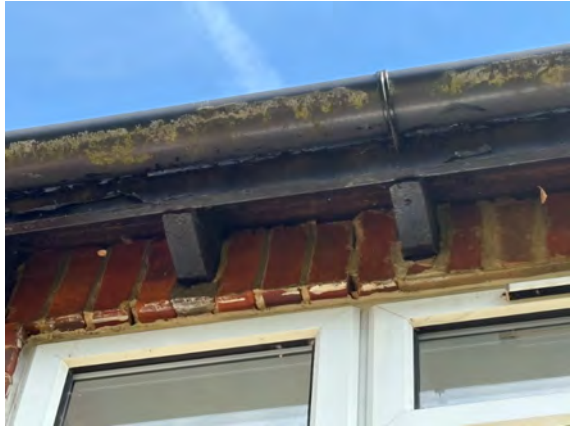
| Detail | Photograph |
|---|---|
| <p><i>Gaps beneath soffits and between brickwork on front elevation of B1</i></p> | |

The northern elevation of Building B1 features areas of exposed brickwork due to ongoing internal refurbishment. A number of gaps were observed beneath the soffit boards and fascias, some of which may offer potential access points for roosting bats. A structure resembling a potential bat box was noted beneath the soffits, although this could not be confirmed from ground level. Slipped roof tiles were also evident at roof height, contributing to the building's low bat roosting potential on this elevation.

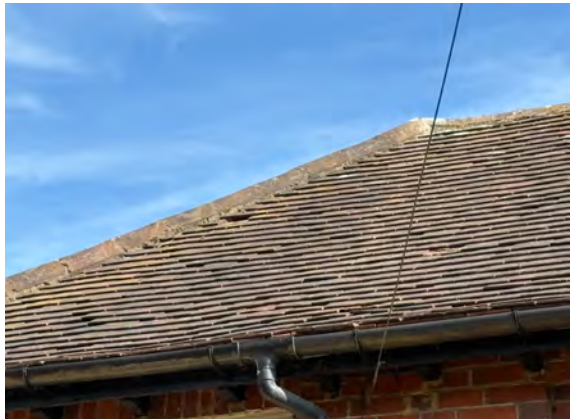
| Detail | Photograph |
|---|---|
| <p><i>Missing and lifted tiles on front elevation roof of B1</i></p> | |

The pitched roof is of traditional clay tile construction with a central ridge along its apex. Several slipped and missing tiles were recorded on multiple slopes, representing possible ingress points for bats, particularly into the void spaces between the tiles and roofing membrane. However, internal inspection of the loft void revealed it to be insulated and well sealed, with no evidence of bat occupation such as droppings, staining, or feeding remains. Nonetheless, due to the external access opportunities, the roof retains low potential to support roosting bats.

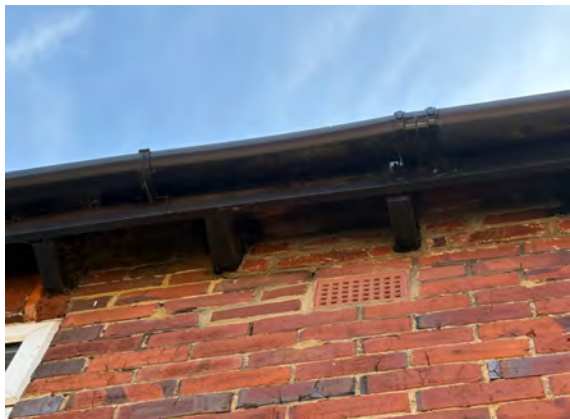
| Detail | Photograph |
|---|---|
| <p><i>Gaps under soffits on side elevation of B1</i></p> | |

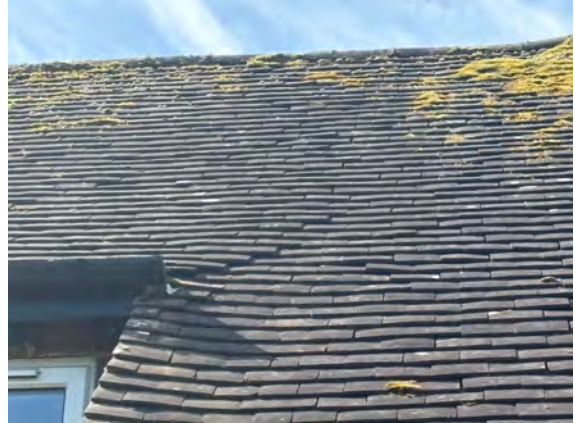
*Lifted tiles on roof of rear elevation of B1*

The eastern elevation, overlooking the rear garden, displayed slipped tiles near the eaves and intermittent crevices along the fascia boards. These defects offer potential commuting and roosting opportunities for crevice-dwelling bats. Works proposed along this elevation, including the rear extension, may result in temporary disturbance or loss of these features and should be appropriately mitigated. The adjacent vegetated space provides direct connectivity to surrounding garden habitats, further enhancing its ecological value.

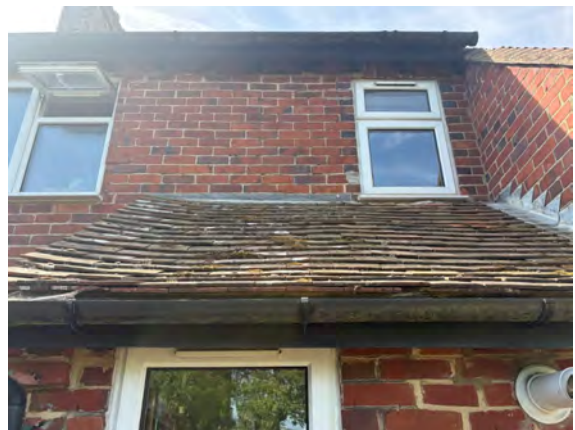
*Lifted tiles on roof of extension on rear elevation of B1*

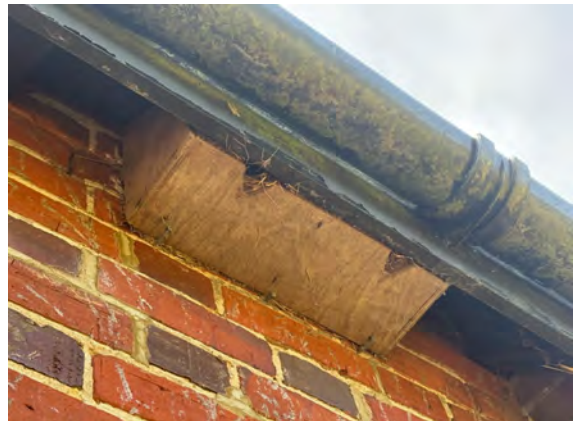
*TN2 - Potential bat box under soffit on rear elevation of B1*

| Bats (Chiroptera) | Presence/Potential | Further Comments | Potential Impacts | Recommendations for Mitigation |
|---|---|---|---|---|
| Roosting Bats | Low | Building B1 displays a range of PRFs including slipped/missing roof tiles and gaps beneath fascias and soffits, which may accommodate crevice-dwelling bats such as common pipistrelle ( <i>Pipistrellus pipistrellus</i> ). No evidence of current or historic bat use was recorded internally despite accessible voids, and these features are considered of limited suitability when assessed against the 2023 Bat Conservation Trust guidelines. | If unmitigated, the removal of external features such as roof tiles and replacement of fascia elements may result in the loss of occasional or transient roosting opportunities for individual bats. | <p>One bat presence/absence survey (NBW) is to be carried out.</p> <p>The surveys should be carried out between May and September (with September considered to be sub-optimal), a minimum of three weeks apart should further surveys be required.</p> <p>No works must proceed until further surveys have been carried out and appropriate mitigation strategies have been identified.</p> <p>Any existing potential bat box should be inspected by a licensed ecologist.</p> |

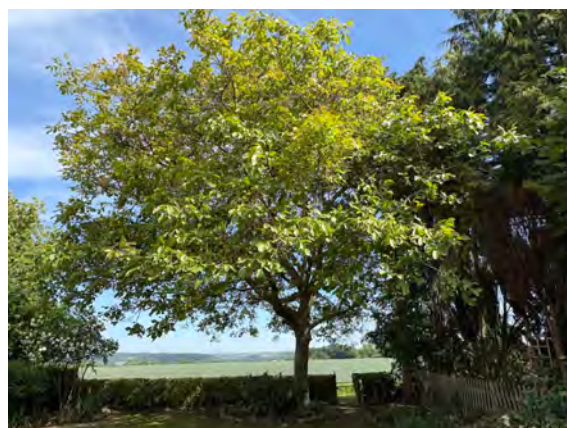
T4 refers to a mature walnut tree (*Juglans regia*) located at the southern boundary of the rear garden. This tree possesses several potential roost features (PRFs) with suitability for use by roosting bats. On the north-facing elevation of the canopy, multiple broken limbs, historic pruning wounds, and split branches were observed. These features create narrow crevices and cavities that may offer sheltered conditions for a range of bat species, particularly those that utilise cracks and voids such as common pipistrelle (*Pipistrellus pipistrellus*), soprano pipistrelle (*Pipistrellus pygmaeus*), or brown long-eared bat (*Plecotus auritus*). The tree's position within a well-vegetated garden setting, with connectivity to boundary hedging and nearby woodland across the road, enhances its value as part of a wider foraging and commuting network. The presence of suitable roosting features combined with favourable landscape context supports the assessment of the tree as having moderate bat roost suitability.

*T4- Walnut tree*

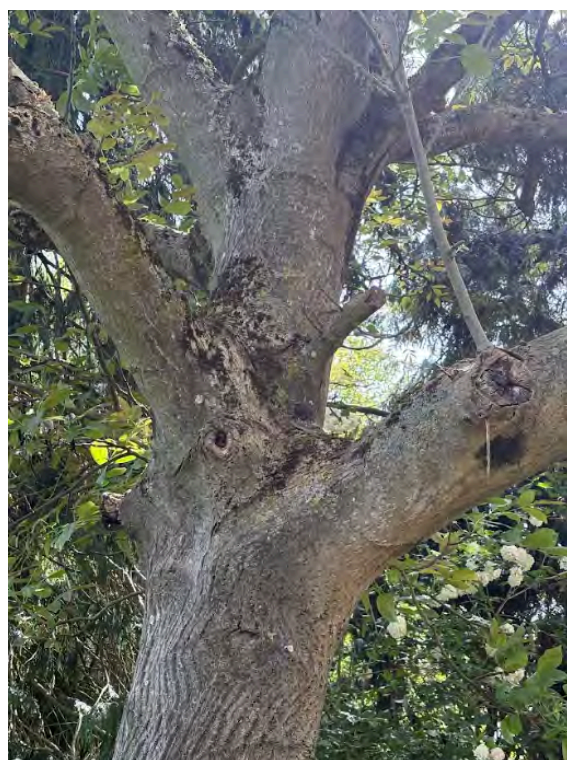
*PRFs of T4*

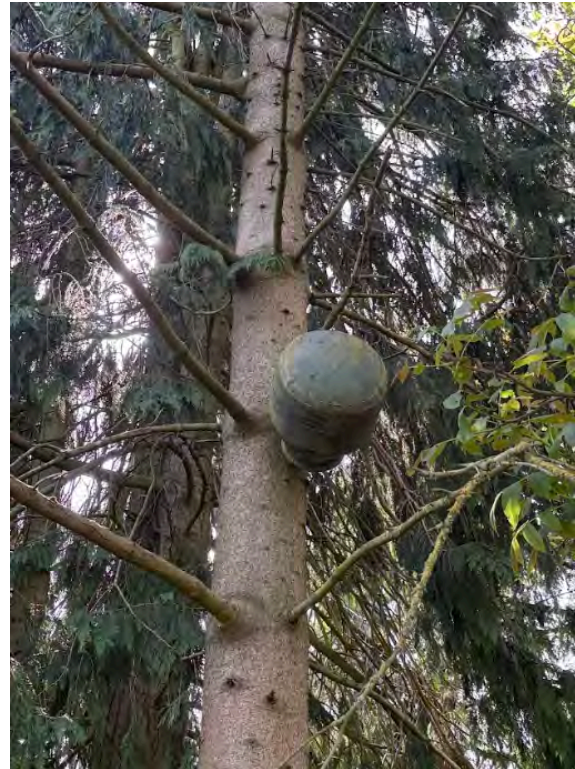
TN3 - potential beehive cover on Norway Spruce (T5)

TN3 – In the northeastern corner of the rear garden, fixed to a Norway spruce tree (*Picea abies*; referred to on site as T5), a housing structure was observed that may function as a protective cover for a beehive. The item is mounted at height and is securely attached to the trunk of the tree. While not a PRF in itself, its presence within a vegetated and sheltered section of the garden contributes to the wider ecological value of the site. It may also incidentally increase insect biomass locally, thereby enhancing nocturnal foraging conditions for bats in the immediate vicinity.
