# Proposed Renovations at Bird Place, Henley-on-Thames, Berkshire, RG9 2LN

## Bat Emergence Surveys

September 2025

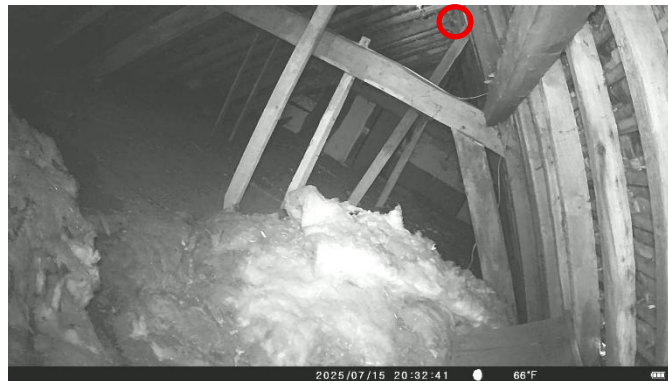
When deploying the static bat detector and motion camera, one brown long-eared bat (*Plecotus auritus*) was observed in the loft space. It was seen flying within the loft space before hanging on a roof rafter at the eastern end of the loft. The bat was not seen to have emerged during the survey so may have remained within the loft space after being disturbed.

*Brown long-eared bat roosting on the rafter when deploying the remote monitoring equipment*

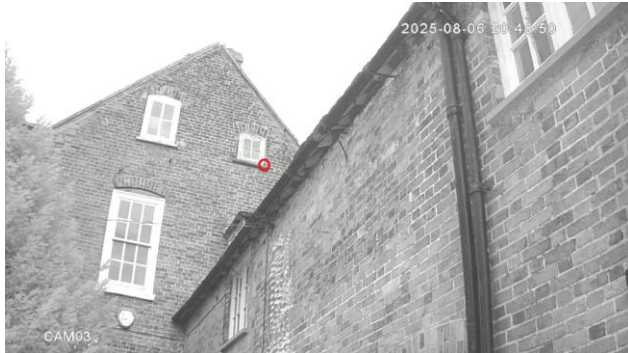
The first bat recorded was a soprano pipistrelle bat and was seen at 20:48 emerging from a gap in the mortar to the right-hand side of a window situated to the right of the western gable end of Bird Place. A second soprano pipistrelle bat emerged from the same window but from a gap in the mortar to the left of the window, at 21:06. At 21:23, a brown long-eared bat emerged from a lifted tile near the roof ridge on the northern elevation of Rose Cottage. Foraging activity was noted to be frequent and primarily from soprano pipistrelles, with occasional recordings of commuting and foraging common pipistrelles. Two counts of noctule were recorded commuting over the site.

*First soprano pipistrelle bat seen emerging on the infrared camera during the second survey*

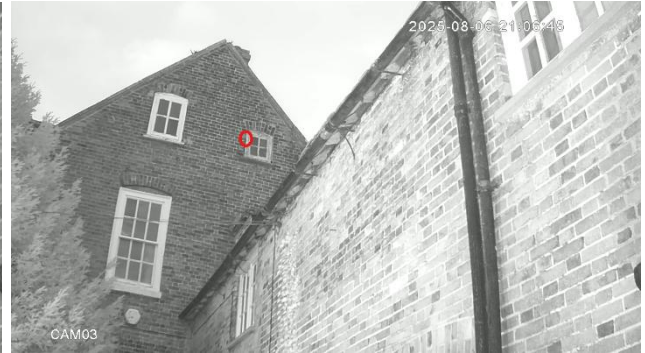
*Second soprano pipistrelle bat seen emerging on the infrared camera during the second survey*

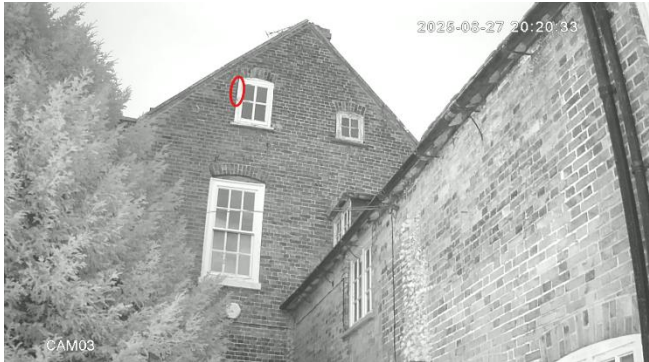
The first bat recorded was a soprano pipistrelle bat and was seen at 20:06 emerging from a gap in the mortar to the left of a window situated to the left of the western gable end of Bird Place (a different window to the emergence location of Visit 2). Three further soprano pipistrelle bats emerged from the same location at 20:12, 20:15 and 20:20. At 20:31, a brown long-eared bat emerged from the same location as in the second survey, the roof ridge of Rose Cottage. During the survey, several soprano pipistrelle social calls were recorded to the front of the property, with intermittent soprano pipistrelle commuting and foraging activity. Two counts of noctule were recorded commuting over the site.

*Location of four emerging soprano pipistrelle bats seen on the infrared camera during the third survey*

As it is not considered possible to retain the locations of the soprano pipistrelle bat roosts around the windows on the western gable end wall of Bird Place as the windows will be replaced, it is recommended that replacement bat roosting provision be provided by installing three bat boxes. Any feature installed needs to be a minimum of 3m high, and not illuminated by any lighting, with a clear path for the bats to access the boxes. Ideally the bat boxes would be positioned as close as possible to where the bats were recorded roosting on the gable end wall. A suggested brand is shown below where the colour can be selected and the brand of bat box is known to have good uptake of bats. It is not known if there may be restrictions due to the listed building status, therefore alternative designs and locations can be considered if required.

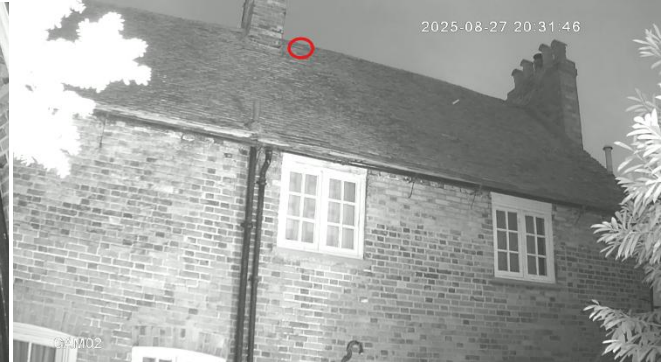
*Brown long-eared bat seen emerging on the infrared camera during the third survey*

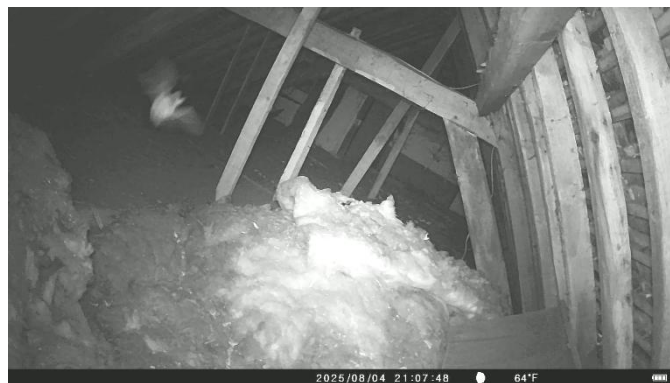
During the remote monitoring period inside the loft space between the first and second emergence survey, the motion activated trail camera was triggered by flying brown long-eared bats, all on 4<sup>th</sup> August 2025, starting at 21:04 and finishing at 21:22. The bat appeared to be attempting to forage on a moth within the loft. A rat (*Rattus norvegicus*) was also observed on one occasion within the loft.

*Brown long-eared bat in the loft recorded on the trail camera*

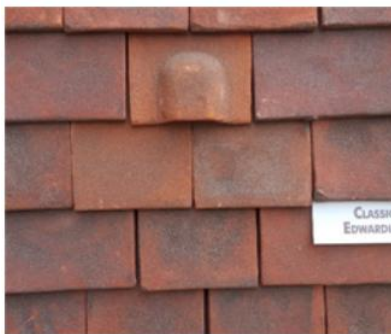
*Example of a bat access tile (from Heritage Clay Tiles Ltd) which can be purchased*

recommended that five bat roosting opportunities are incorporated into the scheme. It is recommended that brown long-eared bat roost within the loft space of Bird Cottage is retained so bats can continue to use the loft space. It is understood that new insulation will be installed, but if roof felt is required, only Type 1F bitumen should be used (bats can become entangled in breathable membranes). Ideally the access feature being used by the bat (the lifted tile near the ridge) should be retained or re-created during the re-roofing / repair works, but if this is not possible, then two access features into the loft space should be created, such as lifted tiles or areas of missing mortar. Contractors could advise how best to achieve the lifted tiles but may be possible through placing a small piece of wood / mortar / tile etc behind the tiles, or using a piece of lead to create an access feature. The two features should be created near the ridge on the northern elevation to best replicate where the bats are currently roosting (and provides the bats an option should one become blocked by other animals). Alternatively, specific bat access tiles can be purchased. Examples are listed below, but others are available:

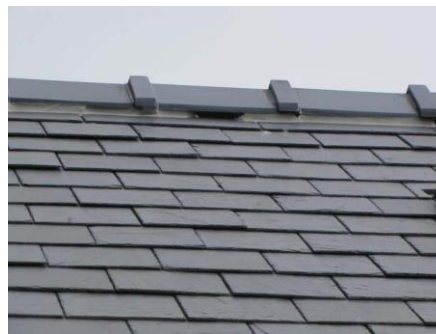
*Access feature created from a gap in the mortar*

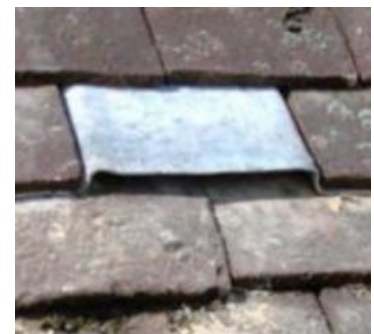
*DIY of a bat access feature in lead*

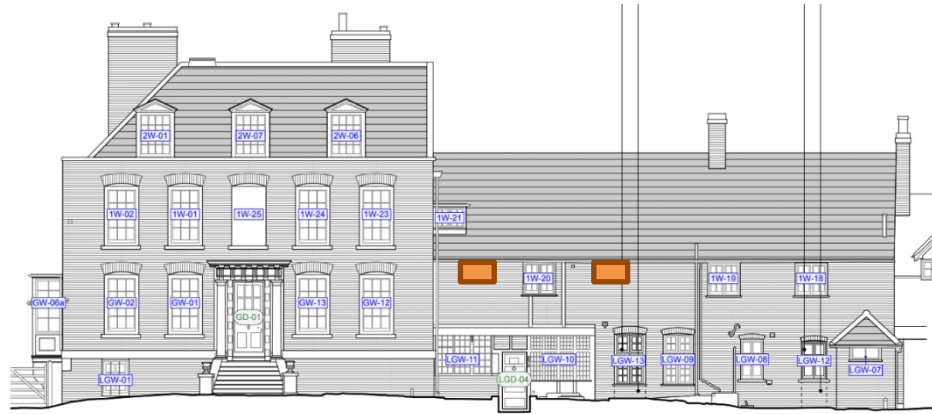
Front Elevation, North  
Scale 1:100

*Suggested swift box locations*

As bird nesting opportunities will be lost, compensation will be required to ensure there is no net loss of bird nesting habitat on site. It is recommended that three bird boxes are installed within the scheme, including two swift boxes and one hole nest box. The swift boxes should be installed at least 3m high and on a north or shaded elevation. Durable materials such as Woodcrete are recommended to provide longevity of the potential nesting habitat. A bird box should be erected on a nearby tree or within vegetation near the building. A range of bird boxes can be purchased from [www.nhbs.com](http://www.nhbs.com), examples and suggested locations are listed below but other equivalent brands are available.
