15<sup>th</sup> November 2025

Our reference: 126-128 Victoria Road PRA Report

██████████  
**126-128 Victoria Road, Wargrave - Bat Preliminary Roost Assessment (PRA)**

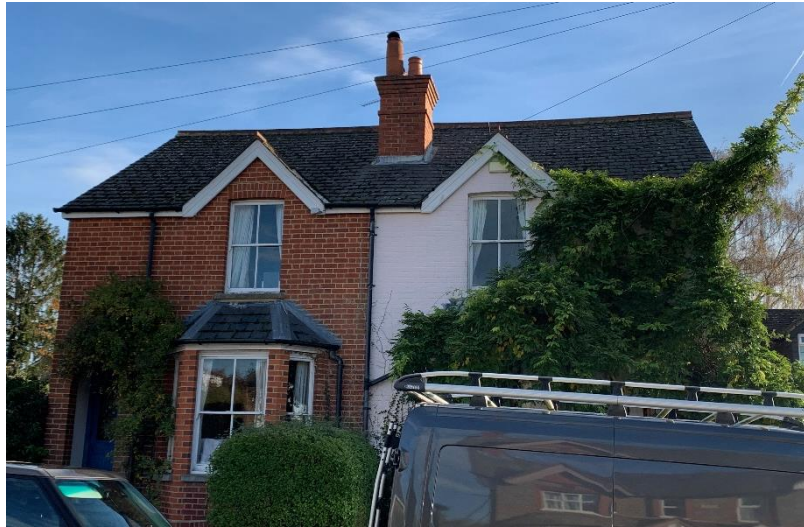
**Plate 1 - The building shown from the front**

The current properties are two semi-detached homes built of typical brick construction with slate tile roof. The building appears to have been constructed in approximately early 1900s. There have been some previous alterations including single storey rear extensions. Plates 1 & 2 shows the building from the front and rear.

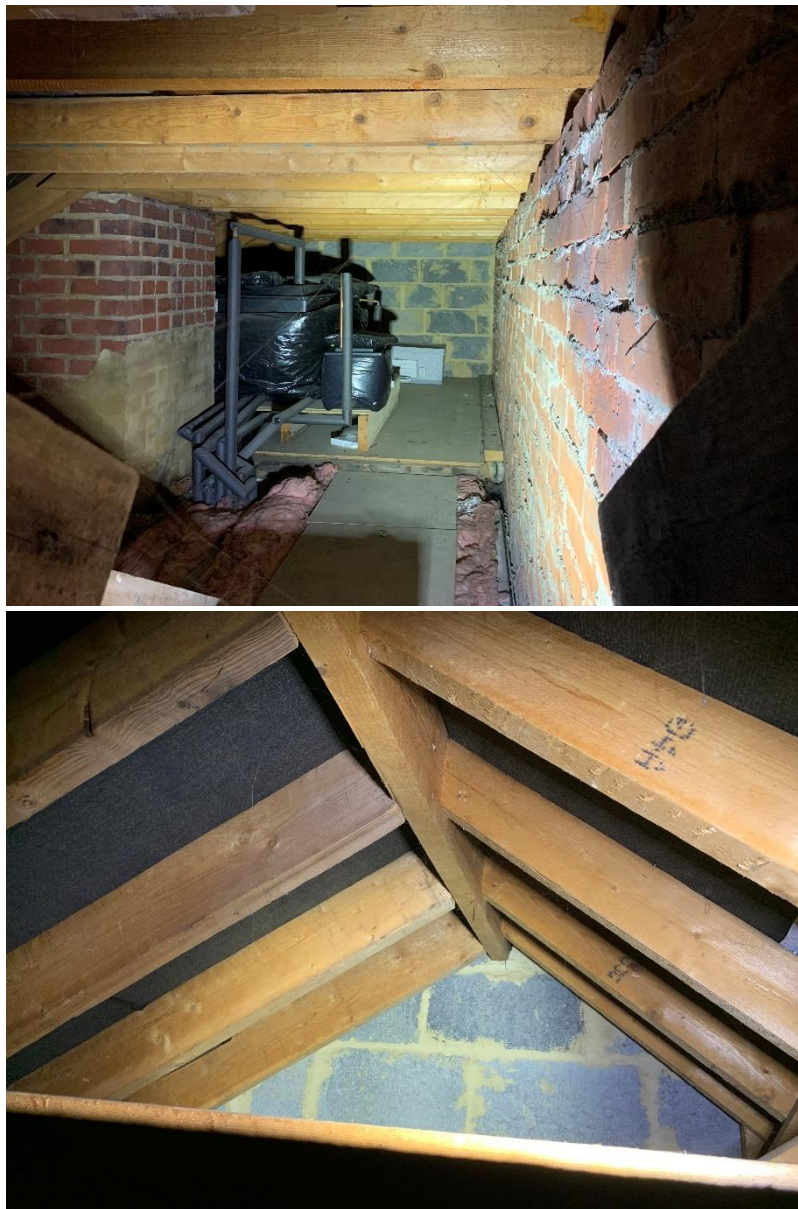
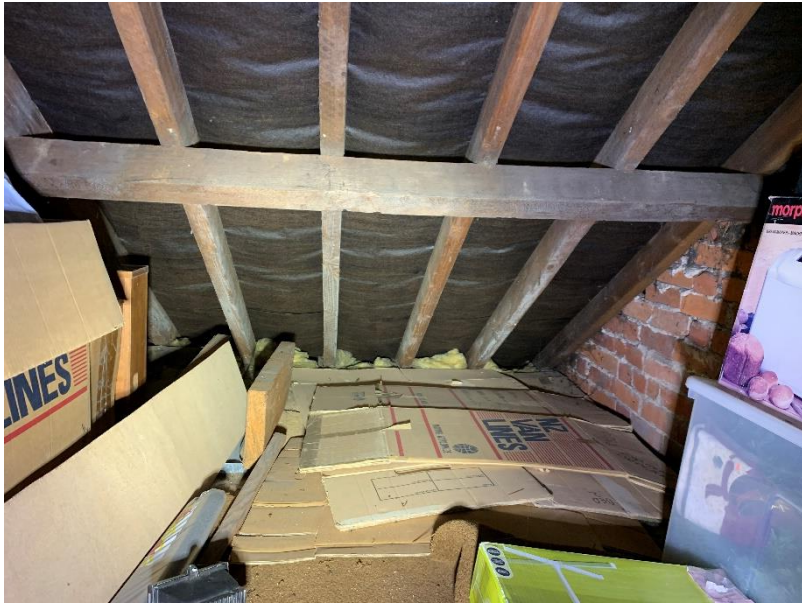
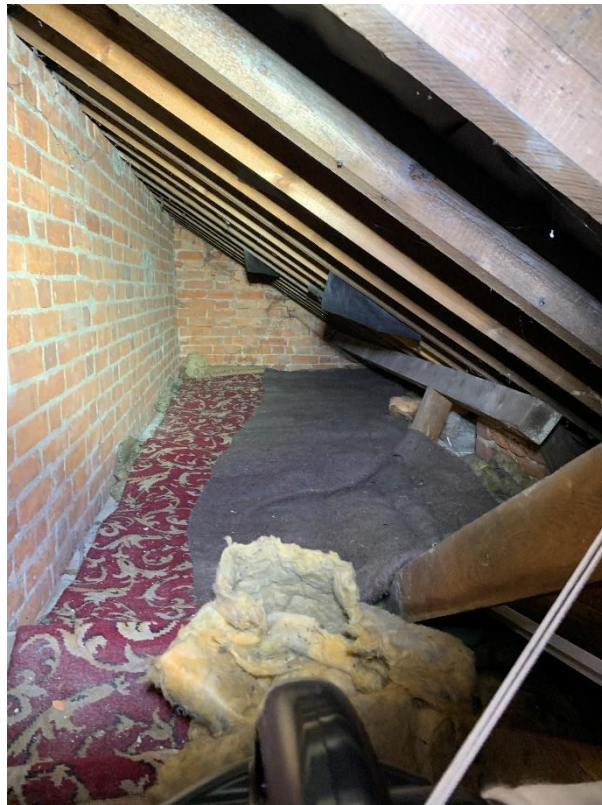
#### **Plates 3-6 - Internal roof space images**

Based on the development proposals the impacts will be focused on the existing rear extensions. There will be a very small impact for the 'tie-in' of the new roof to the existing main house roof. The assessment focused on these areas of building only as there are no predicted significant impacts to trees and other habitats that would affect bats or other species e.g. great crested newts, reptiles etc. Both of the roof spaces were inspected internally and showed largely unmodified main roof spaces. A traditional cut-timber structure was present with felt sarking. Where roof repair and replacement has been done previously the felt and timbers are of the same traditional style. There was no evidence of bat presence within the roof space e.g. droppings, staining, scratching, feeding remains or bats themselves.

Plates 3-6 provide photographs of the internal roof spaces of the building.

The PRA survey found no evidence of bats (e.g. bat droppings). No potential bat access points to the property were found. Taking into account the surrounding habitats and bat licence records within 2 km of the property it is considered that the building has **negligible potential** to support bats. This level is not 'none' and there is a very minimal chance that a bat may unexpectedly cling to a non-standard feature on the property for example. Therefore basic recommendations are made to keep survey information up to date and for awareness during building work, plus for enhancement for bats to be able to use the site in the future

Recommendations to safeguard bats are made based on the results of this PRA. Based on the inspection revealing no evidence of bat presence and no features able to support roosting bats, further surveys are not considered to be appropriate. During all work an ecologist should be on-call to attend site and advise should there be any unexpected discoveries of bats or other wildlife.

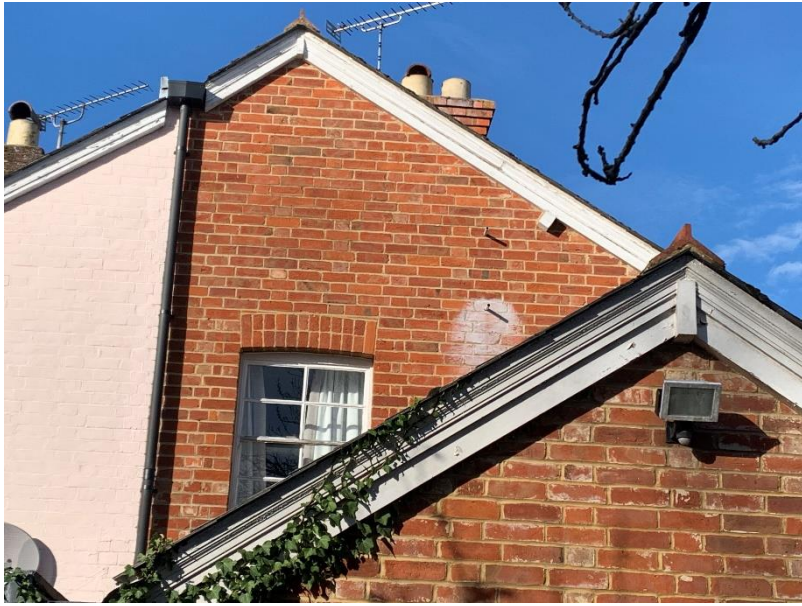
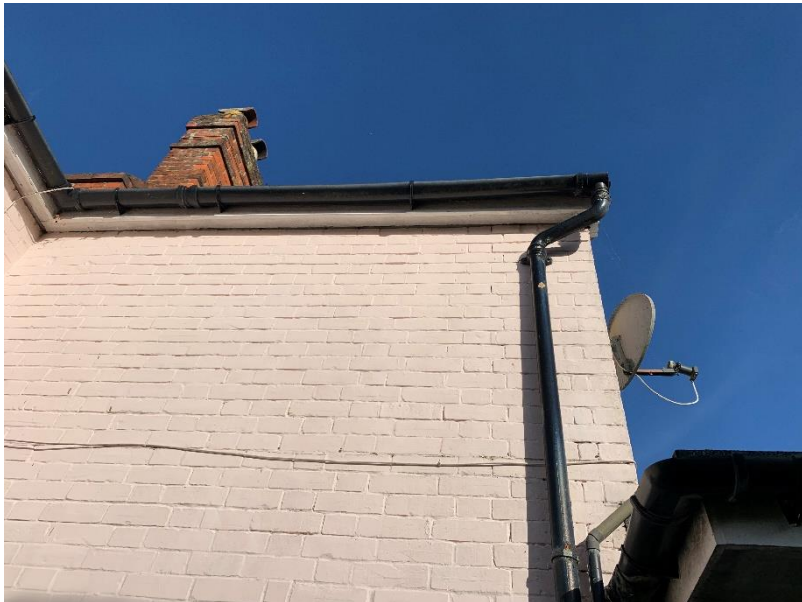
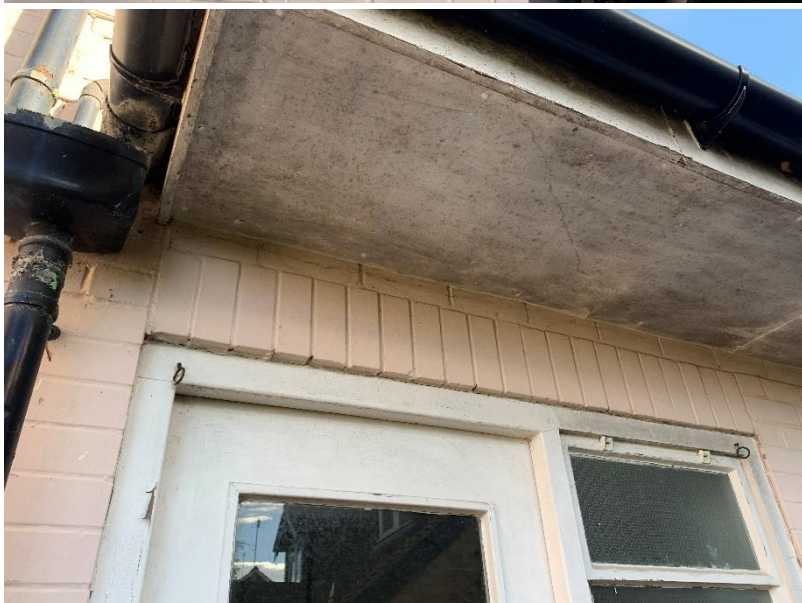
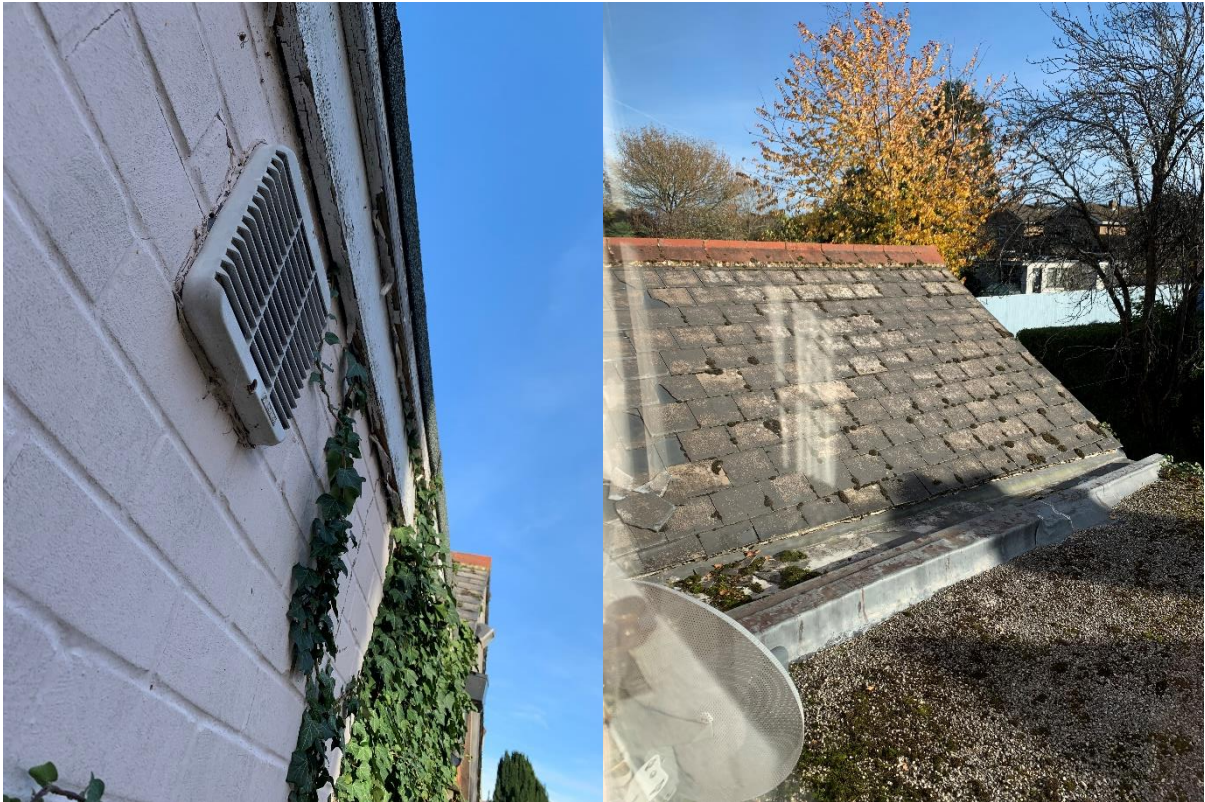
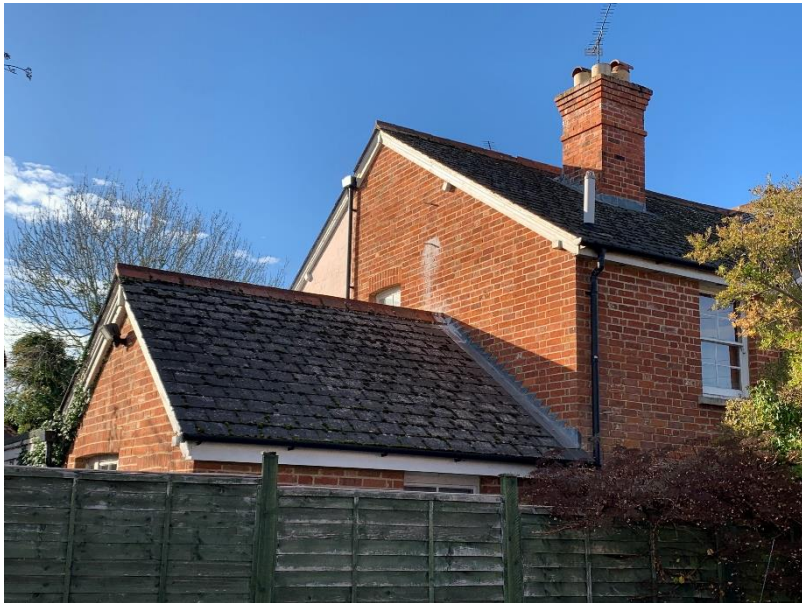
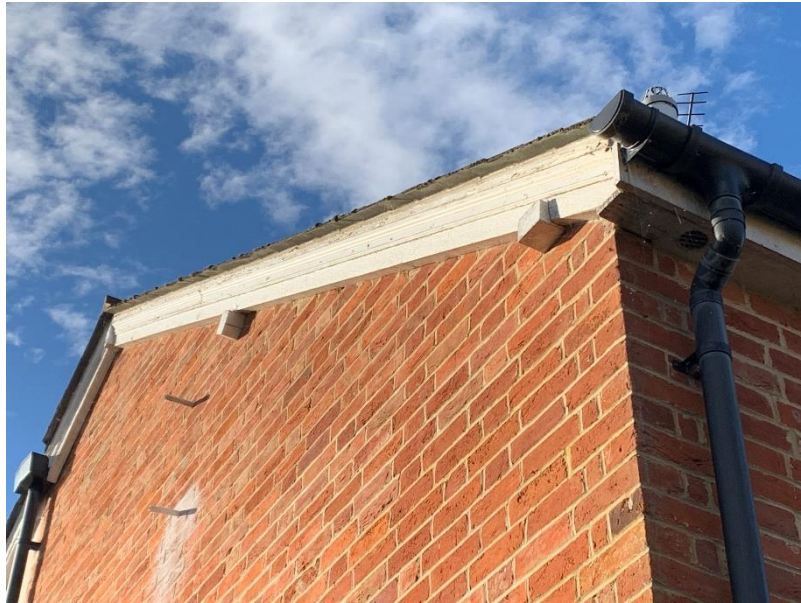
**Plates 7-13 - external inspection images**

External inspection of the building showed a well-sealed roof on the main building with tightly fitted slate tiles and pointing in a good state of repair. Features such as soffit boxes and similar woodwork which can be potential points of access for bats on other properties were all well sealed to the walls of the building. The flat roof extension to the rear of 126 Victoria Road was tightly fitted and the wooden weatherboarding around the edge did not have any gaps large enough for bat access. Plates 7-13 show external views from the inspection.

If renovation work has not started within 24 months of this PRA it is recommended that an update visit is completed to check for any alterations that could provide additional bat access to the property.
