## CHILLED CELLAR PITCHED ROOF REPAIR - METHADODOLOGY

The Rose, 30 Market Pl, Wokingham RG40 1AP

**RE: THE ROSE INN, 30 MARKET PLACE, WOKINGHAM, BERKSHIRE RG40 1AP – ROOF OVER CELLAR & PLANT ROOM**

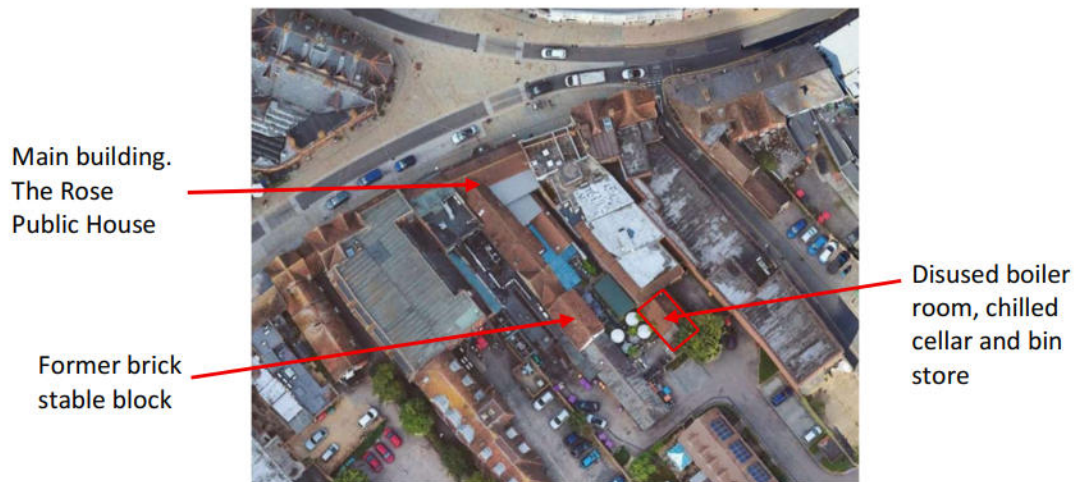
Image 1 – Aerial view of The Rose, Wokingham

1.2. To the rear of the main building, and abutting the neighbouring property, is a C20 single story, part brick, part block-built building which currently houses a disused boiler room, chilled cellar and bin store. Image 1 shows the building in question encircled in red.

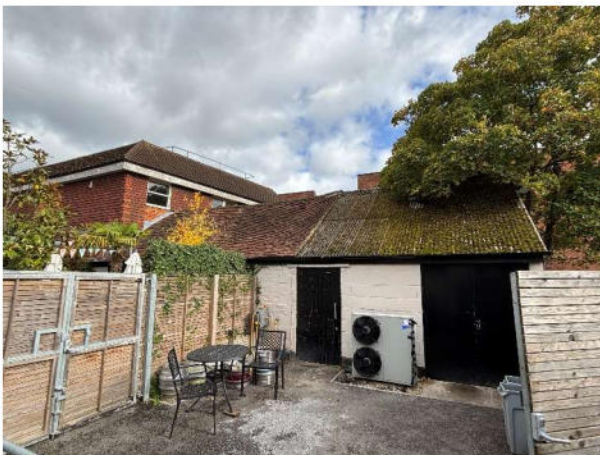
Image 2 – View of south-west elevation

1.3. Images 2 and 3 provide external views of the disused boiler room, chilled cellar and bin store

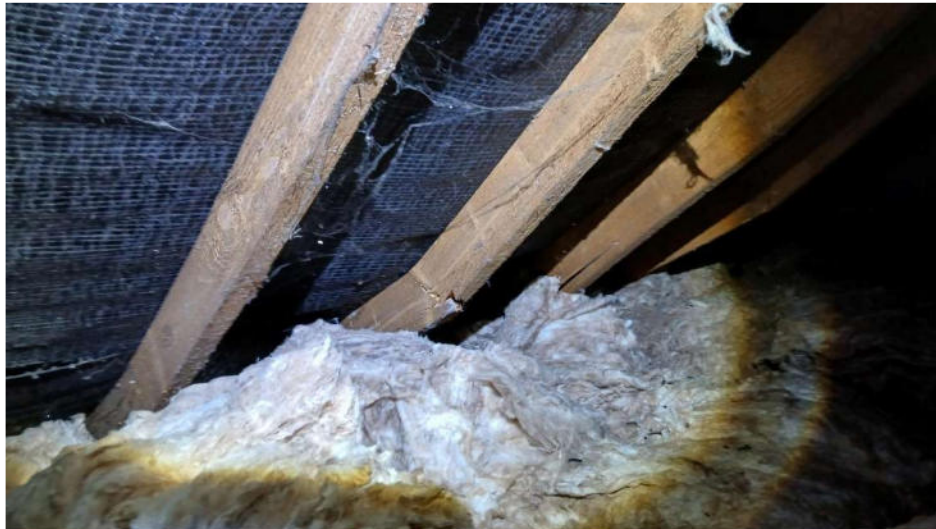
Image 4 – View from within loft space of cellar showing deflected and failed modern rafters.

- 1.4. The tiled roof over the central section of the building, which is occupied by the chilled cellar has a significant inward bow caused by deflected and failed rafters.
- 1.5. Images 4 and 5 are taken within the roof space and show modern rafters, formed of 100 x 35mm timbers with roofing felt over. The cellar roof is finished with clay peg tiles as can be viewed in the previous images.

- 1.6. Images 4 and 5 show snapped rafters due to overloading. A structural report has been completed by Alan Baxter Partnership LLP and is available with the Appendix.
- 1.7. The structural report recommends removing the roof covering, strengthening the roof structure before replacing the clay peg tile roof covering.

- 1.8. Strengthening involves installing a new steel ridge beam supported off existing modern internal block walls, plus a new timber ridge beam part supported off the existing modern internal block wall and part supported on a new timber post to transfer the load to the ground. Deflected or failed rafters will be repaired by bolting 100 x 50mm C24 timbers to the sides of existing rafters.
- 1.9. This document sets out the proposed methodology for the recommended work to the tiled section of roof above the chilled cellar.

- 2.1. Strip existing peg clay tiles from chilled cellar pitched roof and carefully set aside for reinstatement on completion.
- 2.2. Strip roofing felt and tile battens.
- 2.3. Form two new padstone using single dense blocks to support new steel ridge beam. Padstones are formed within existing modern block walls.
- 2.4. Install new steel ridge beam spanning central chilled cellar section.
- 2.5. Install new 100 x 100 C24 timber post, bolted to wall and install new 250 x 50 C24 timber ridge beam spanning disused boiler room.
- 2.6. Bolt new 100 x 50 C24 timbers to the side of any failed or deflecting rafters.
- 2.7. Renew roofing felt and battens
- 2.8. Replace peg clay tiles to match existing layout. Damaged and broken peg clay tiles will be replaced with matching / reclaimed peg clay tiles.
- 2.9. Re-dress lead flashing.
