## **APPENDIX 14.2 - PEARCE'S FARM PHASE 1 REPORT**

**Phase I**  
**Geo-Environmental Site Assessment**

Land at Pearce's Farm, Easthampstead Road, Wokingham, RG40 3BN

***Omnia ref: A11997/1.1***

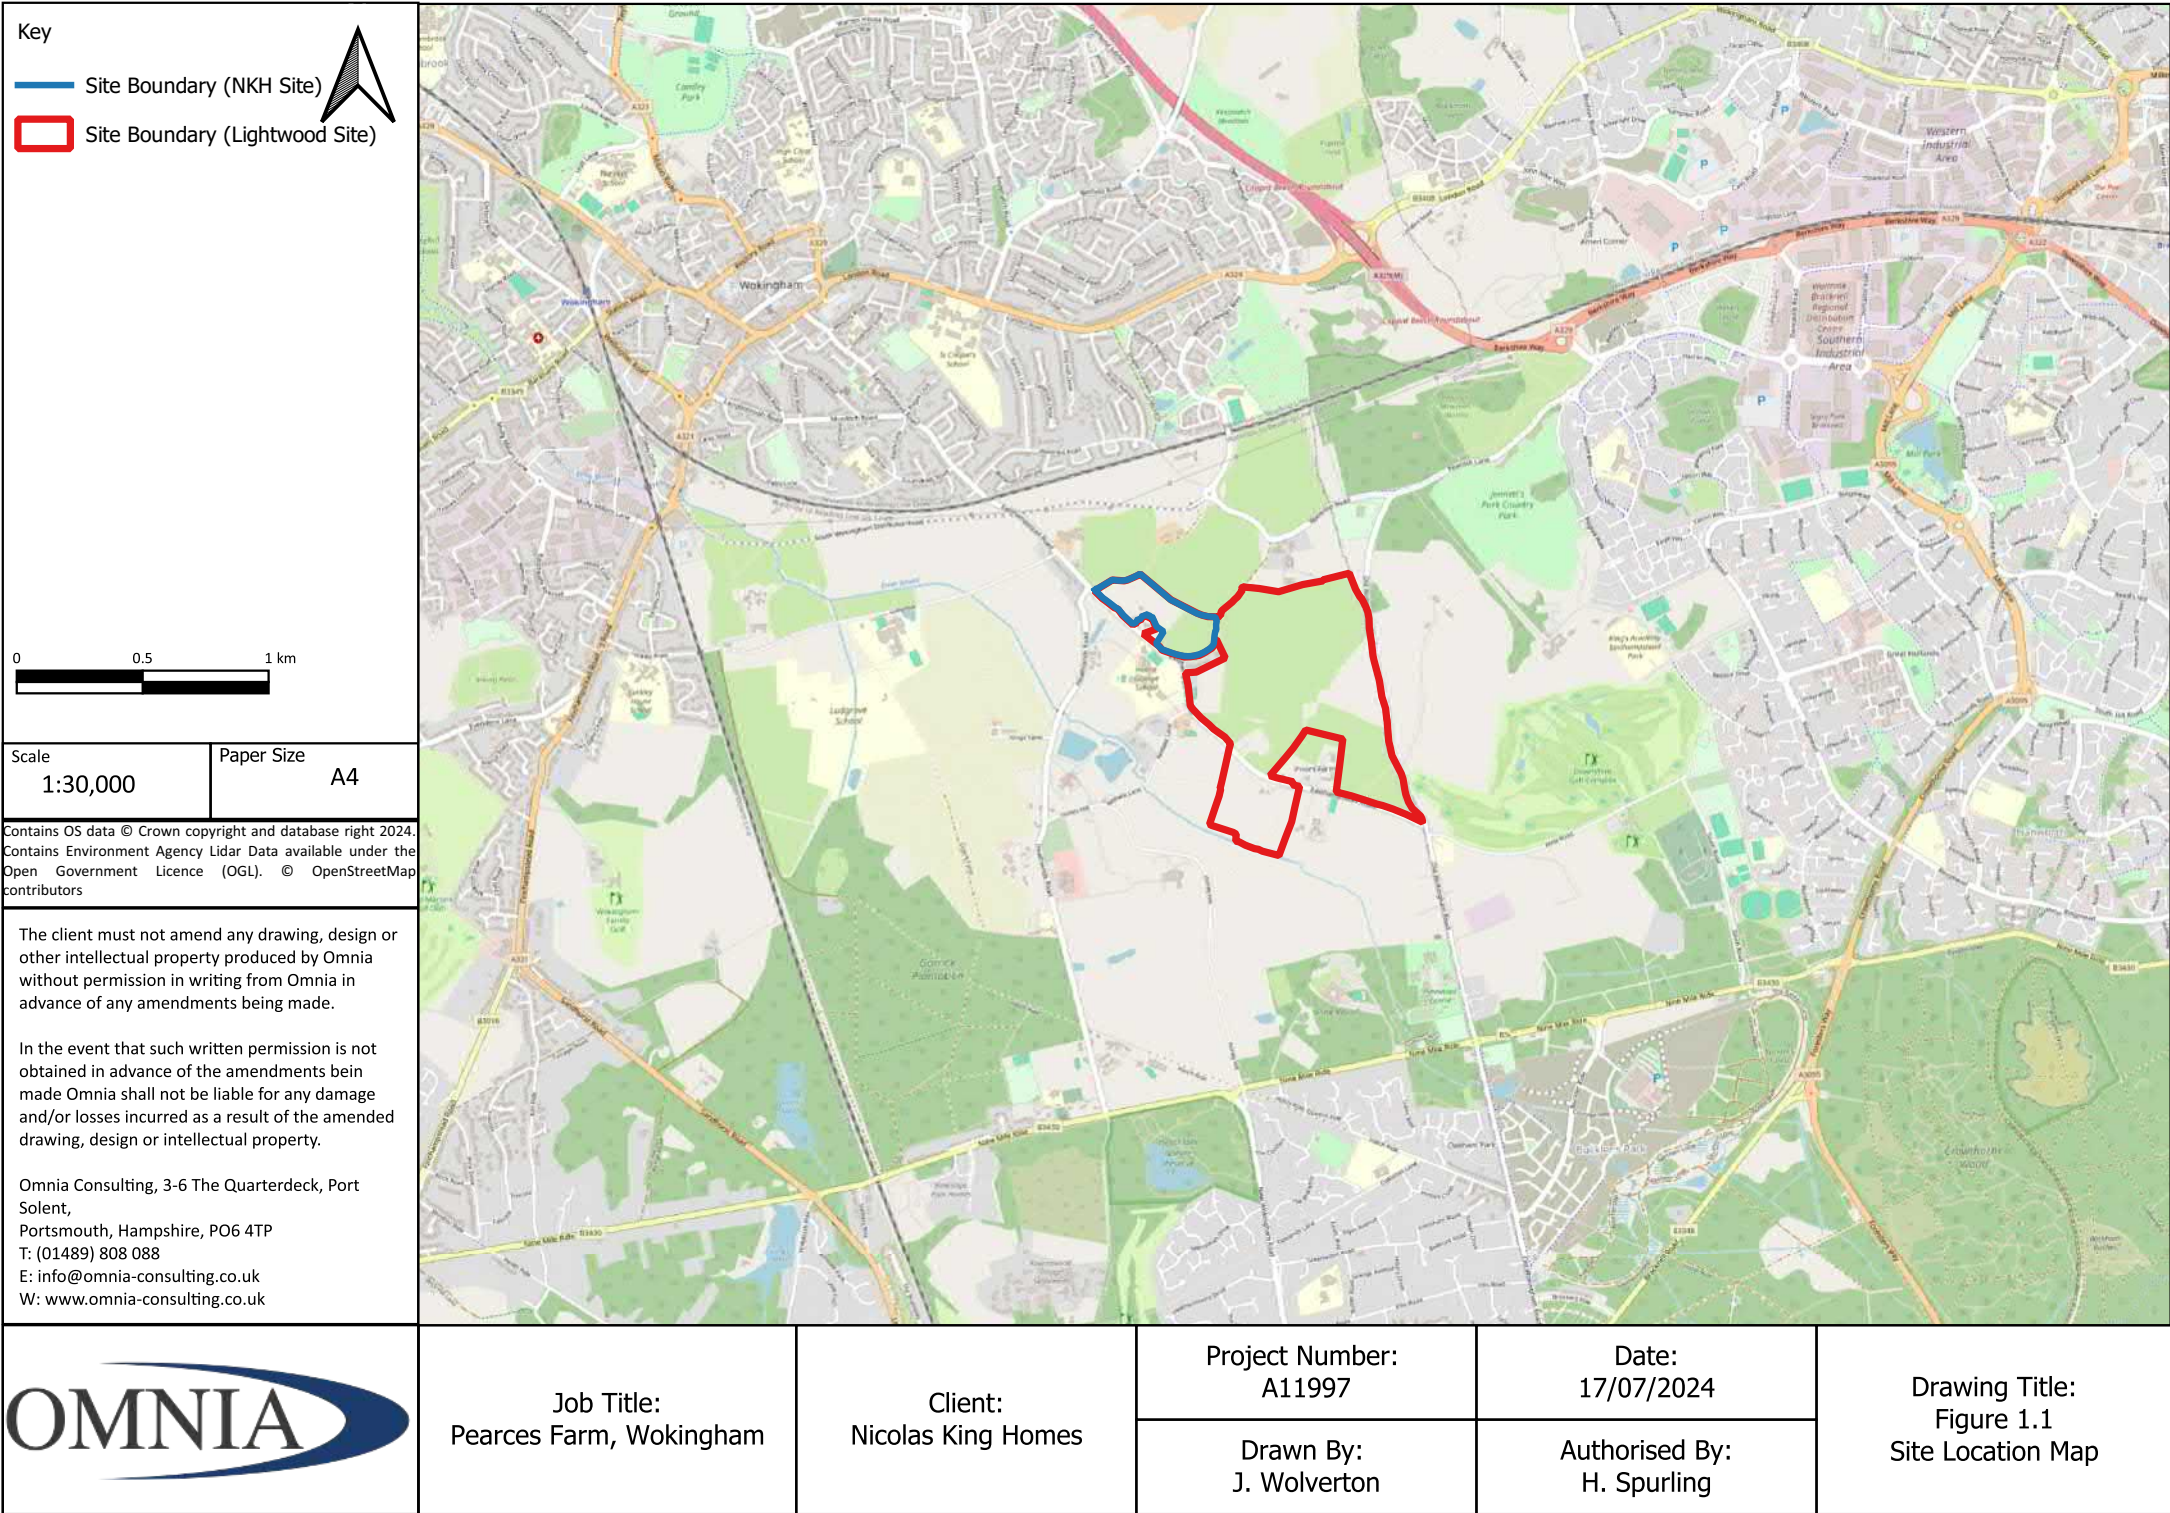
The outline proposed site masterplan is presented as Figure 2.0 (Appendix III).

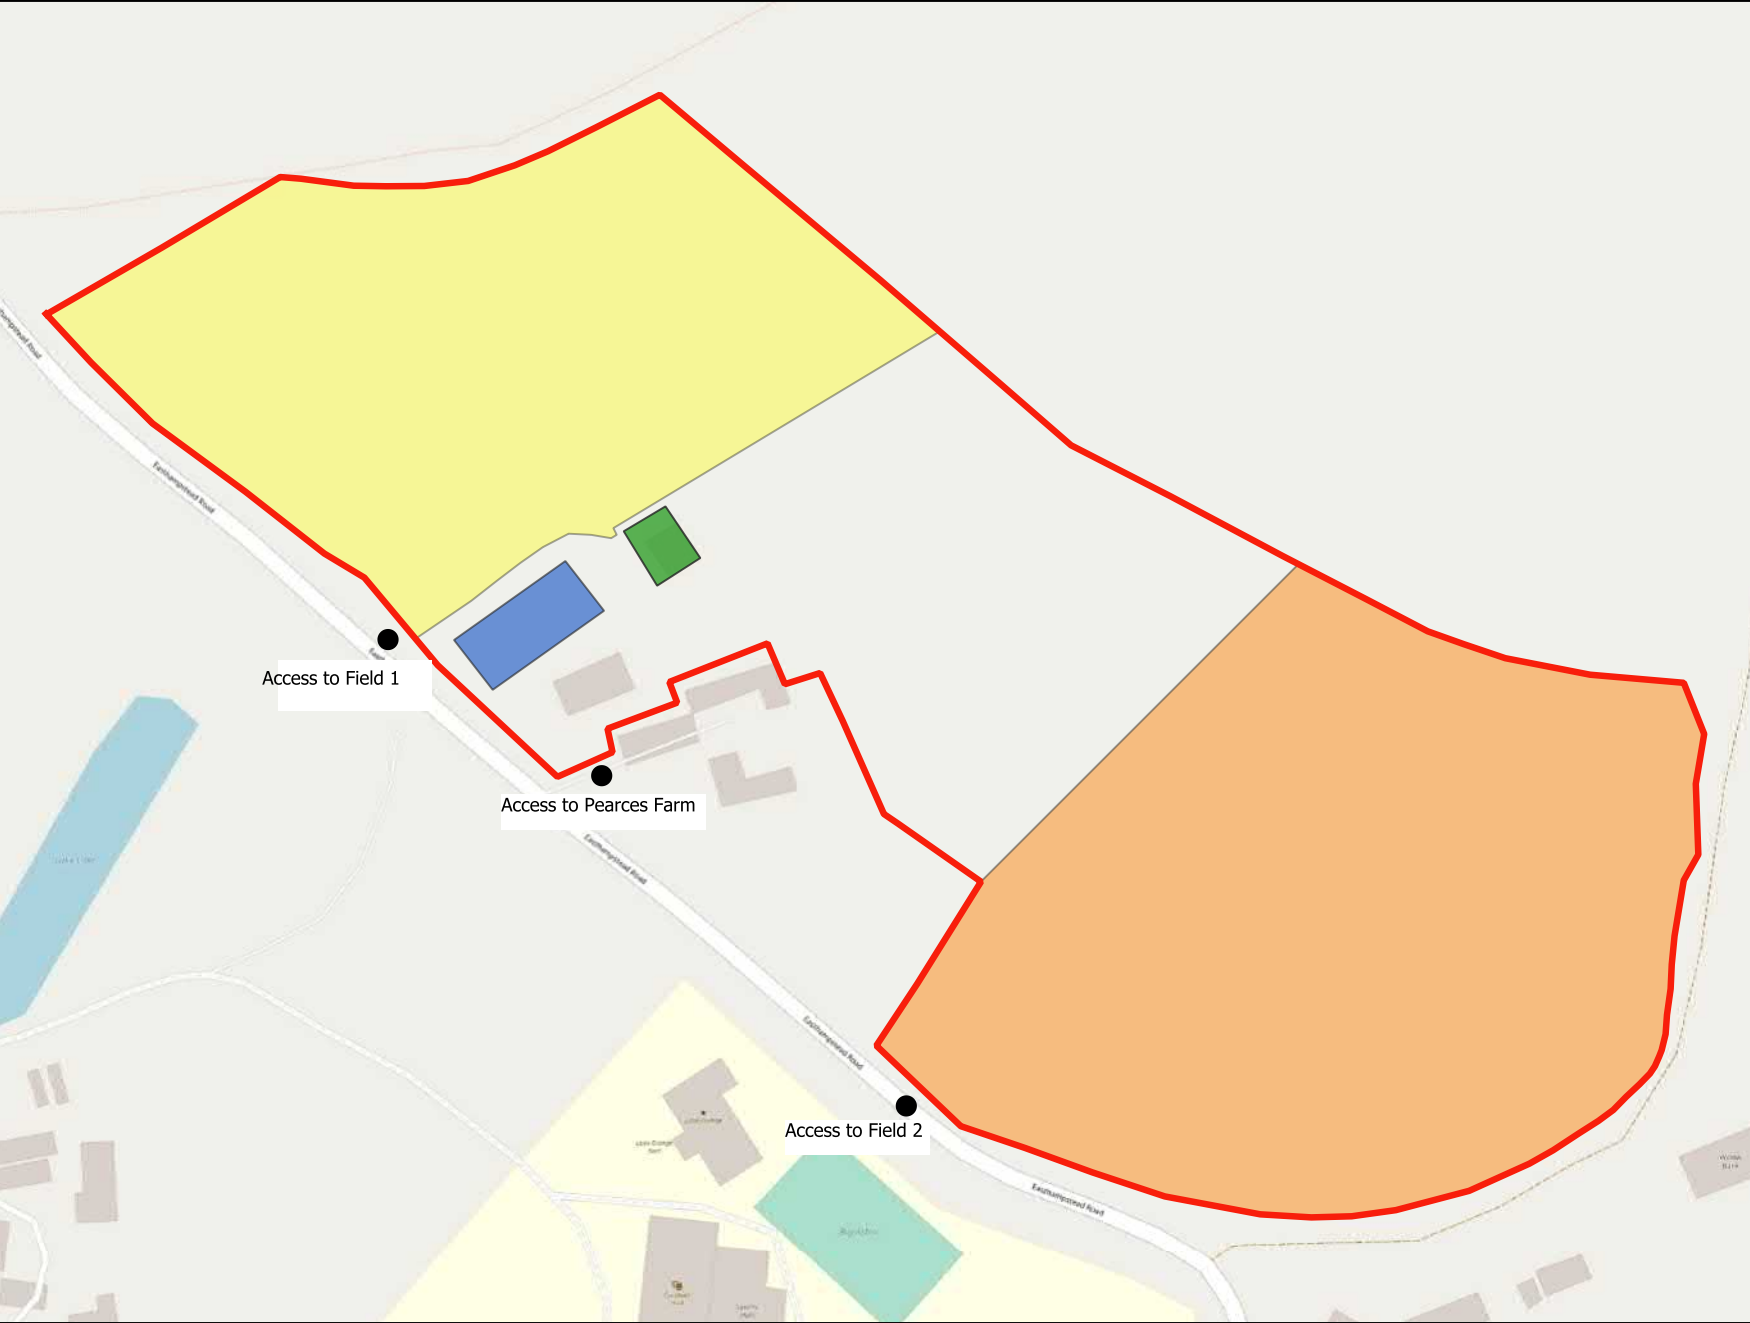
| Job Title:<br>Pearce's Farm,<br>South Wokingham | Client:<br>Nicolas King Homes | Project Number:<br>A11997 | Date:<br>20/01/2023 | Drawing Title:<br>Figure 3.0<br>Site Walkover Plan |

Field 1 was situated within the western extent of the site, and Field 2 the eastern extent (Figure 3.0, Appendix III).

A concrete track ran up the western extent leading to an equestrian menage and stabling. A farmhouse building was situated east of the Manège on site (Figure 3.0, Appendix III). The remainder of Pearce's Farm consisted of six (6no.) buildings between one and two storeys. From the exterior of the buildings, it was presumed that these were configured as residential dwellings with associated garages and outbuildings, however a detailed inspection was not undertaken.

An annotated site location plan showing observations from the walk-over survey is presented as Figure 3.0 (Appendix III). Relevant photographs from the site walk-over survey are located in Appendix IV.

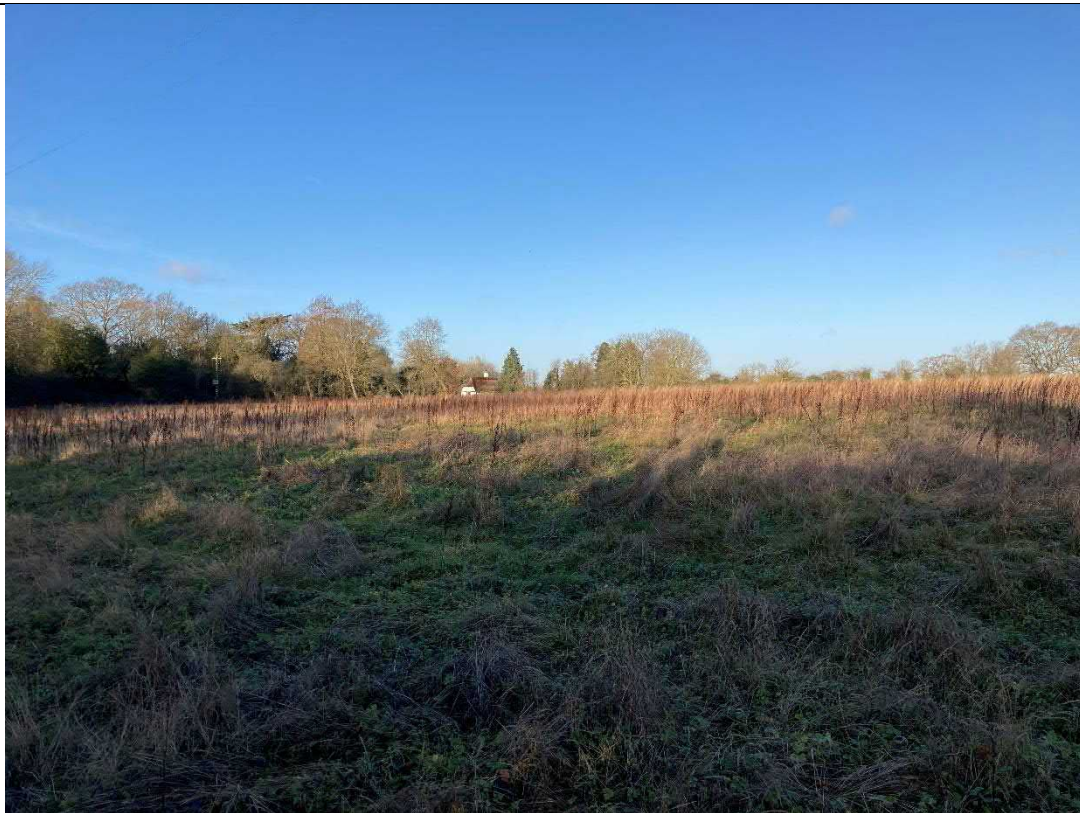
Photograph 2 – View of Field 2 facing west
