## East Court, Finchampstead RG40 3SD

2024 Final Bat Survey Report

| Document title | Updated Final Bat Survey Report, East Court, Finchampstead_2024 |

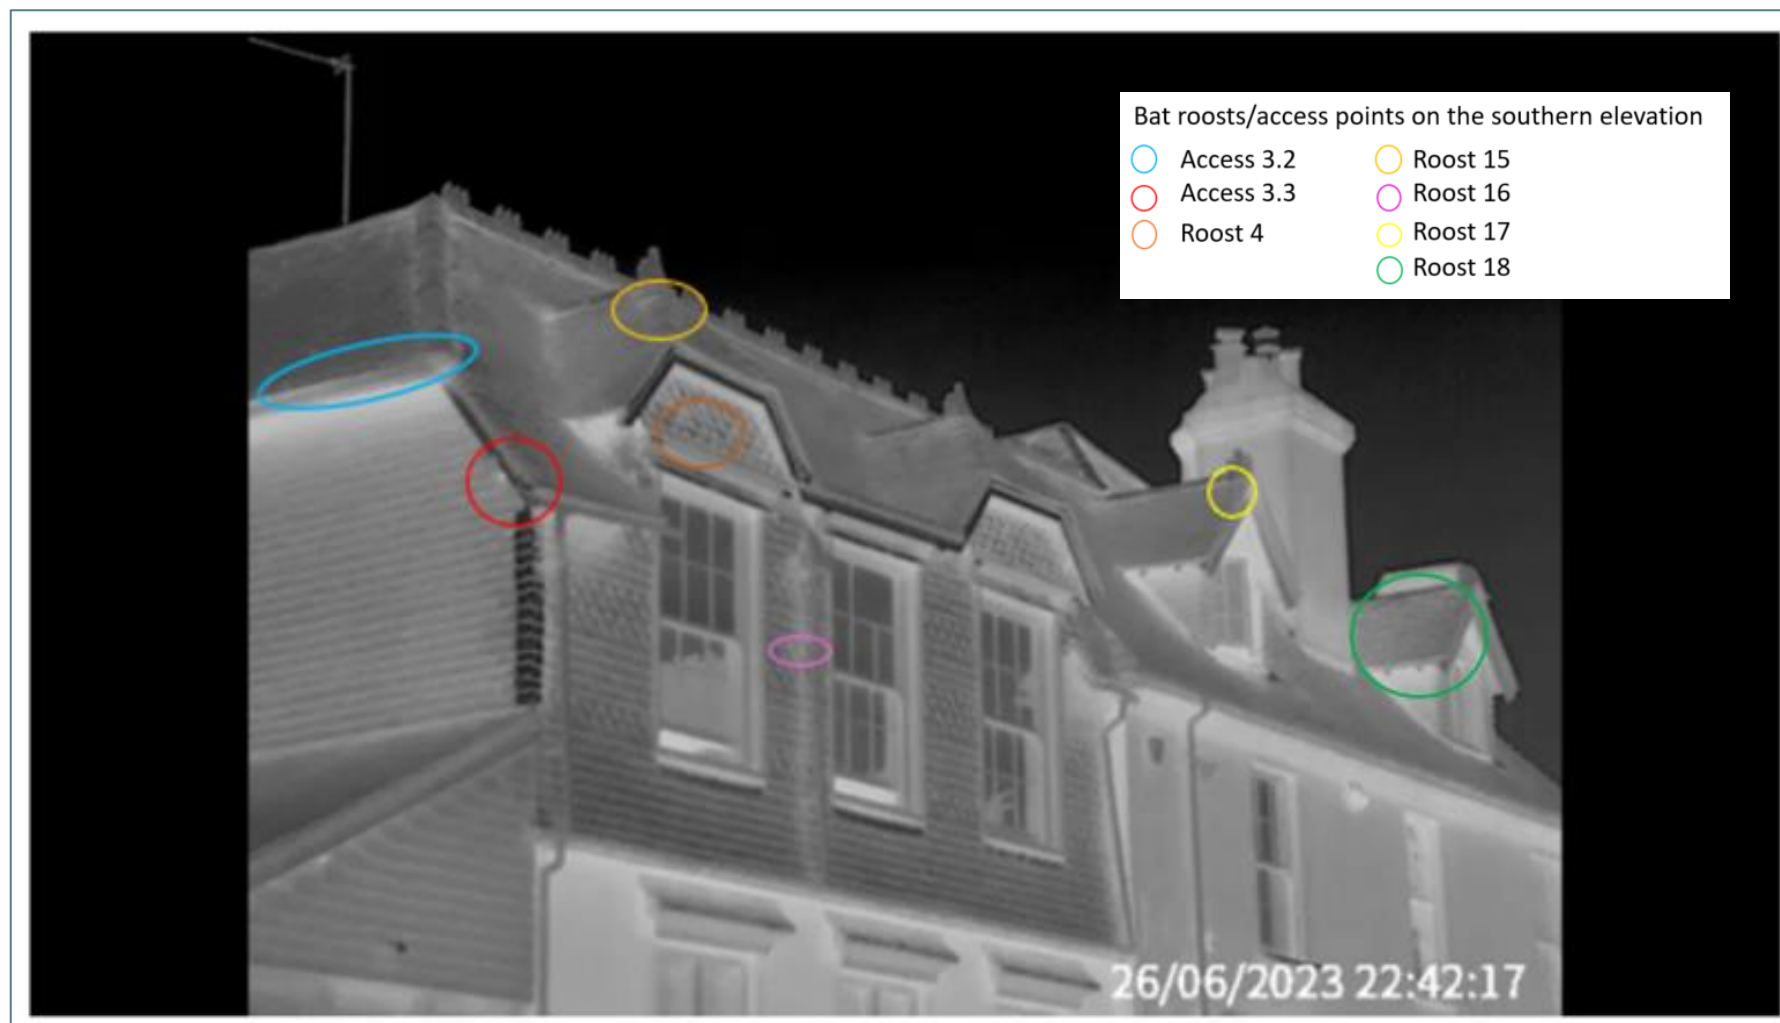
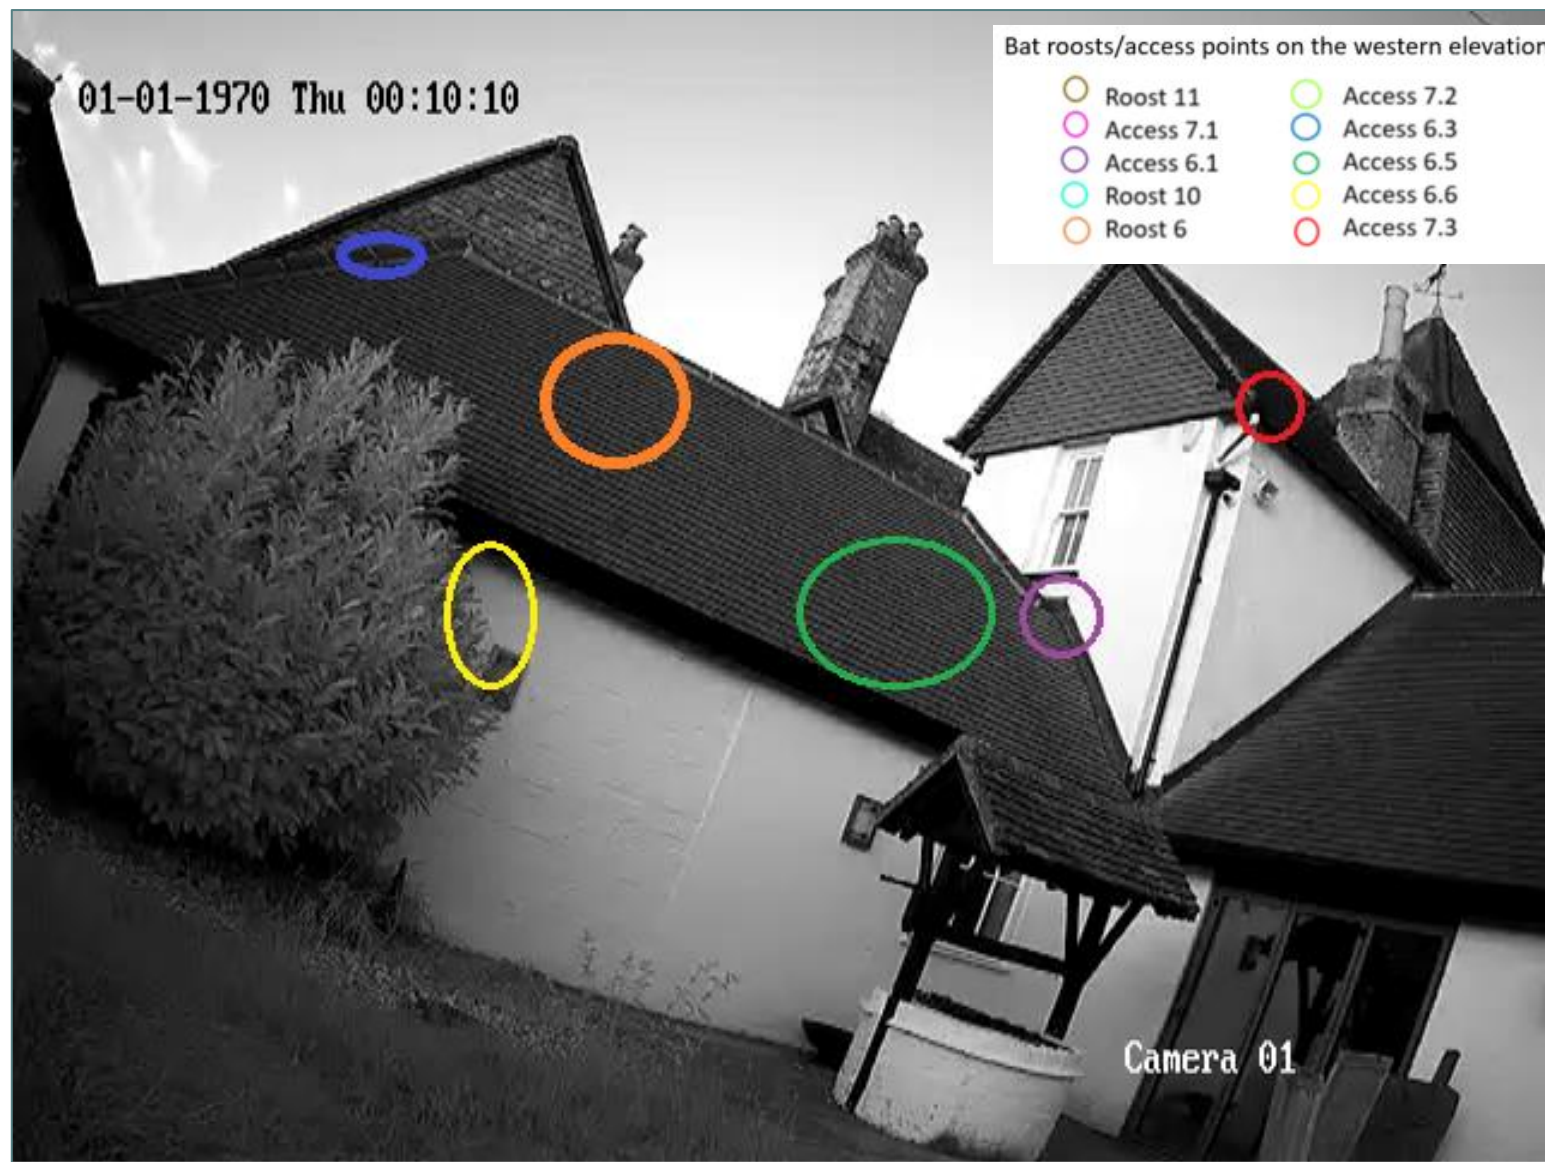
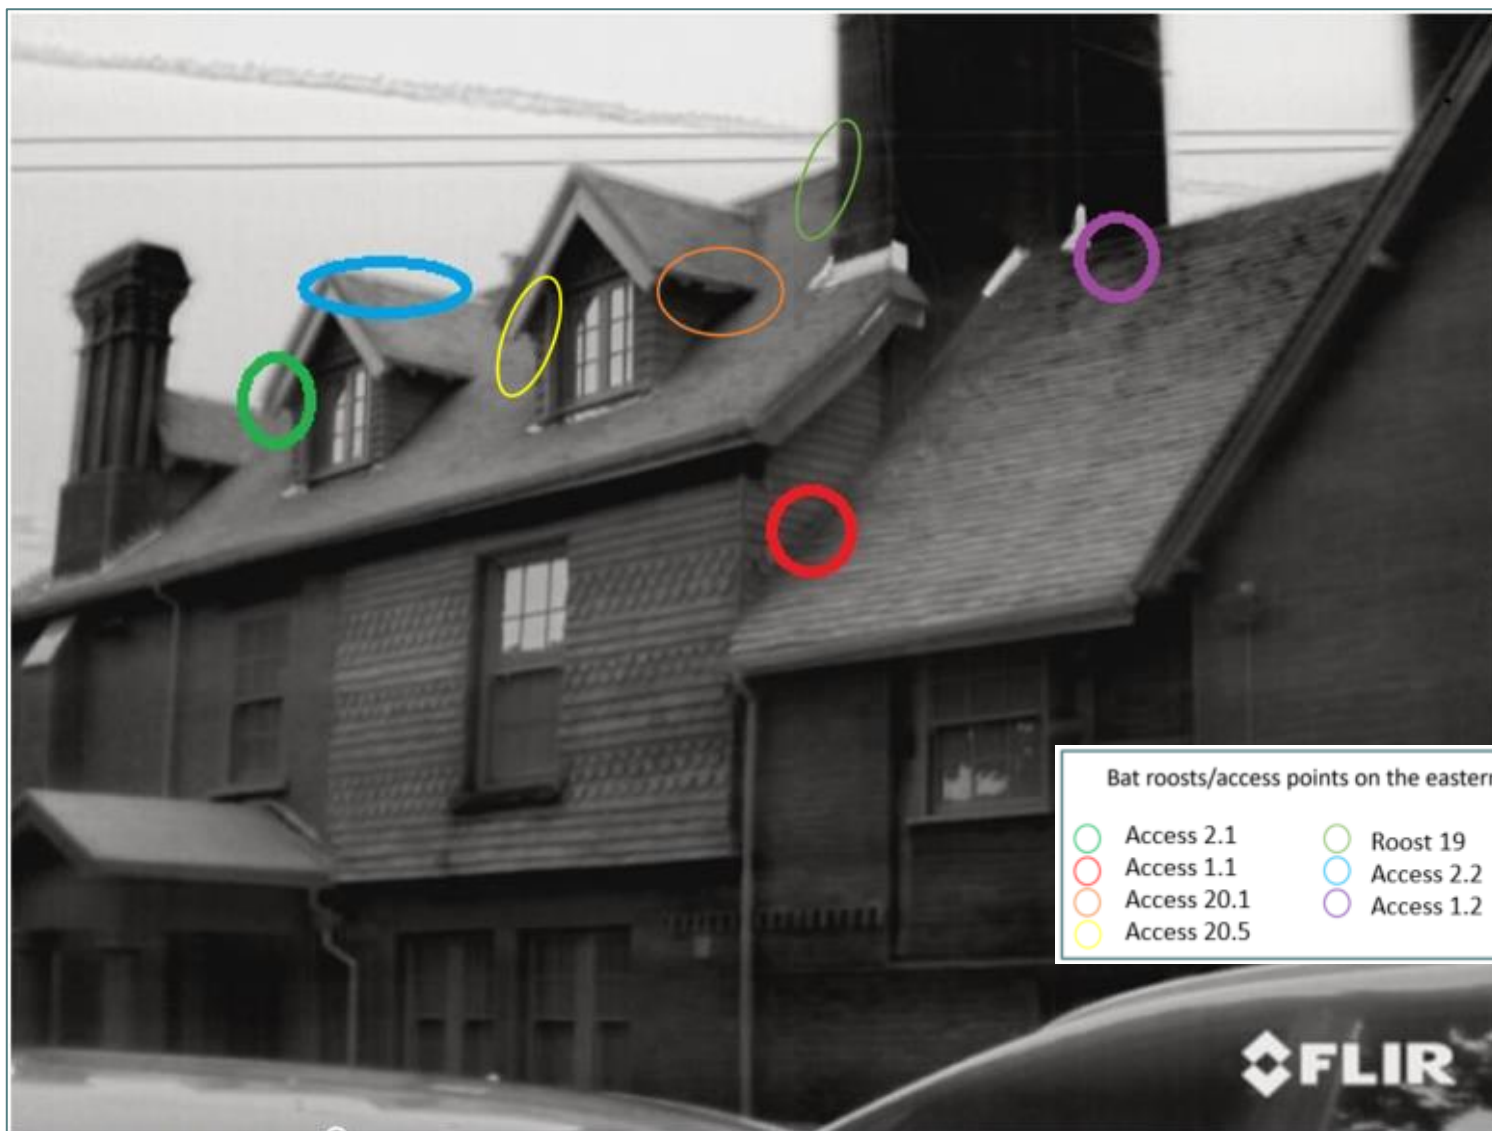
Figure 5: Annotated photographs of roost access locations for three elevations (2023)

A number of potential entry points were observed among the roof tiles, cladding features, bargeboards, chimney flashing, and at gaps where one construction material joined another. Evidence of bats (droppings) were also seen on roof tiles surrounded potential entry points.

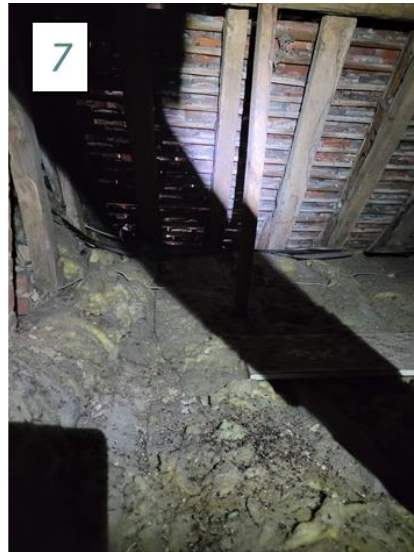
6: Loft 1 looking into the void space.

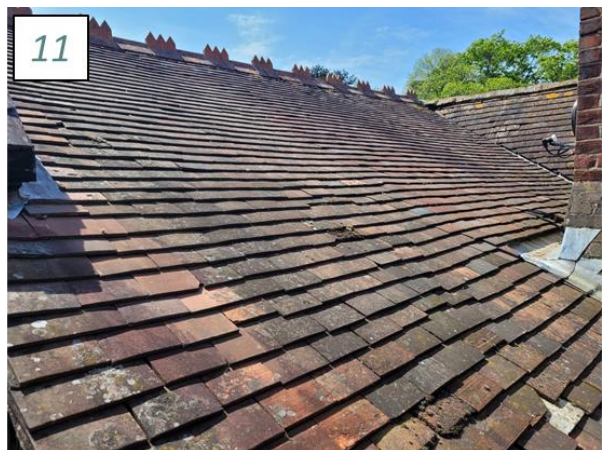
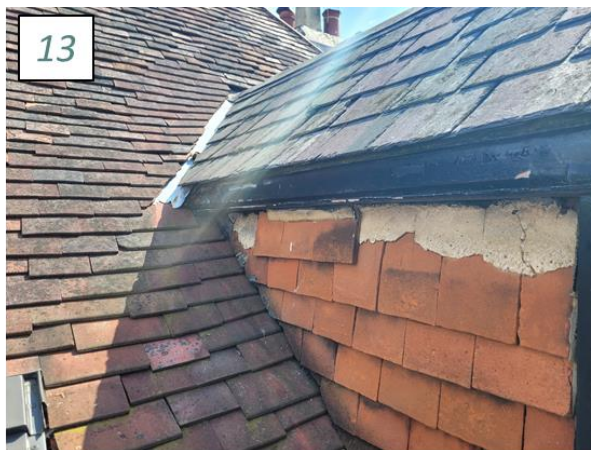
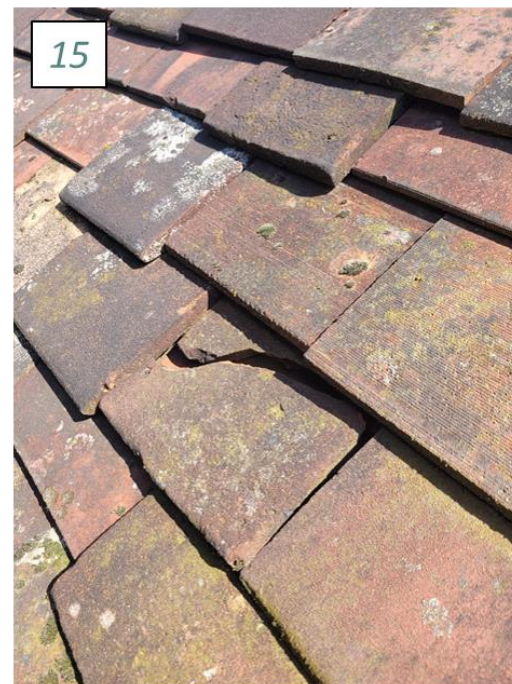
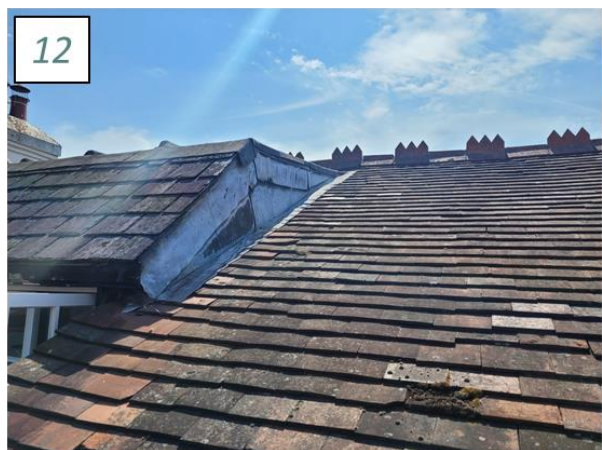
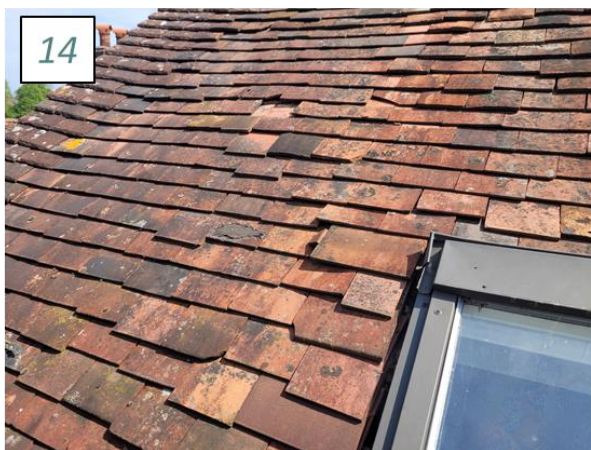
11 – 15: views of the myriad lifted and hanging tiles on the roof

Due to the entanglement risk posed by modern breathable roofing membranes, traditional F1 roofing felt must be used throughout and will be a condition of any licence issued by Natural England.

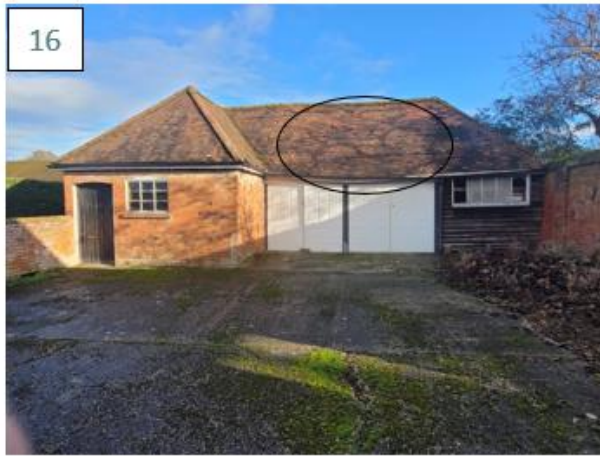
**Detached outbuilding:** This outbuilding is mainly constructed of red brick with a small section of shiplap. It has two double garage sections with a stable section. The eaves are open but have been historically blocked off with chicken wire. The roof above the garage doors is starting to bow and, in this area, there are raised roof tiles. To the rear there is one metal roofed disused chicken coop and a fenced off chicken run. The chicken coop walls are constructed from fence panels which do not meet the roof above.

16: External view of the detached garage, black circle to show where the roof is bowing. 17: Rear elevation showing disused chicken coop and run.  
18: Eaves of the building. 19: Internal view of the stable area with false ceiling.

In terms of mitigation on site, this outbuilding will also be subject to a supervised soft strip to safeguard any bats present. Given that the tiles will be replaced on a like-for-like basis, there will be numerous cavities available for bat roosting under tiles on the new roofs, and therefore no impact on the favourable conservation status of any species found present.

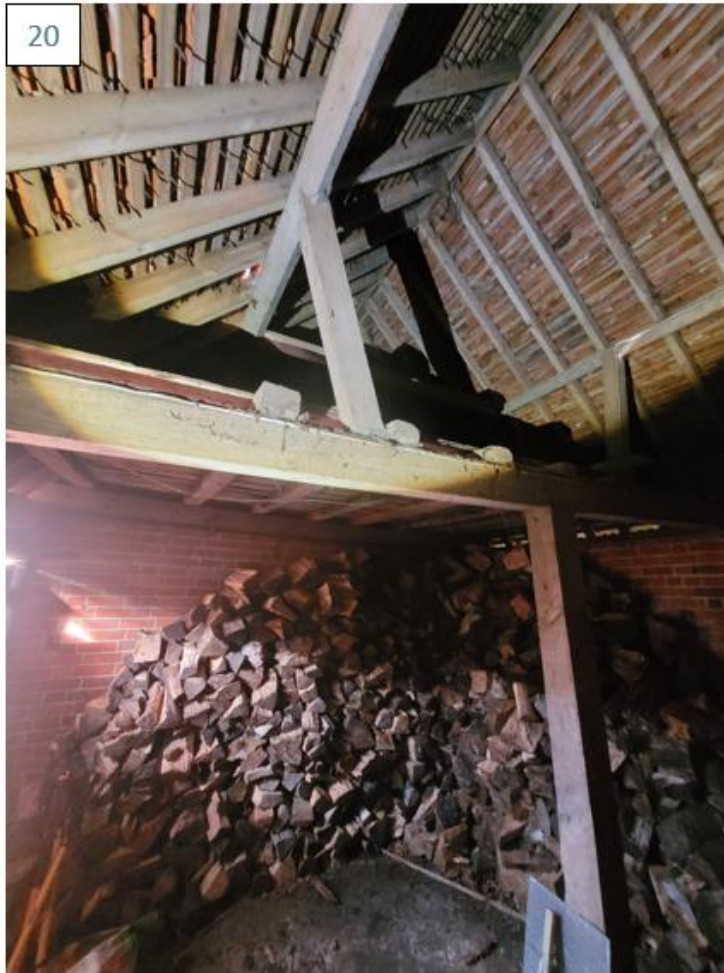
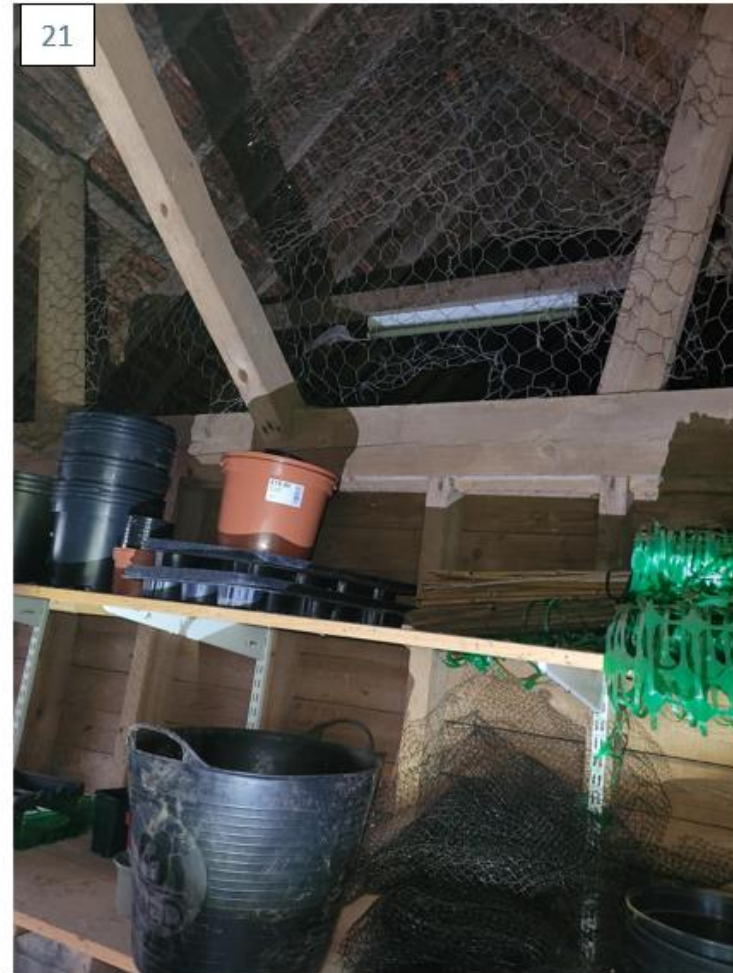
**Detached outbuilding:** The majority of this building (stable and one garage section) has a false ceiling comprising wooden boards with a roof void present but no internal access. Between the stable and garage there is a wall of wooden shiplap from floor to apex. These areas are currently used to store wood and garden supplies. The second garage section and potting shed are open from floor to unlined roof above. Areas of the roof have had chicken wire added above the potting shed. No evidence of bats was found internally.

20: Wood store with unlined roof above. 21: Potting shed with chicken wire above.
