# GLASSPOOL FARM

## DEMOLITION & REFURBISHMENT SURVEY

## **ASBESTOS SURVEY REPORT**

Glasspool Farm  
Part Lane  
Riseley  
Reading  
RG7 1RU

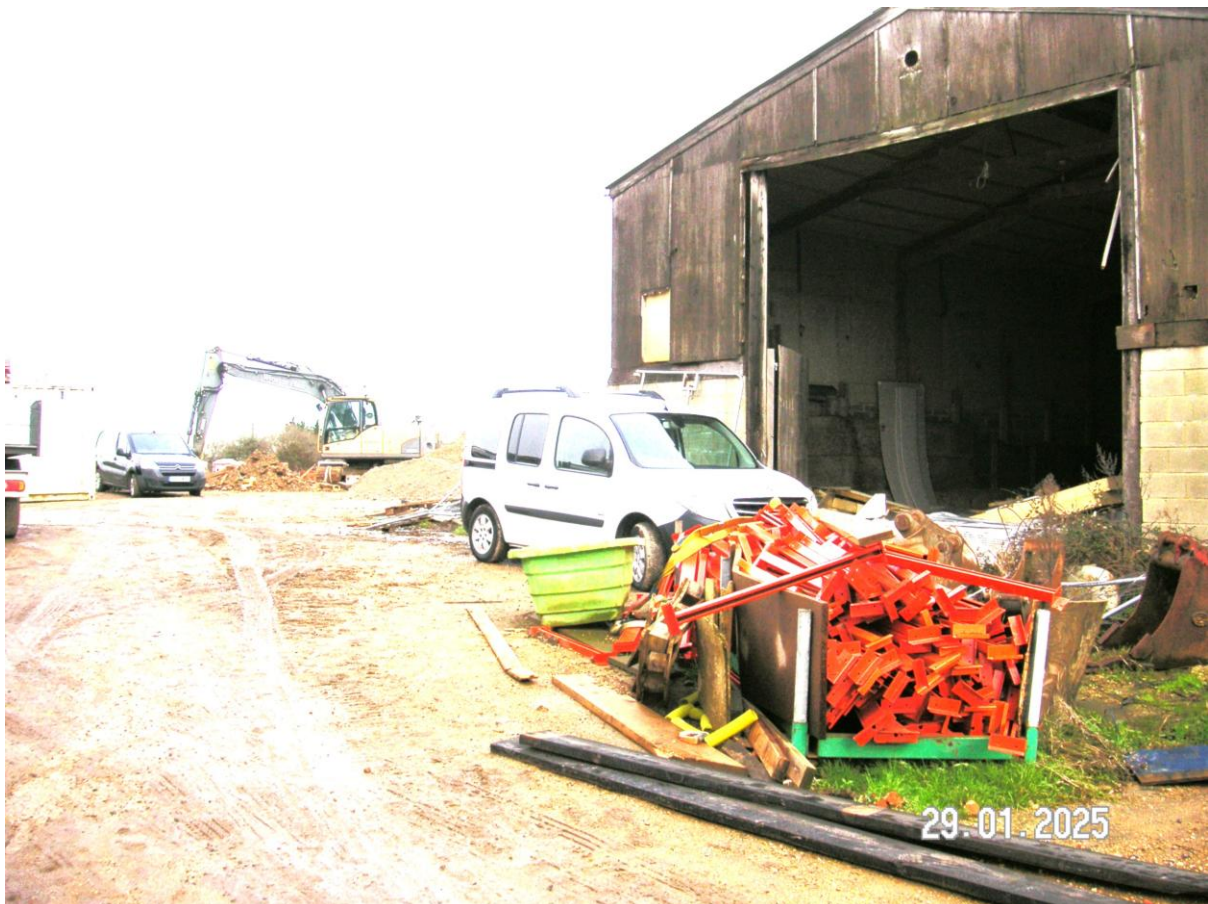
| THIS SAMPLE CONTAINS ASBESTOS | | | | | |
|---|---|---|---|---|---|
| Sample No | | GPF/2425/356/00 | | | |

| THIS SAMPLE CONTAINS ASBESTOS | | | | | |
| Room / Area | | Barn 1 Internal | | | |
| Component | | Fibre Board to Walls and Ceiling | | | |
| SURVEY RESULTS | | Approximate Area | 960m <sup>2</sup> | Asbestos Type | Chrysotile |
| Location | Walls & Ceiling | | | Product Type | Fibre Board |

| <b>REMOVE PRIOR TO REFURBISHMENT / DEMOLITION</b> | | | |
|---|---|---|---|
| 001 | Fibre Board | Chrysotile | |

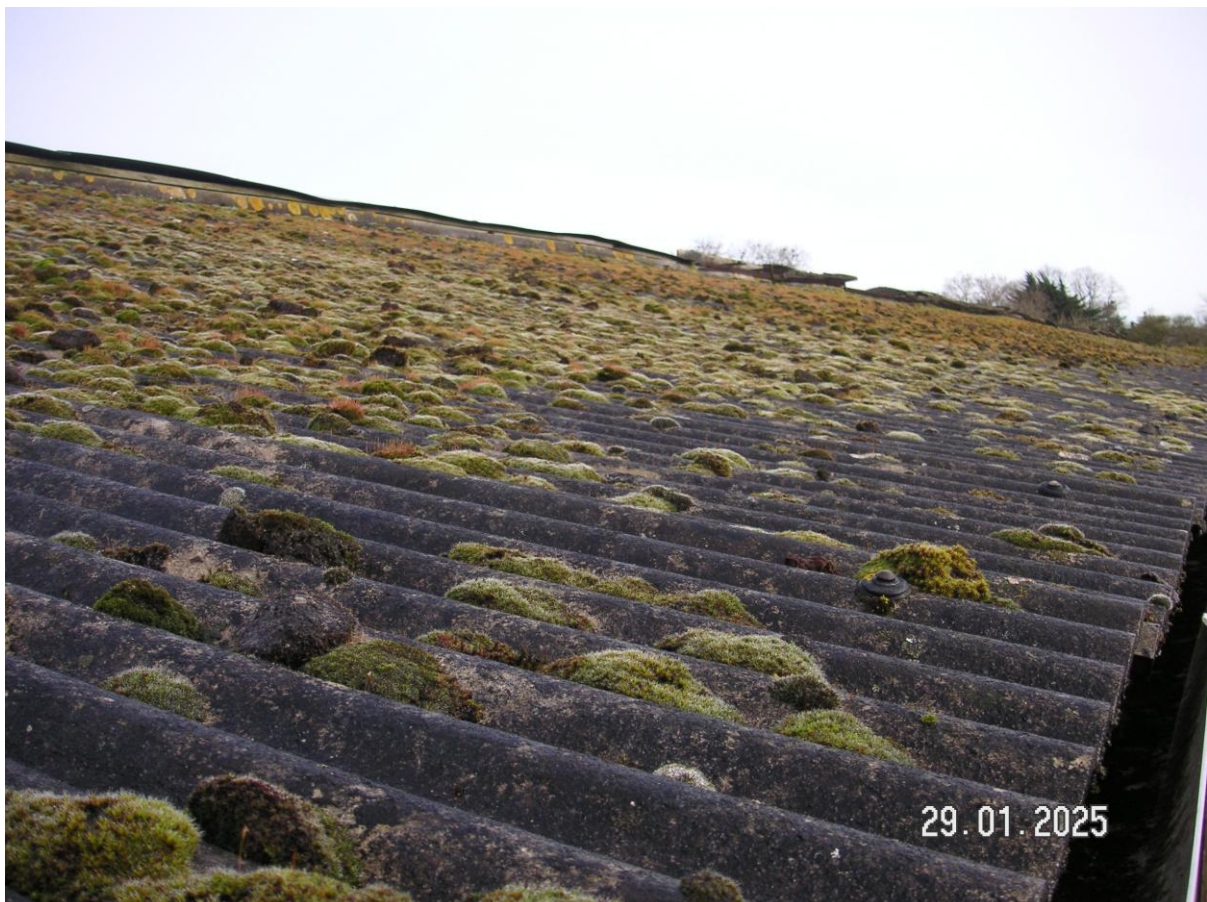
| THIS SAMPLE CONTAINS ASBESTOS | | | | | |
|---|---|---|---|---|---|
| Sample No | | GPF/2425/356/002 | | | |

| THIS SAMPLE CONTAINS ASBESTOS | | | | | |
| Room / Area | | Barn 1 | | | |
| Component | | Corrugated Profile Sheetting | | | |
| SURVEY RESULTS | | Approximate Area | 600m <sup>2</sup> | Asbestos Type | Chrysotile |
| Location | Roof | | | Product Type | Cement |

| <b>REMOVE PRIOR TO REFURBISHMENT / DEMOLITION</b> | | | |
|---|---|---|---|
| 002 | Corrugated Profile Sheet | Chrysotile | |

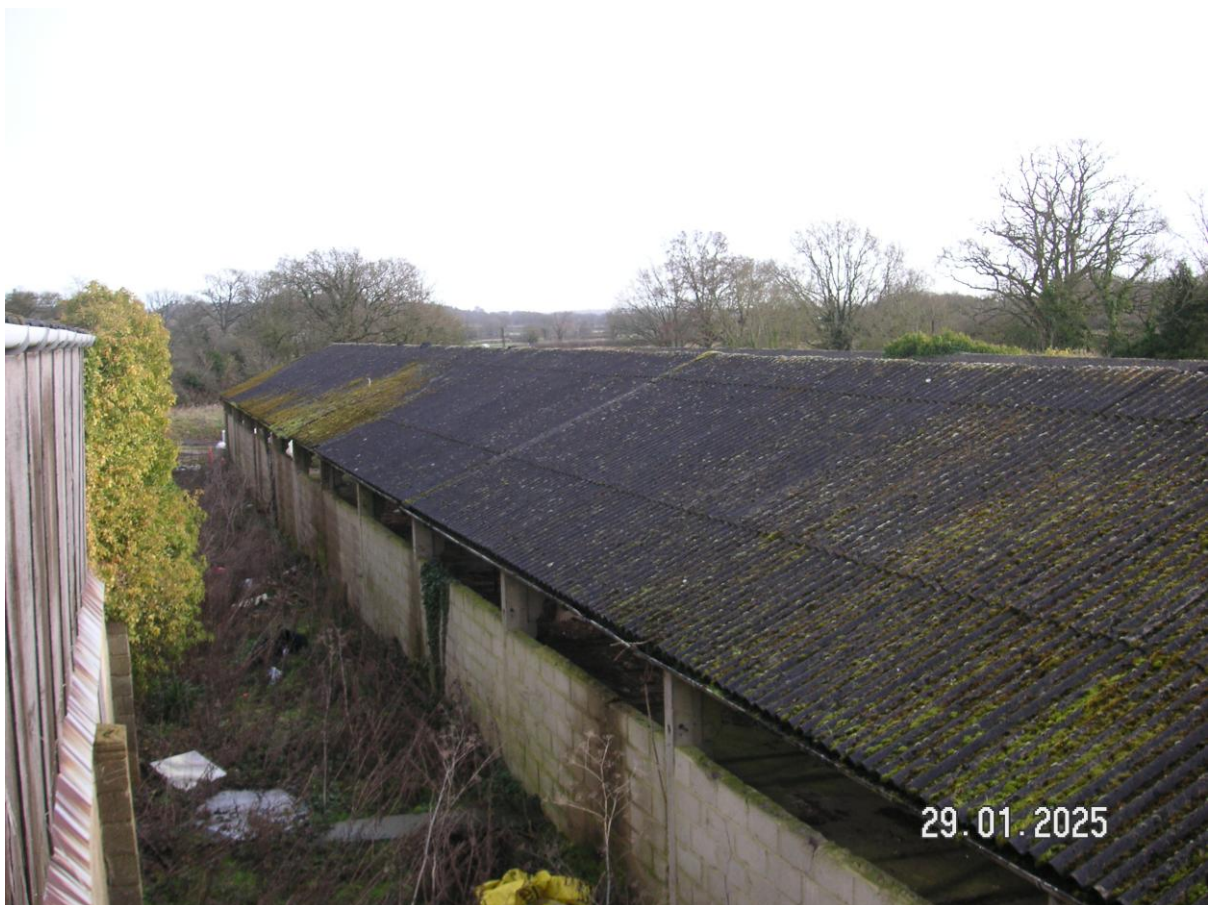
| THIS SAMPLE CONTAINS ASBESTOS | | | | | |
|---|---|---|---|---|---|
| Sample No | | GPF/2425/356/003 | | | |

| THIS SAMPLE CONTAINS ASBESTOS | | | | | |
| Room / Area | | Barn | | | |
| Component | | Corrugated Profile Sheetting | | | |
| SURVEY RESULTS | | Approximate Area | 480m <sup>2</sup> | Asbestos Type | Chrysotile |
| Location | Roof | | | Product Type | Cement |

| <b>REMOVE PRIOR TO REFURBISHMENT / DEMOLITION</b> | | | |
|---|---|---|---|
| 003 | Corrugated Profile Sheet | Chrysotile | |

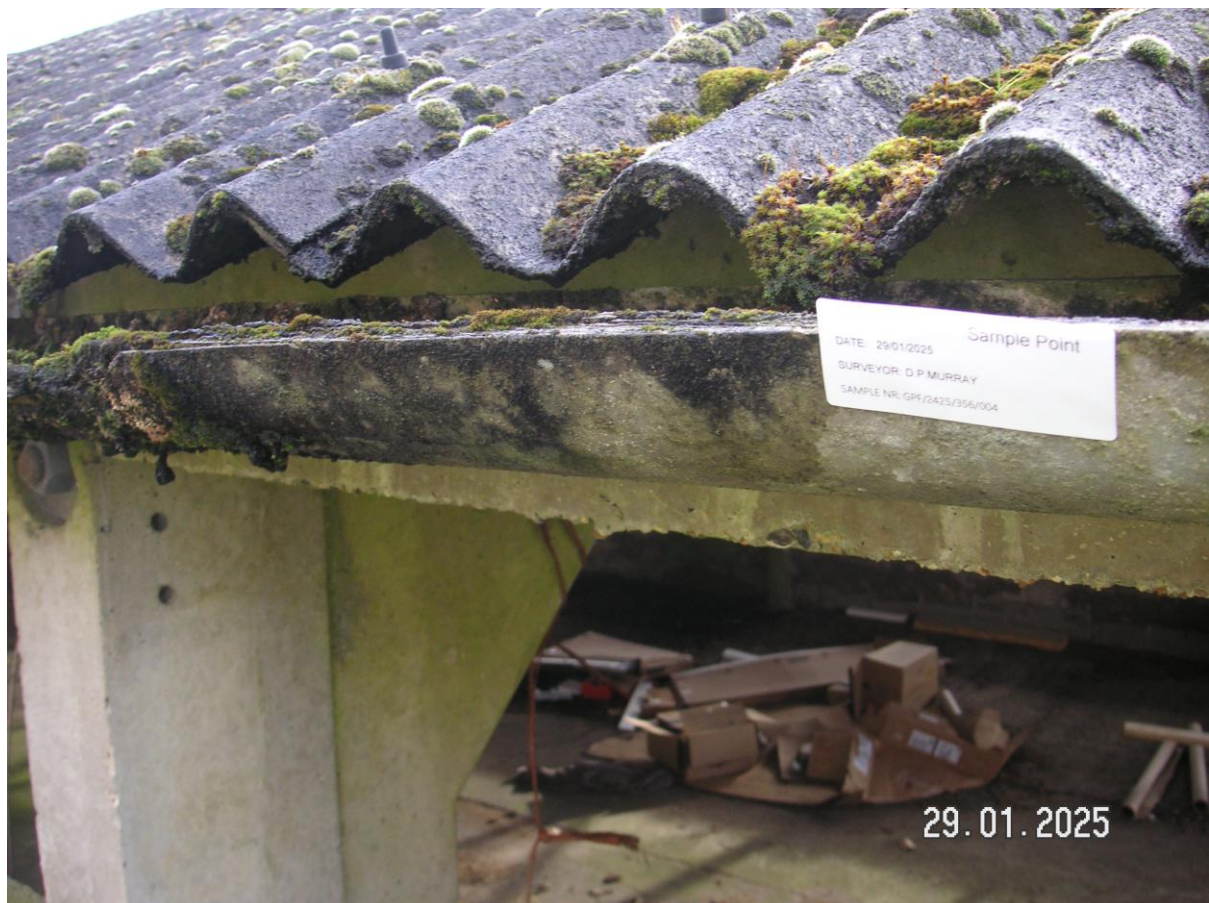
| THIS SAMPLE CONTAINS ASBESTOS | | | | | |
|---|---|---|---|---|---|
| Sample No | | GPF/2425/356/004 | | | |

| THIS SAMPLE CONTAINS ASBESTOS | | | | | |
| Room / Area | | Barn | | | |
| Component | | Cement Gutter Profile | | | |
| SURVEY RESULTS | | Approximate Area | 240m | Asbestos Type | Chrysotile |
| Location | Roof | | | Product Type | Cement |
| Comments | To Barns 2 & 3 | | | | |

| <b>REMOVE PRIOR TO REFURBISHMENT / DEMOLITION</b> | | | |
|---|---|---|---|
| 004 | Cement Gutter | Chrysotile | |

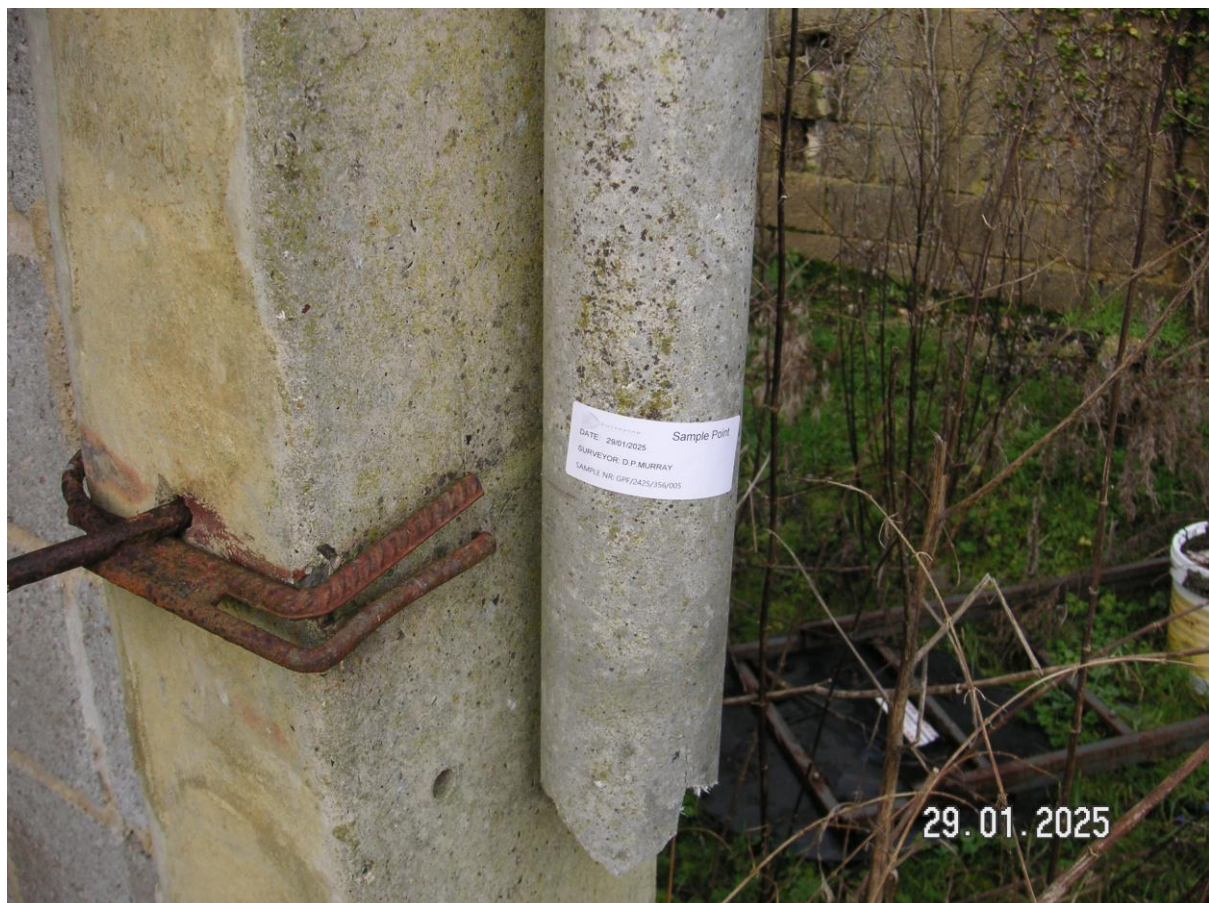
| THIS SAMPLE CONTAINS ASBESTOS | | | | | |
|---|---|---|---|---|---|
| Sample No | | GPF/2425/356/005 | | | |

| THIS SAMPLE CONTAINS ASBESTOS | | | | | |
| Room / Area | | Barn 2 | | | |
| Component | | Cement Pipe | | | |
| SURVEY RESULTS | | Approximate Area | 12M | Asbestos Type | Amosite / Chrysotile |
| Location | Side of Barns | | | Product Type | Cement |
| Comments | To barns 2 & 3 | | | | |

| <b>REMOVE PRIOR TO REFURBISHMENT / DEMOLITION</b> | | | |
|---|---|---|---|
| 005 | Cement Pipe | Chrysotile / Amosite | |

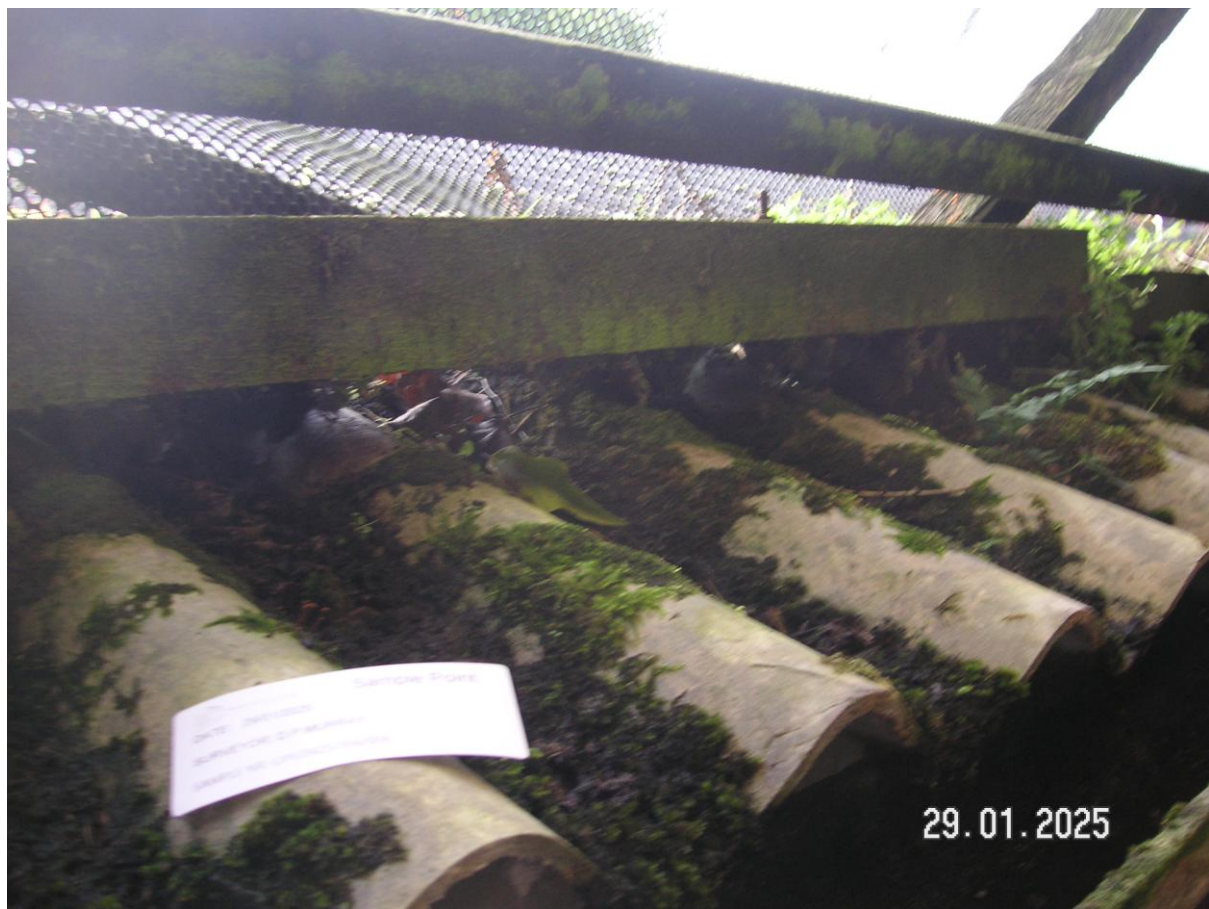
| THIS SAMPLE CONTAINS ASBESTOS | | | | | |
|---|---|---|---|---|---|
| Sample No | | GPF/2425/356/006 | | | |

| THIS SAMPLE CONTAINS ASBESTOS | | | | | |
| Room / Area | | Barn 3 | | | |
| Component | | Corrugated Profile Sheetting | | | |
| SURVEY RESULTS | | Approximate Area | 480m <sup>2</sup> | Asbestos Type | Chrysotile |
| Location | Roof | | | Product Type | Cement |

| <b>REMOVE PRIOR TO REFURBISHMENT / DEMOLITION</b> | | | |
|---|---|---|---|
| 006 | Corrugated Profile Sheet | Chrysotile | |

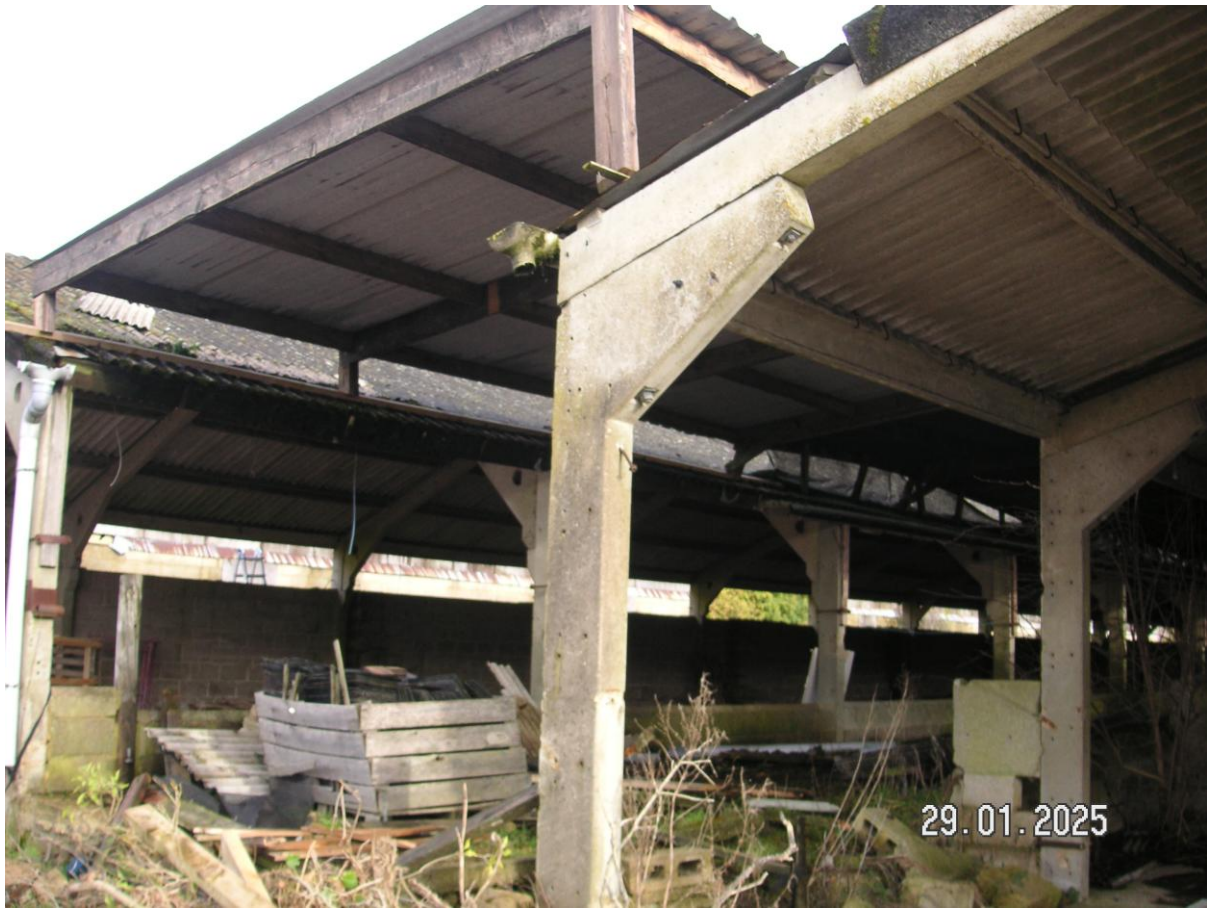
| THIS SAMPLE CONTAINS ASBESTOS | | | | | |
|---|---|---|---|---|---|
| Sample No | | GPF/2425/356/007 | | | |

| THIS SAMPLE CONTAINS ASBESTOS | | | | | |
| Room / Area | | Barn 2-3 | | | |
| Component | | Corrugated Profile Sheetting | | | |
| SURVEY RESULTS | | Approximate Area | 220m <sup>2</sup> | Asbestos Type | Chrysotile |
| Location | Roof | | | Product Type | Cement |
| Comments | Front secretion is newer metal profile sheet | | | | |

| <b>REMOVE PRIOR TO REFURBISHMENT / DEMOLITION</b> | | | |
|---|---|---|---|
| 007 | Corrugated Profile Sheet | Chrysotile | |

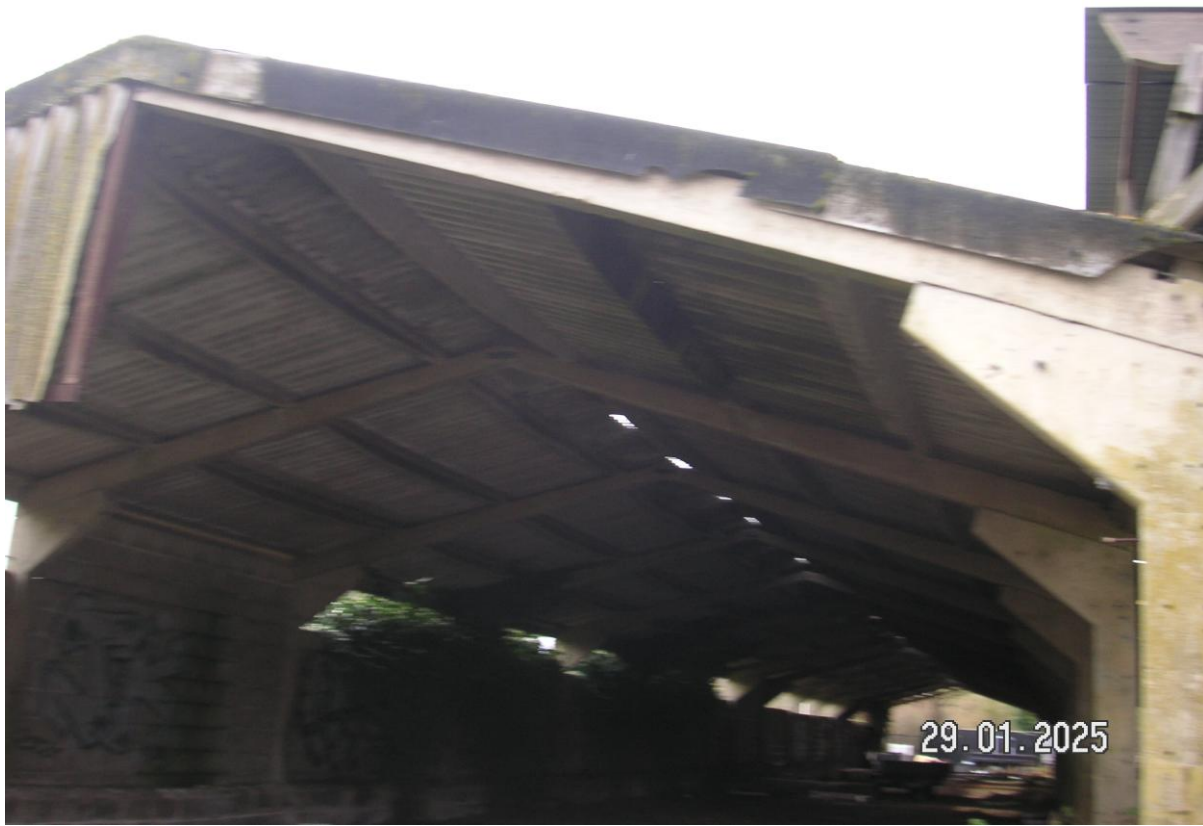
| THIS SAMPLE CONTAINS ASBESTOS | | | | | |
|---|---|---|---|---|---|
| Sample No | | GPF/2425/356/008 | | | |

| THIS SAMPLE CONTAINS ASBESTOS | | | | | |
| Room / Area | | Barn 3 | | | |
| Component | | Cement eaves Profile Sheet | | | |
| SURVEY RESULTS | | Approximate Area | 16m | Asbestos Type | Chrysotile |
| Location | Ends of Roof | | | Product Type | Cement |

| <b>REMOVE PRIOR TO REFURBISHMENT / DEMOLITION</b> | | | |
|---|---|---|---|
| 008 | Cement Eaves Sheet | Chrysotile | |
