## East Court, Finchampstead RG40 3SD

2024 Final Bat Survey Report

December 2024

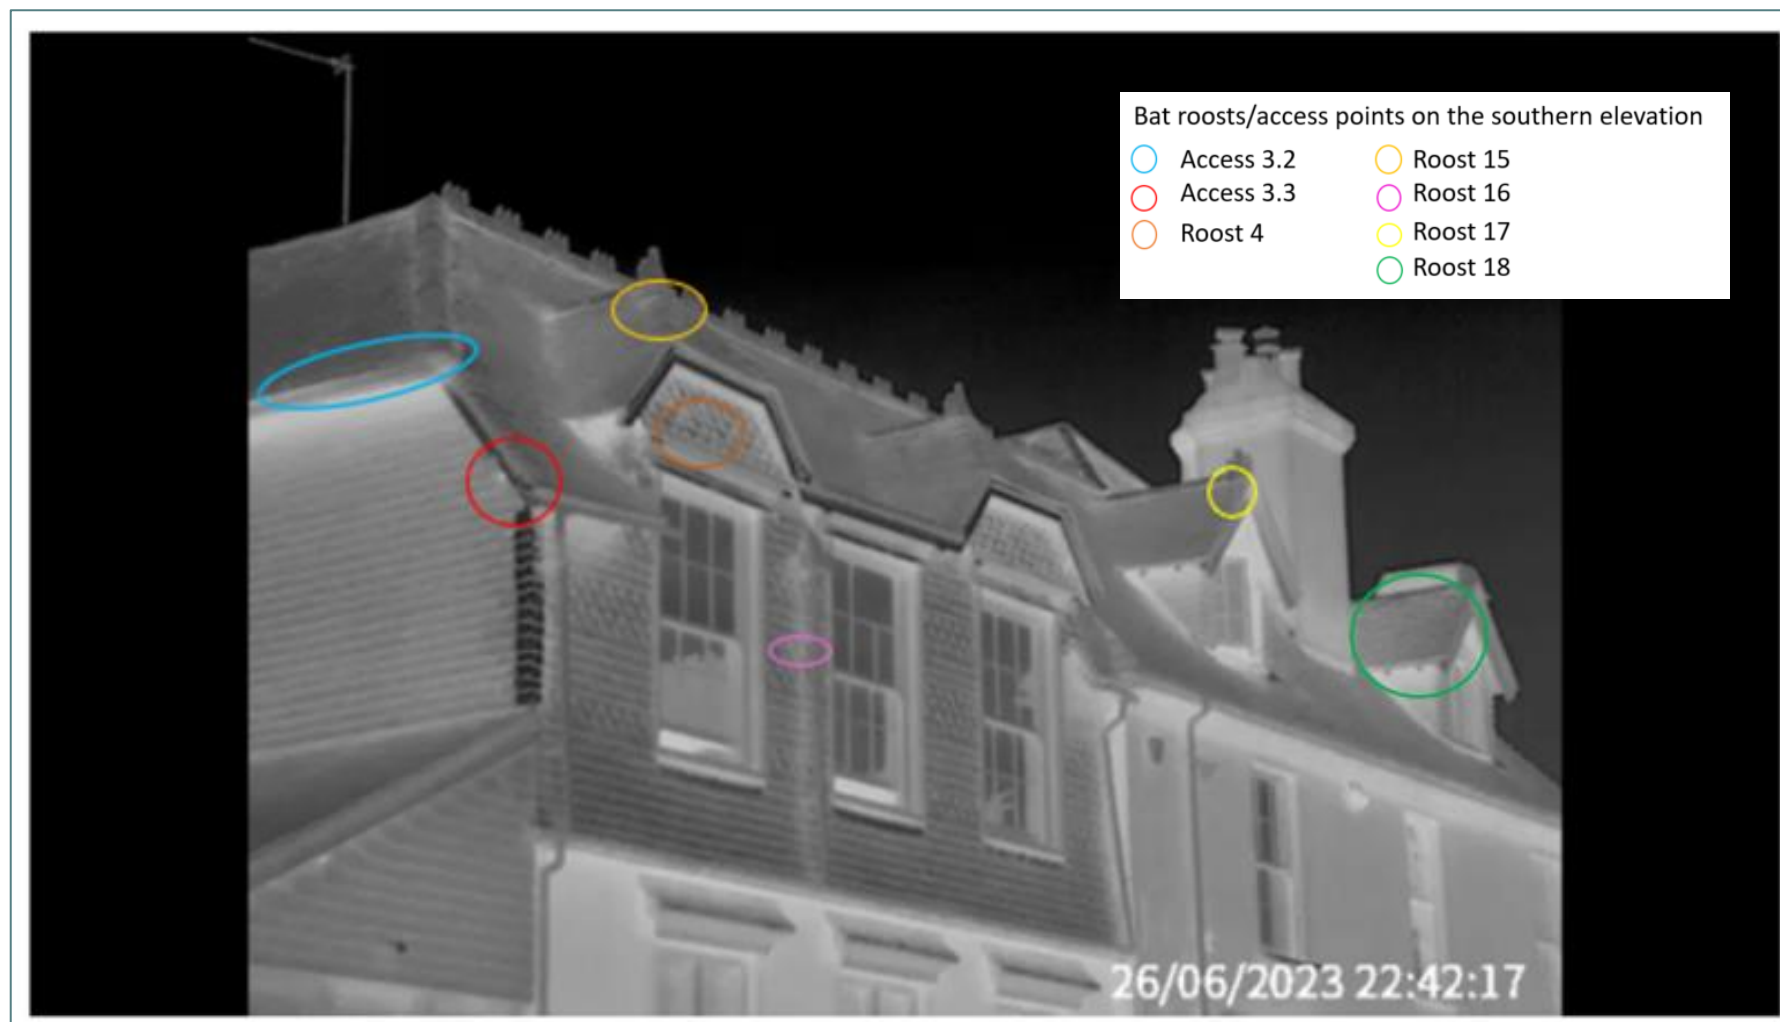
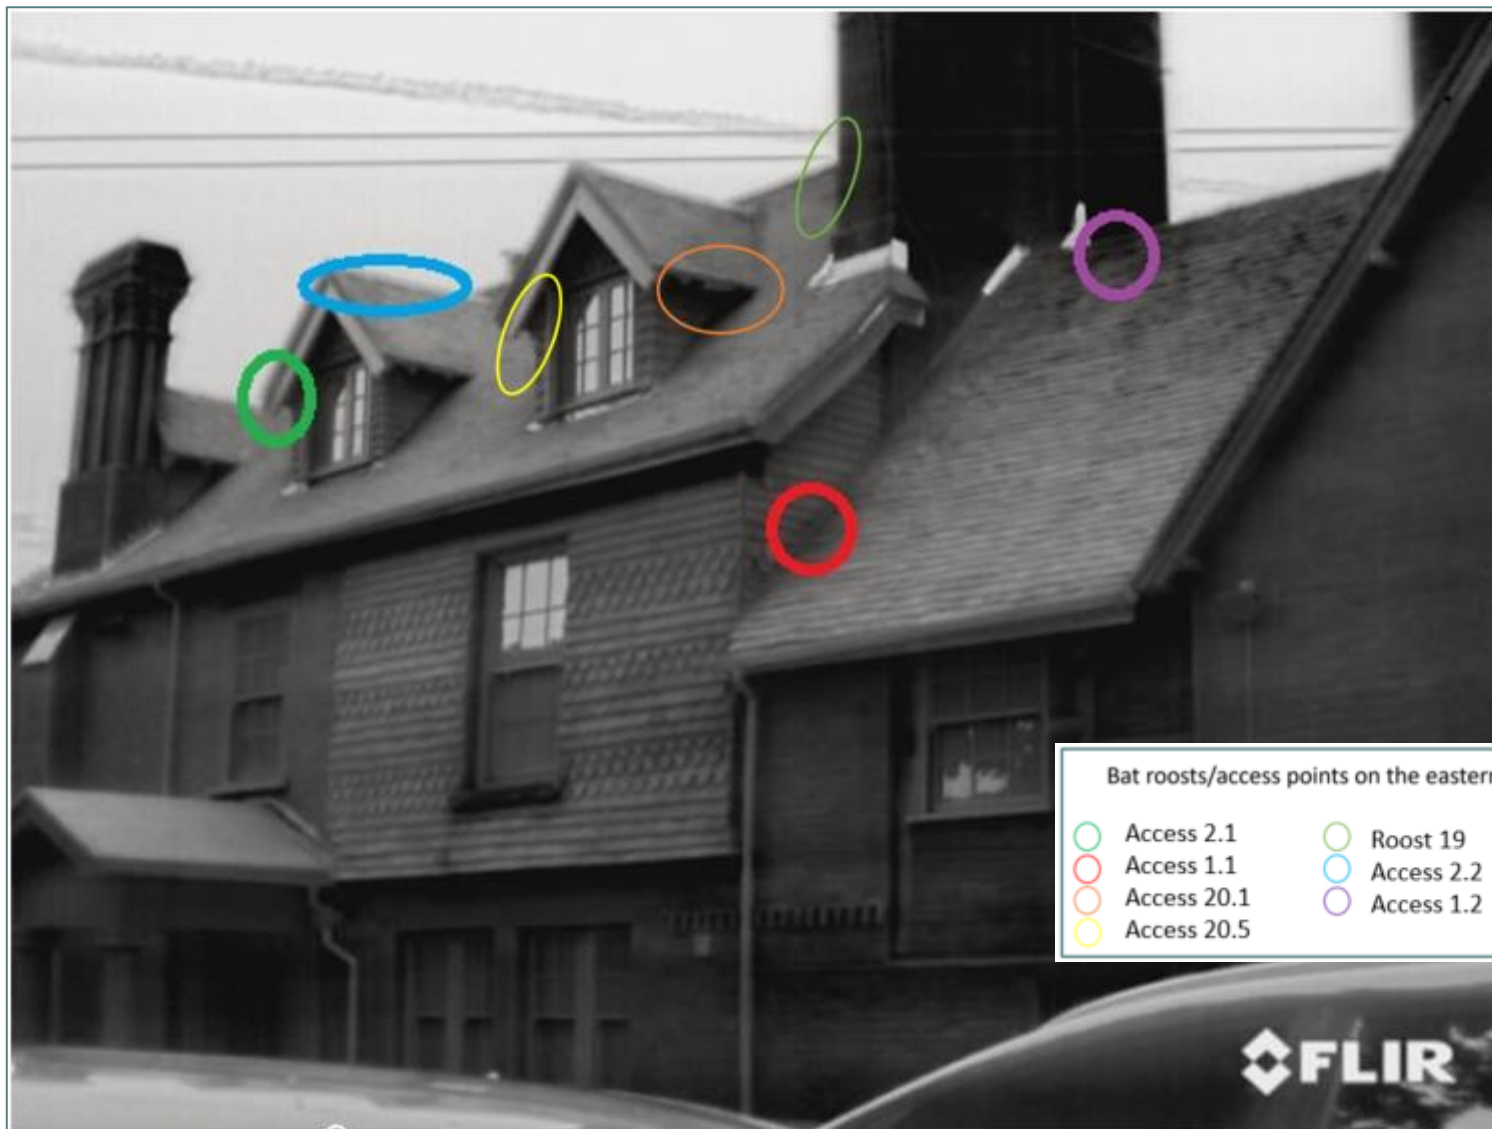
Figure 5: Annotated photographs of roost access locations for three elevations (2023)

A number of potential entry points were observed among the roof tiles, cladding features, bargeboards, chimney flashing, and at gaps where one construction material joined another. Evidence of bats (droppings) were also seen on roof tiles surrounded potential entry points.

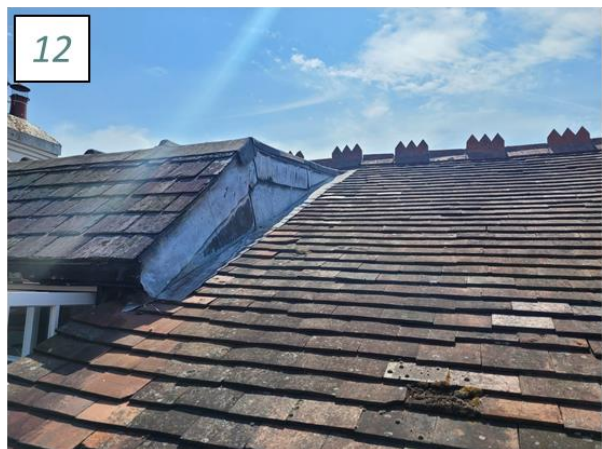
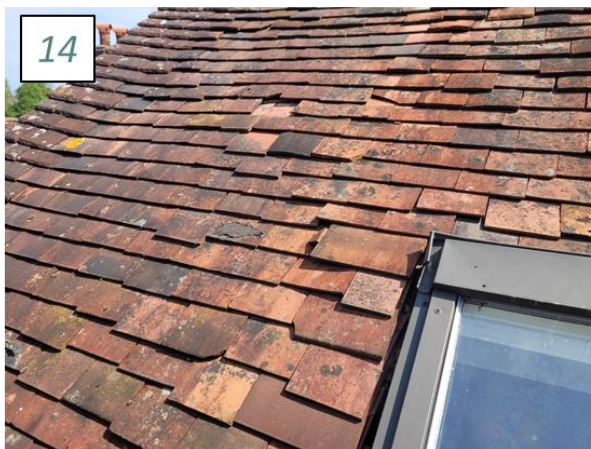
11 – 15: views of the myriad lifted and hanging tiles on the roof

Due to the entanglement risk posed by modern breathable roofing membranes, traditional F1 roofing felt must be used throughout and will be a condition of any licence issued by Natural England.

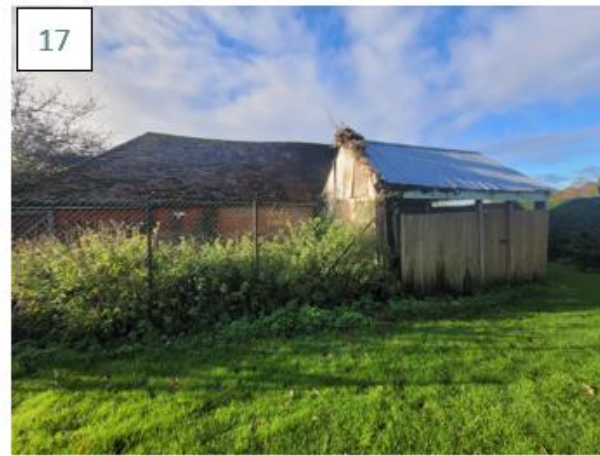
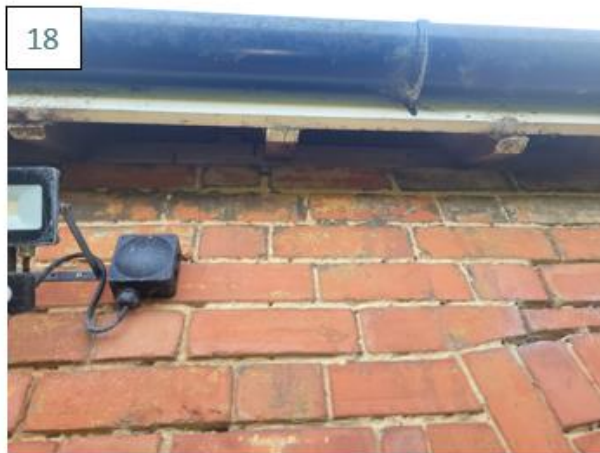
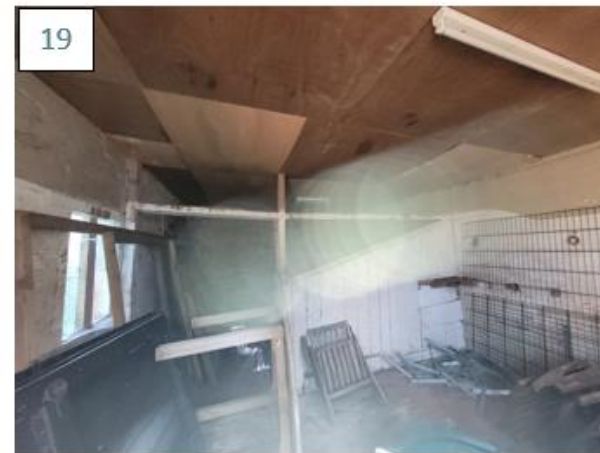
*16: External view of the detached garage, black circle to show where the roof is bowing. 17: Rear elevation showing disused chicken coop and run.  
18: Eaves of the building. 19: Internal view of the stable area with false ceiling.*
