Outbuildings at 78 Barkham Ride  
Finchampstead  
Wokingham  
Berkshire  
RG40 4ET

## Preliminary Roost Assessment

Report ref.: R2912\_PRA\_a

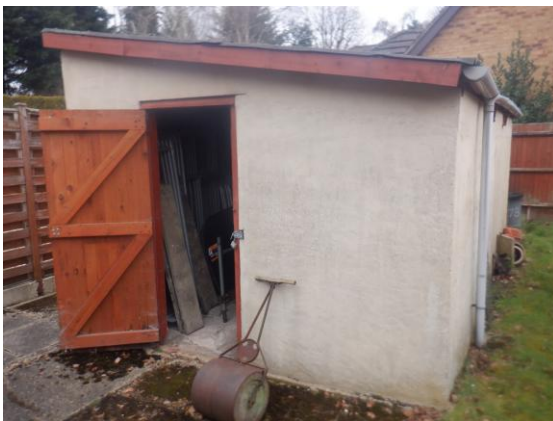
**5.2.2** The outbuilding was a rendered single-skin shed with a sloping roof covered by corrugated metal sheets where the grooves were blocked by spray foam (**Photographs 1 & 2**).

*Photograph 1. Outbuilding 1.*

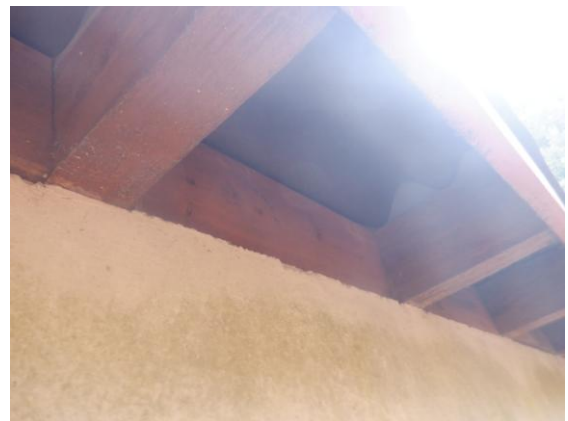
*Photograph 2. Gaps within grooves of corrugated sheets blocked by felt (Outbuilding 1).*

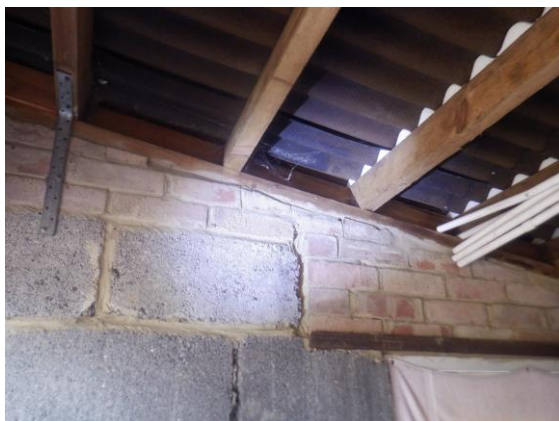
**5.2.3** Whilst a slight gap was situated above the door frame, the internal timbers were otherwise sealed to the foam and brickwork walls (**Photograph 3**).

*Photograph 3. Timbers sealed to brickwork walls and foam (Outbuilding 1).*

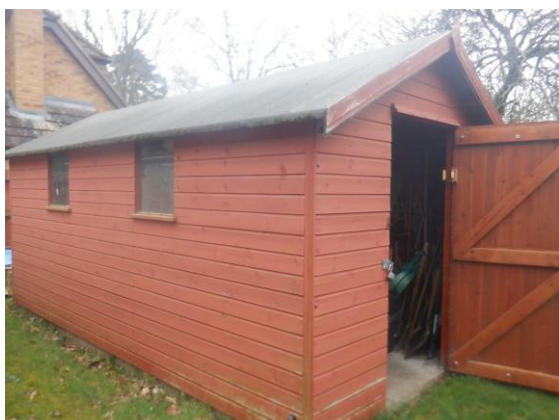
- 5.2.4** The outbuilding was a pre-fabricated shed with single-skin timber panel walls and a pitched roof covered by bitumen felt (**Photograph 4**). The bitumen felt roof and rear gable was fully sealed to the internal wooden boards (**Photograph 5**).

*Photograph 4. Outbuilding 2.*

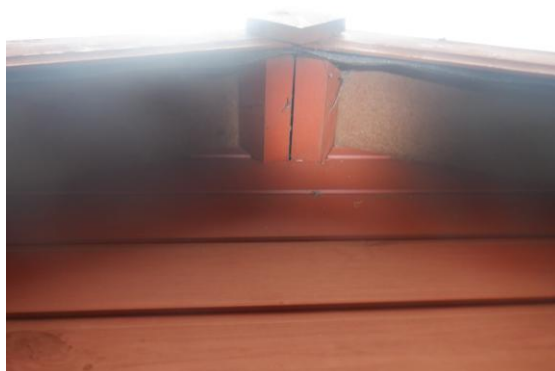
*Photograph 5. Gable sealed to internal roof lining (Outbuilding 2).*

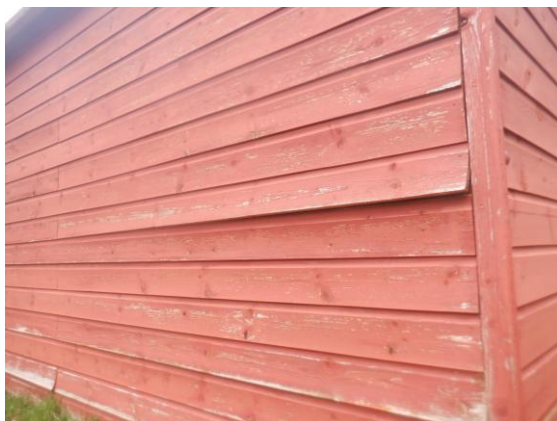
- 5.2.5** A timber panel was slightly lifted on the rear elevation, but a close inspection with a high-powered torch confirmed the feature to be of limited extent (**Photograph 6**). Internally, the roof and walls were lined by timber boards and paper-back felt respectively, with both fully sealed throughout (**Photograph 7**).

*Photograph 6. Gap of limited extent behind lifted timber cladding (Outbuilding 2).*

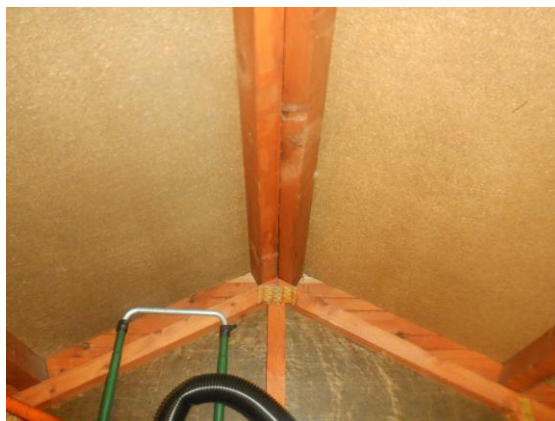
*Photograph 7. Wooden boarding and paper-back felt fully sealed to the timbers (Outbuilding 2).*

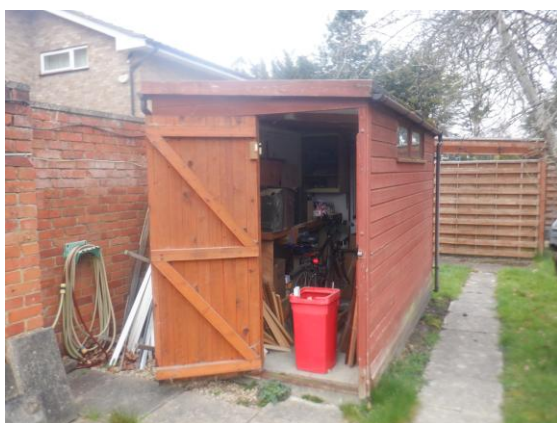
- 5.2.6** The outbuilding was a simple single skin timber panel shed with a flat wooden roof (**Photograph 8**). Internally, the plaster boarded walls and ceiling were fully sealed throughout (**Photograph 9**).

*Photograph 8. Outbuilding 3.*

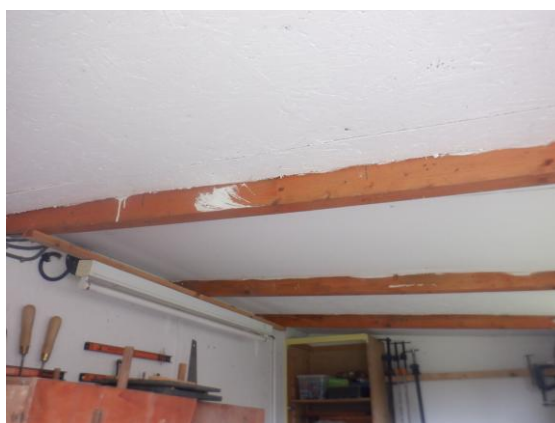
*Photograph 9. Plaster boarded walls and ceiling fully sealed (Outbuilding 3).*

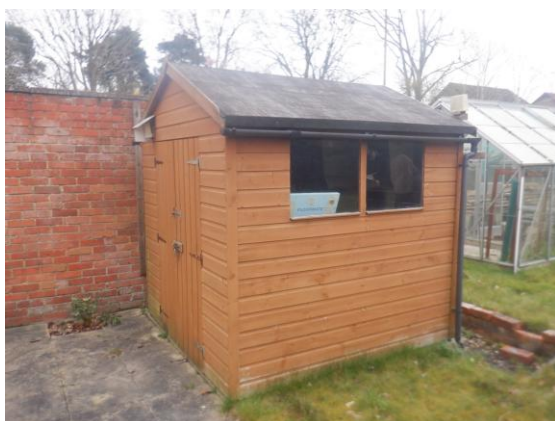
- 5.2.7** The outbuilding was also a simple single-skin shed with timber panel walls and a pitched bitumen felt roof that was fully sealed (**Photograph 10**). Internally, the timber chipboard roof was partially covered by plaster boarding and the timber panel walls were sealed throughout (**Photograph 11**).

Photograph 10. Outbuilding 4.

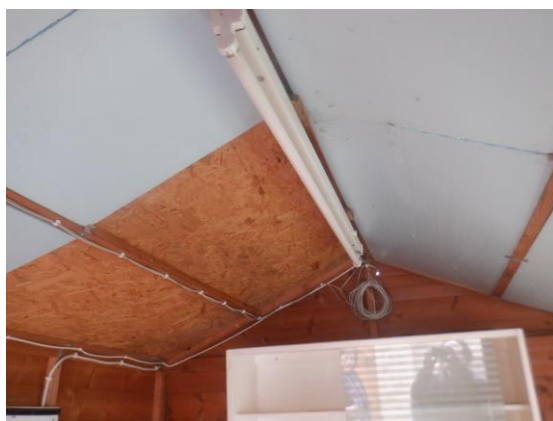
Photograph 11. Timber panel walls and chipboard roof fully sealed (Outbuilding 4).

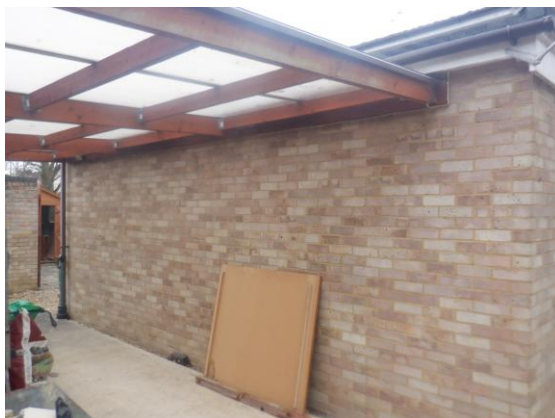
- 5.2.8** The garage was attached to the southeast elevation of the house and had a flat roof covered by a fully sealed bitumen felt (**Photograph 12**).

Photograph 12. Garage & carport.

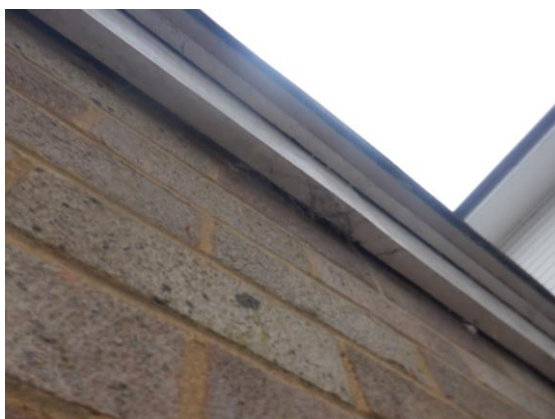
- 5.2.9** Whilst cobwebbed gaps were situated behind the uPVC fascia and within small weep holes across the rear elevation of the garage, these features were closely inspected with a high-powered torch and confirmed to be of limited extent (**Photographs 13 & 14**).

Photograph 13. Feature of limited extent behind lifted uPVC fascia (Front elevation of the garage).

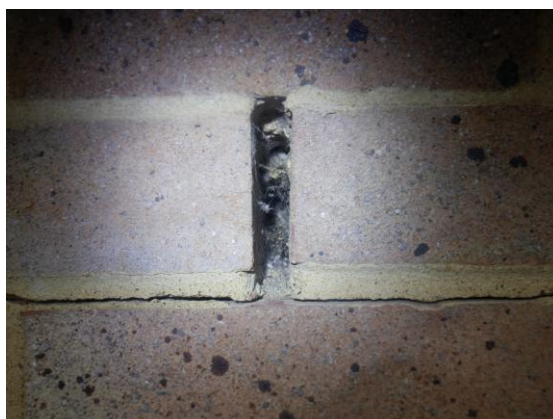
Photograph 14. Features of limited extent within slits filled with debris (Rear elevation of the garage).

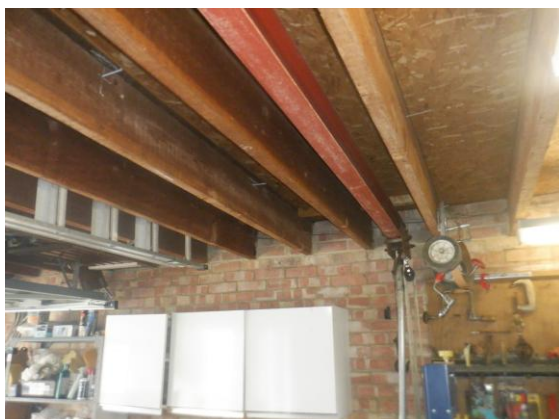
**5.2.10** Internally, the open-roof garage was used for storage and had a chipboard ceiling that was fully sealed to the brickwork walls (**Photograph 15**).

*Photograph 15. Chipboard roof sealed to the internal brickwork walls (Garage).*
