## **BS 5837:2012 TREE SURVEY FOR 91 READING ROAD WOODLEY**

**Prepared on behalf of:  
Mr D Fisher  
91 Reading Road  
Woodley  
Reading  
RG5 3AE**

**Ref: SPH/5837-24/20.11**

**27 November 2024**

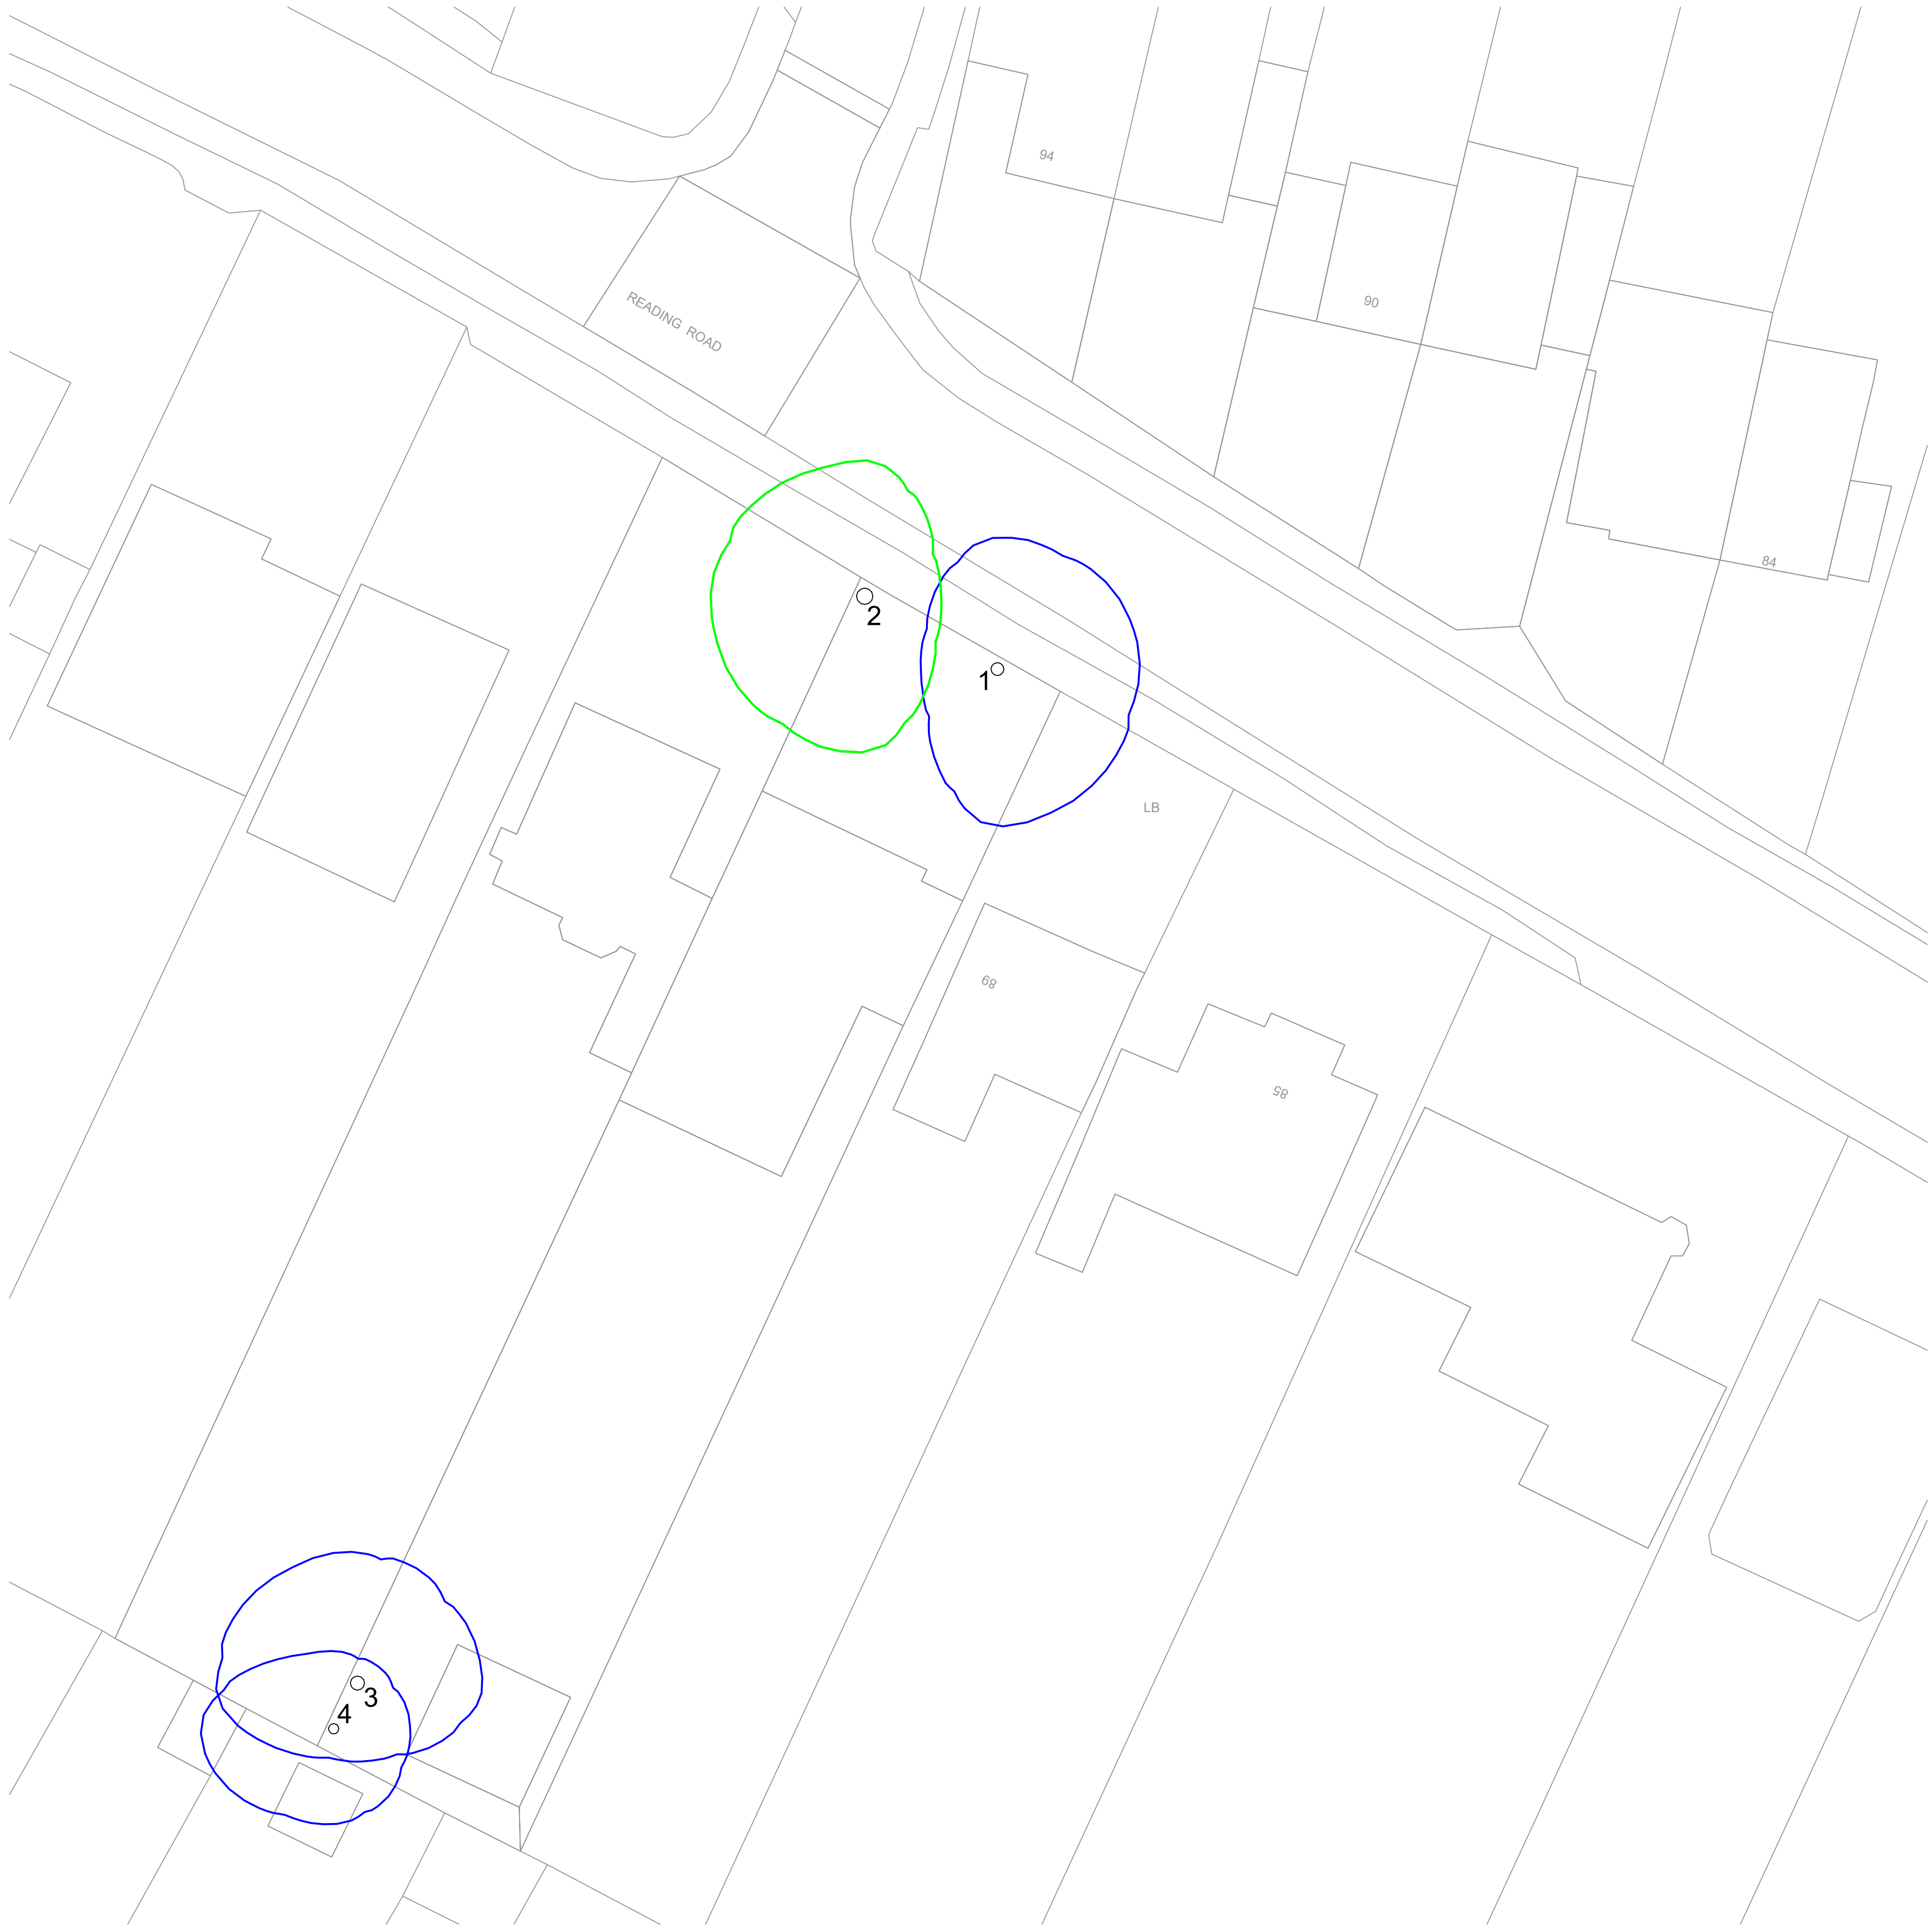
| Drawing Title | TREE LOCATION PLAN | | |

- 3.2.2 For ease of identification the trees are shown on the tree location drawing ref SPH/5837-24/20.11 and have been allocated numbers. These numbers are cross-referenced within the BS 5837:2012 survey schedule.

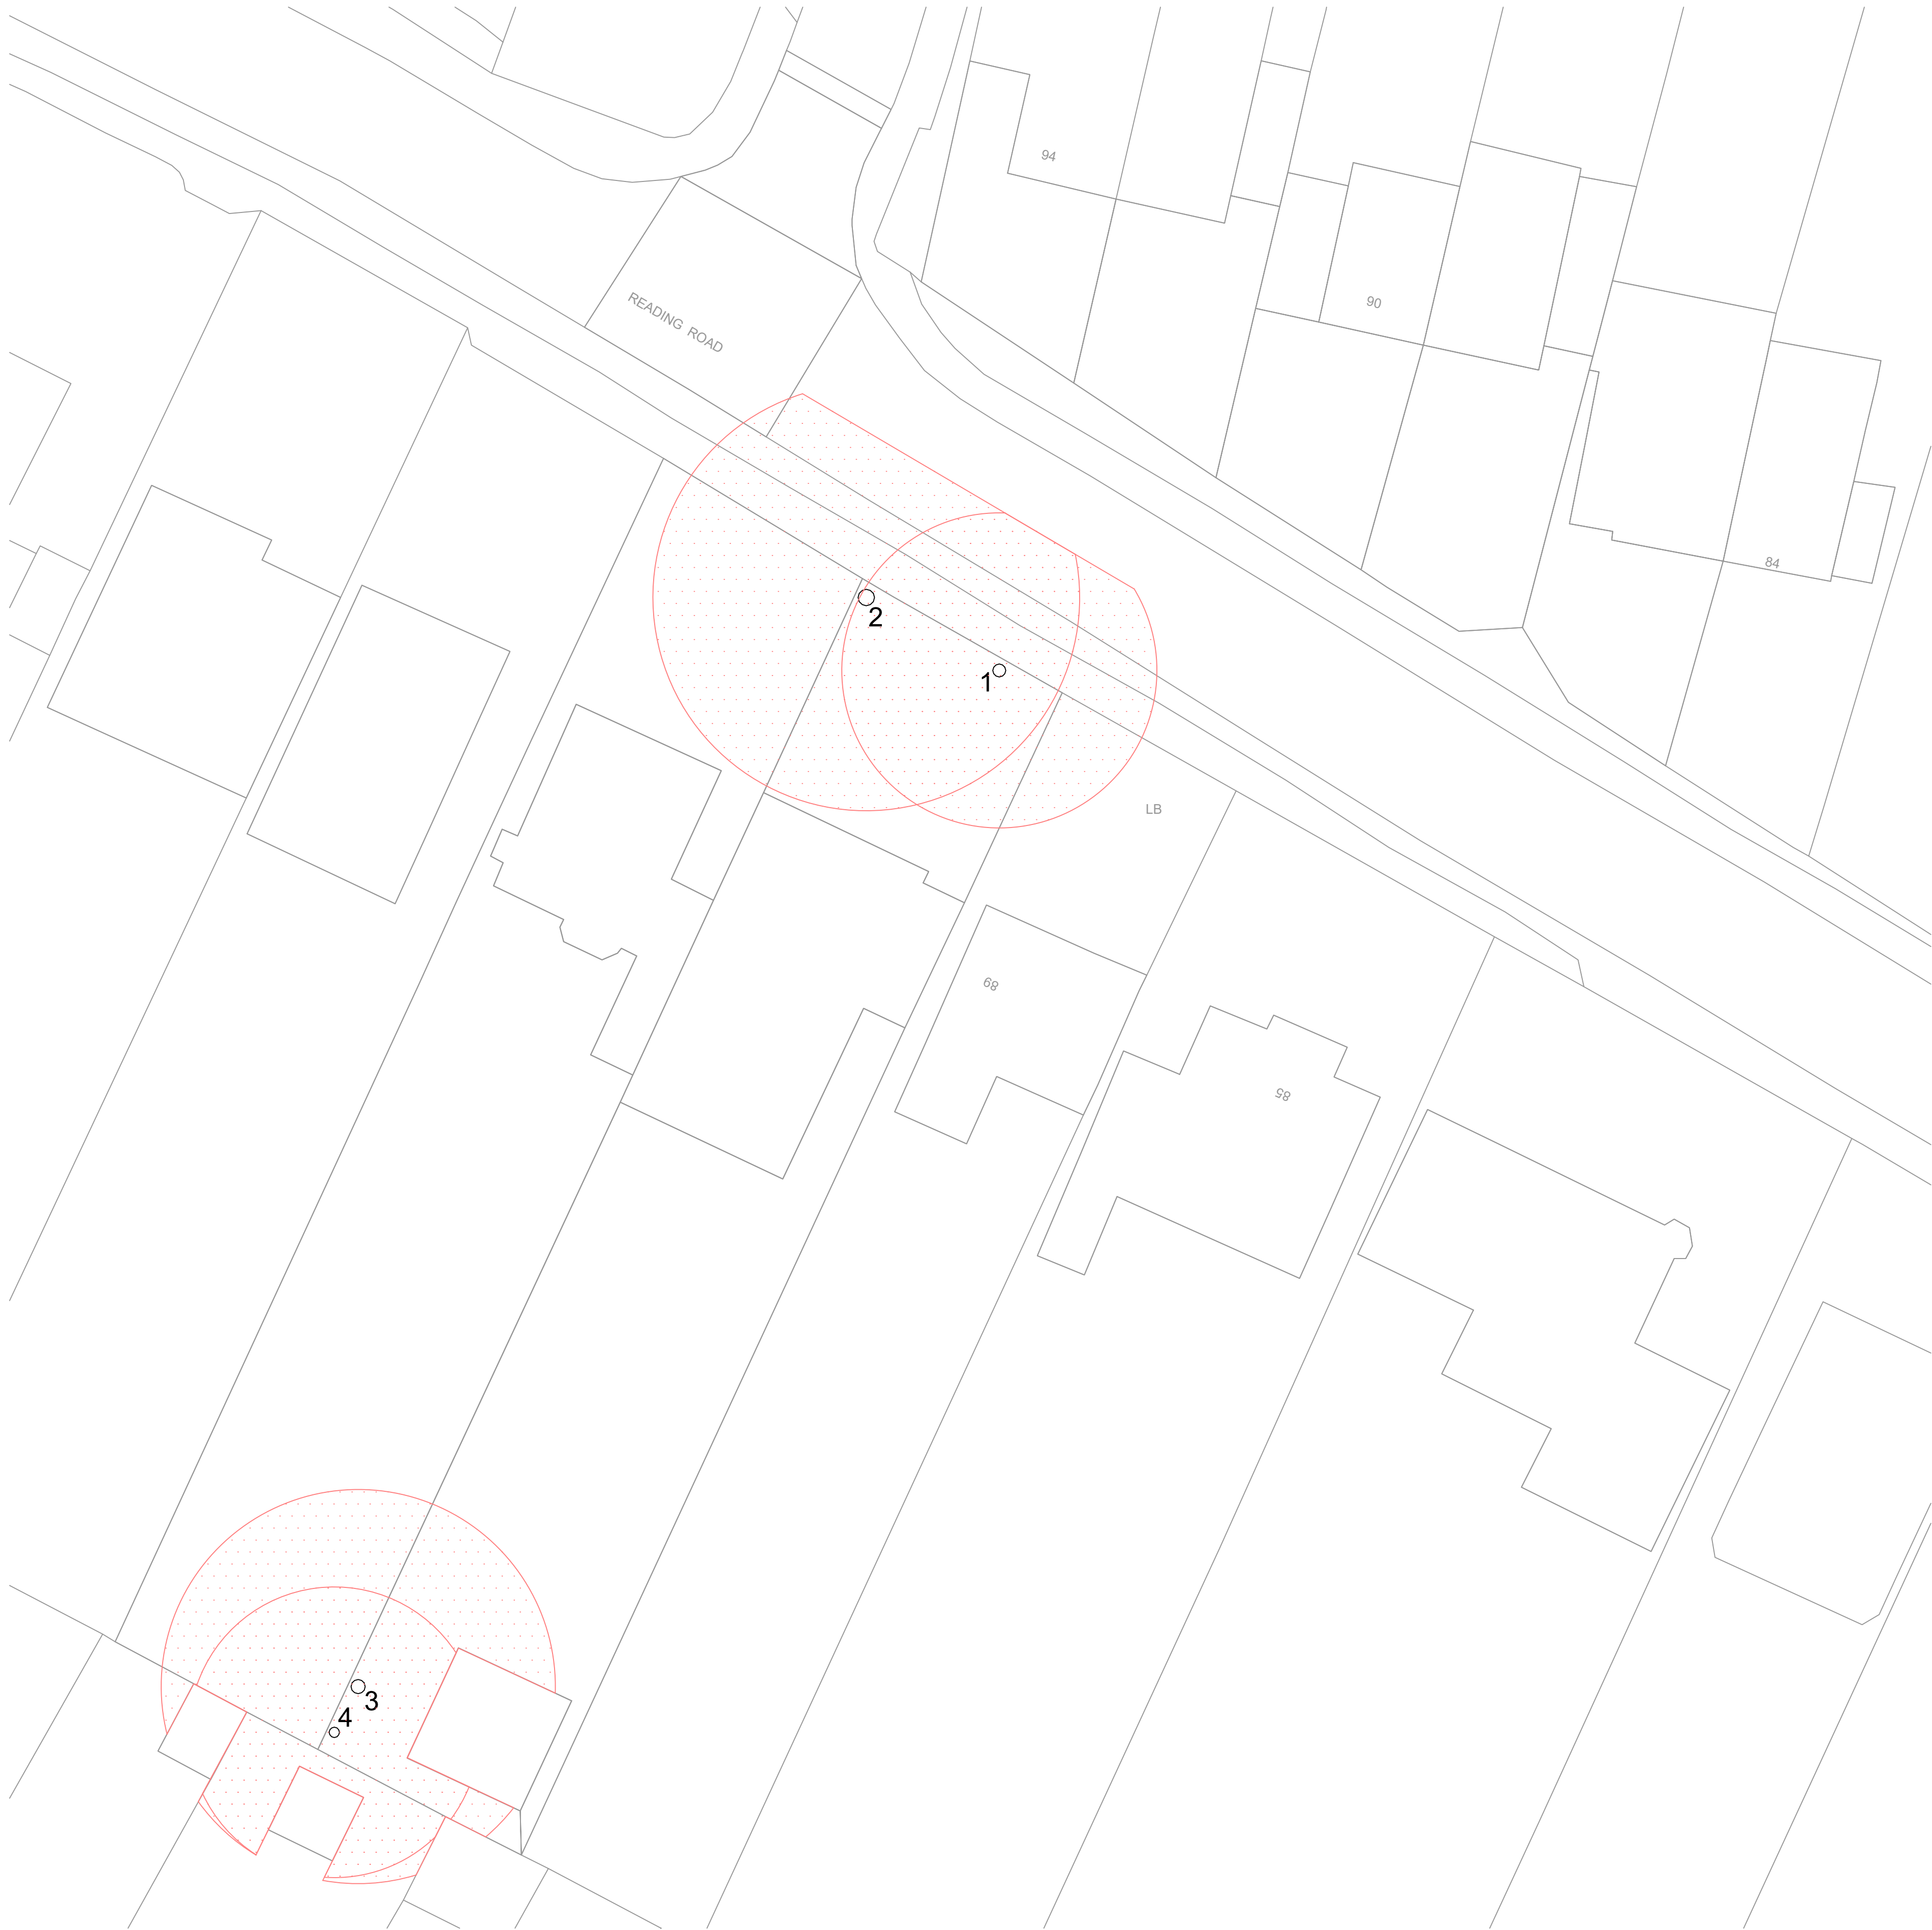
| Drawing Title | ROOT PROTECTION AREA PLAN | | |

- 4.2.1 Using BS 5837:2012 the RPAs have been calculated for the trees by reference to section 4.6.1 (a) and/or (b). The RPA is frequently described as a circle with a radius of prescribed distance within which no unspecified activity should occur and a high level of care is needed during any activities that are authorised within them, if it is to be successfully retained.

- 4.2.2 Specified intrusions into the RPAs can take place only where the ground is adequately protected in accordance with the requirements of section 6 (6.2.3.3) of the BS or as may be agreed with the Local Planning Authority (LPA). The RPAs have been plotted as dodecagons taking account of the site constraints on drawing SPH/RPA-24/20.11.

Mitigation may be required to demonstrate how the retained tree root protection areas (RPA) will be protected during any development, including access to the proposed development area. The RPAs are shown on the drawing included at Appendix 3.

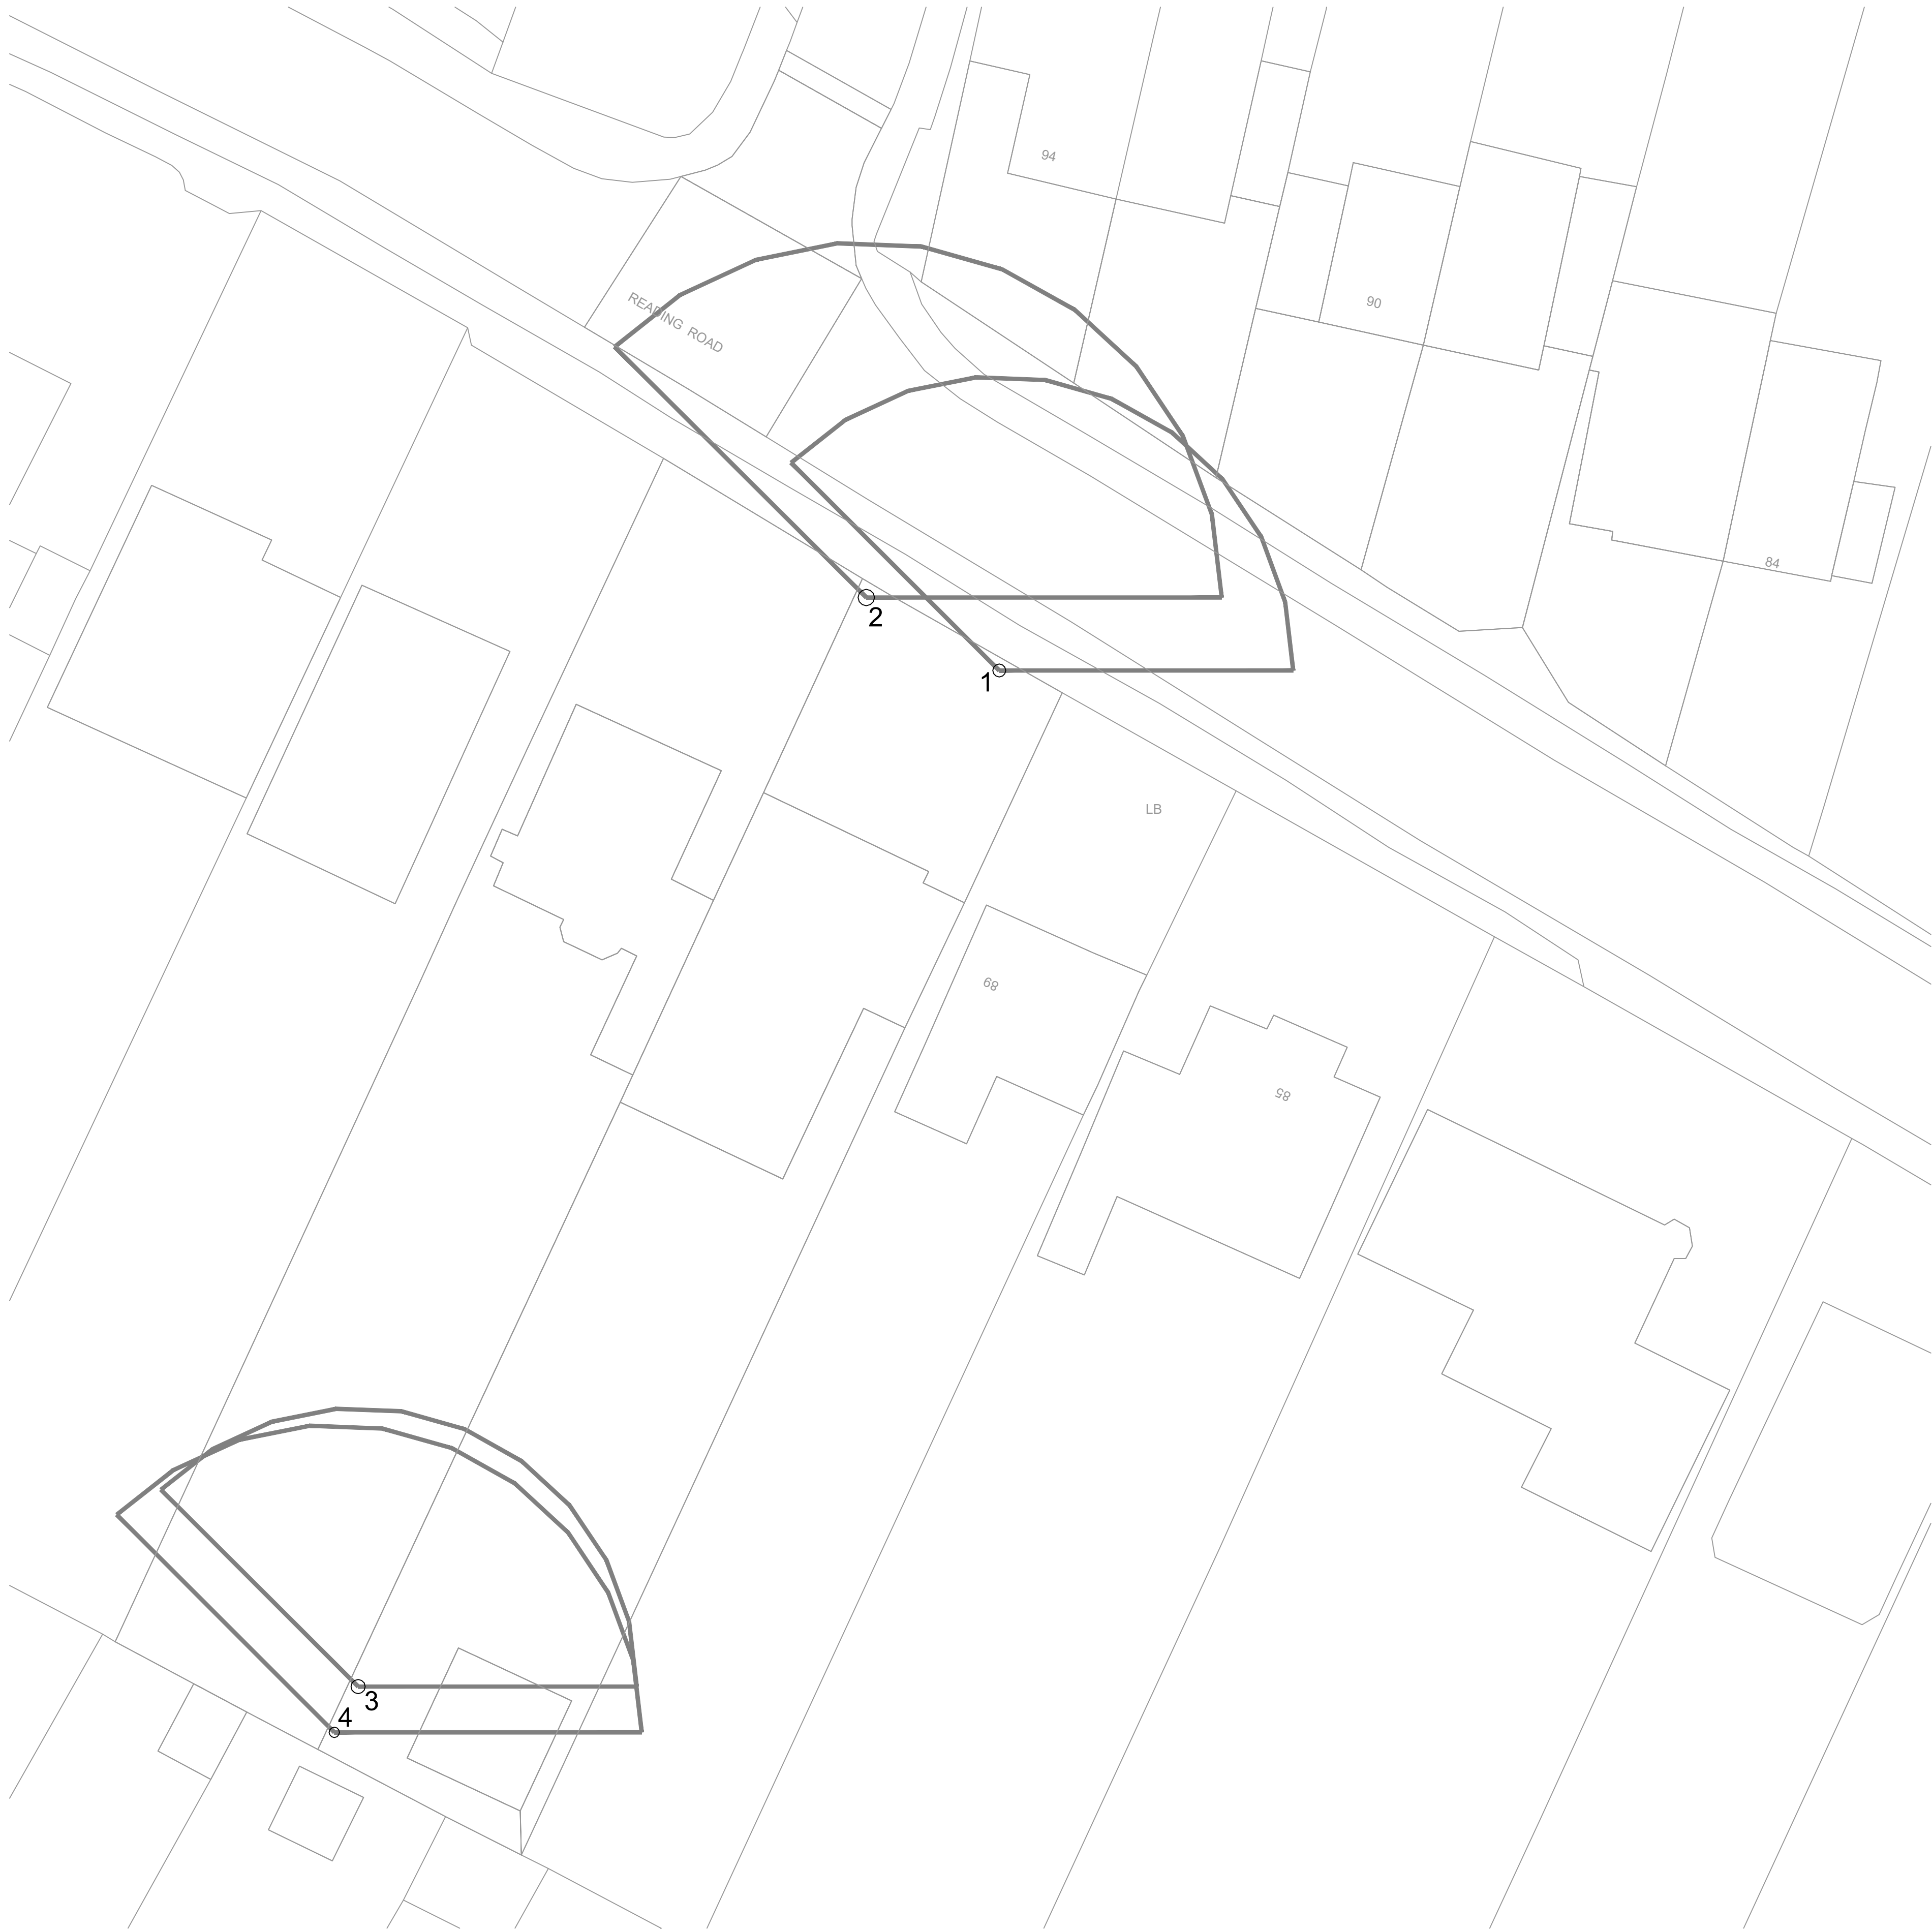
Drawing Title  
SHADE CONSTRAINTS PLAN

- 4.3.1 Large trees that cast dense shade may result in pressure to prune or remove them. Whilst either shade or sunlight might be desirable depending on the potential use; the design should avoid unreasonable obstruction of light. The shade constraints posed by the trees are plotted onto drawing ref SPH/SC-24/20.11.

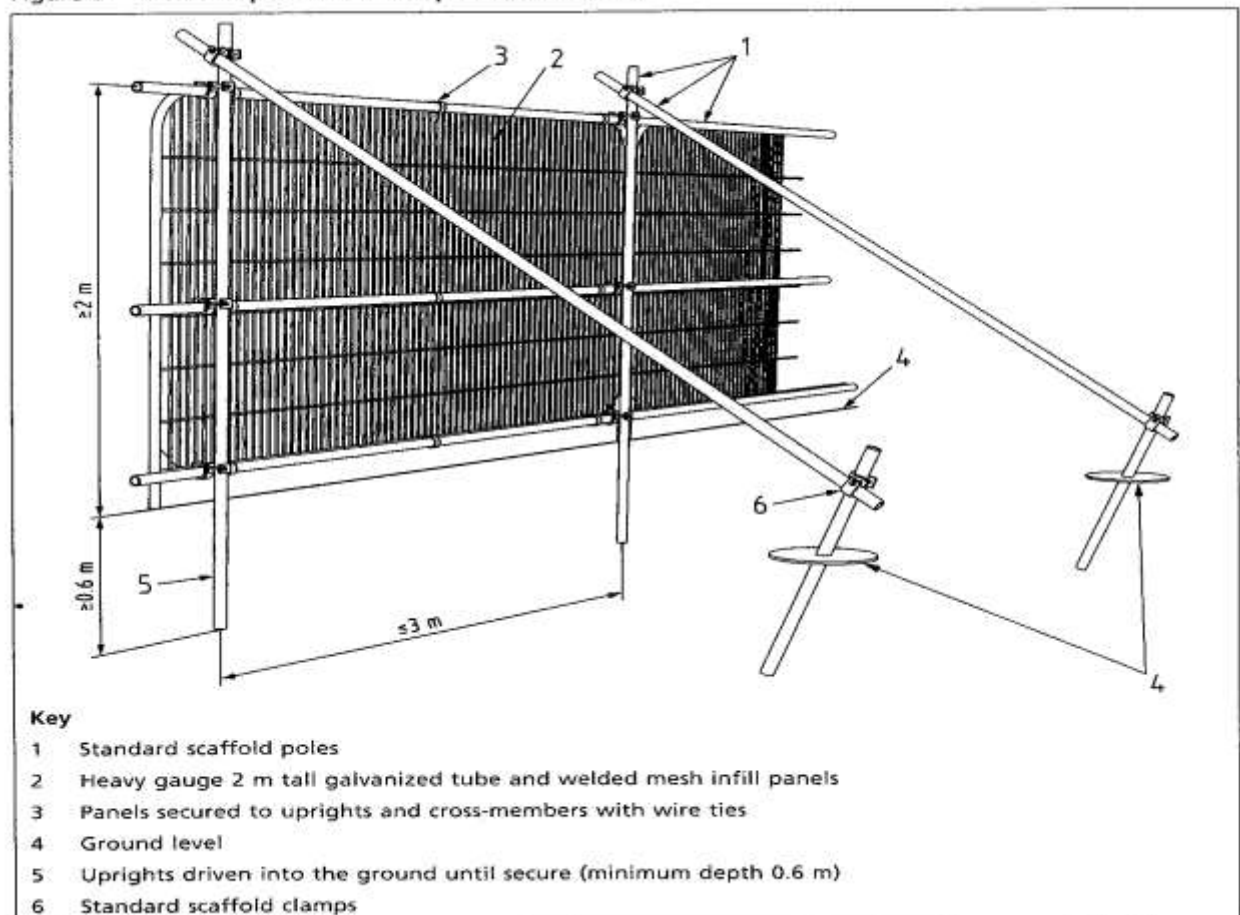
Figure 2 Default specification for protective barrier

**Root Protection Areas (RPAs), enclosed by Default Temporary Protective Fencing, as detailed below and to be agreed with the Local Planning Authority (LPA), shall:**

1. Be protected throughout the development process, as specified and detailed in BS 5837:2012 Section 6.2, Fig 2
2. Be erected prior to any construction, demolition or excavation works and remain in place for the duration of the project.
3. Preclude any delivery of site accommodation and or materials and or plant machinery.
4. Preclude all construction related activity, with the sole exception of specified arboricultural works and any other works carried out under supervision that has been agreed by all parties, and:
5. Preclude the storage of all development related materials and substances including fuel, oils, additives, cement and or any other deleterious substances.
6. Any incursions into RPAs must be by prior arrangement, following consultation with the LPA.

- 5.1 To protect the retained trees from construction activities, they must be protected by suitable protection barriers and ground protection; the accompanying root protection area drawing shows the RPAs.
- 5.2 The tree protection barrier (TPB) is designed to provide construction exclusion zones around the RPAs of the trees to be retained.
- 5.3 The tree protection fencing should be fit for the purpose of excluding construction activity and appropriate to the degree and proximity of work taking place around the retained trees. The default specification for protective barriers is that specified in BS 5837:2012 Figure 2, section 6; and is reproduced at Appendix 5. All weather signs must be attached by cable ties to each Heras panel as set out in Appendix 6.
