## Preliminary bat roost assessment

| Site Location | 380 Barkham Rd, Wokingham RG41 4DL |
| Document reference | CE4672 |

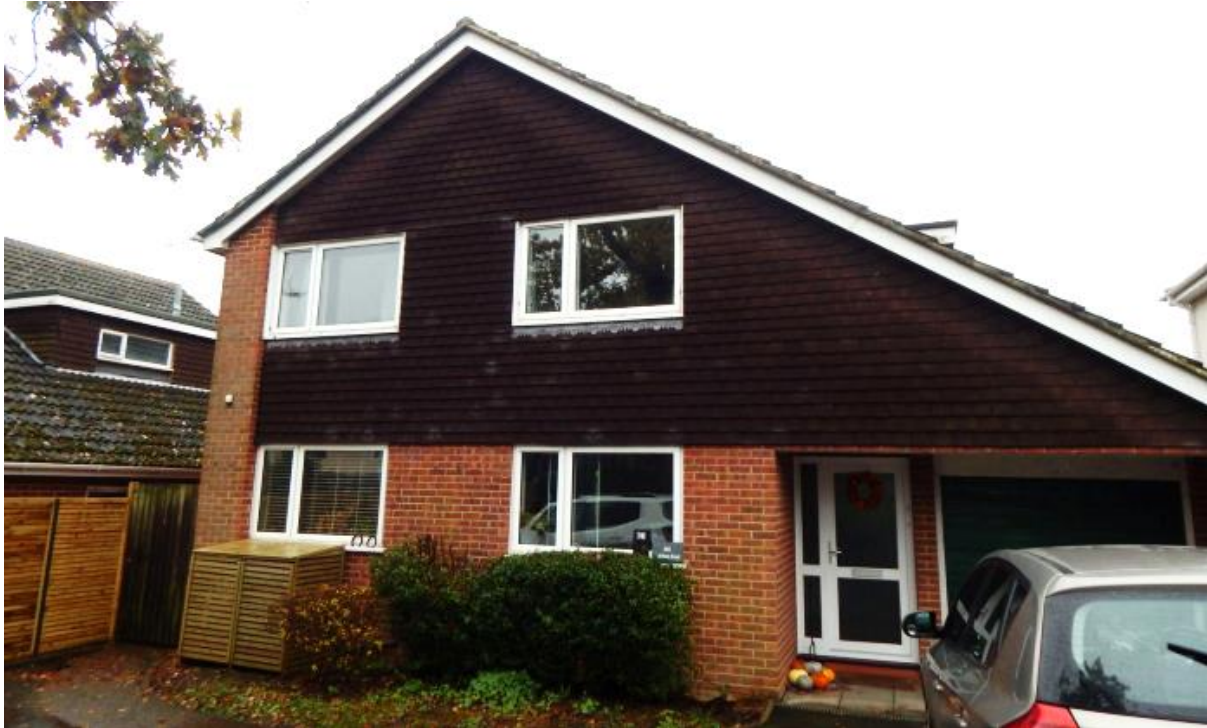
Image 1 – North facing elevation of the property

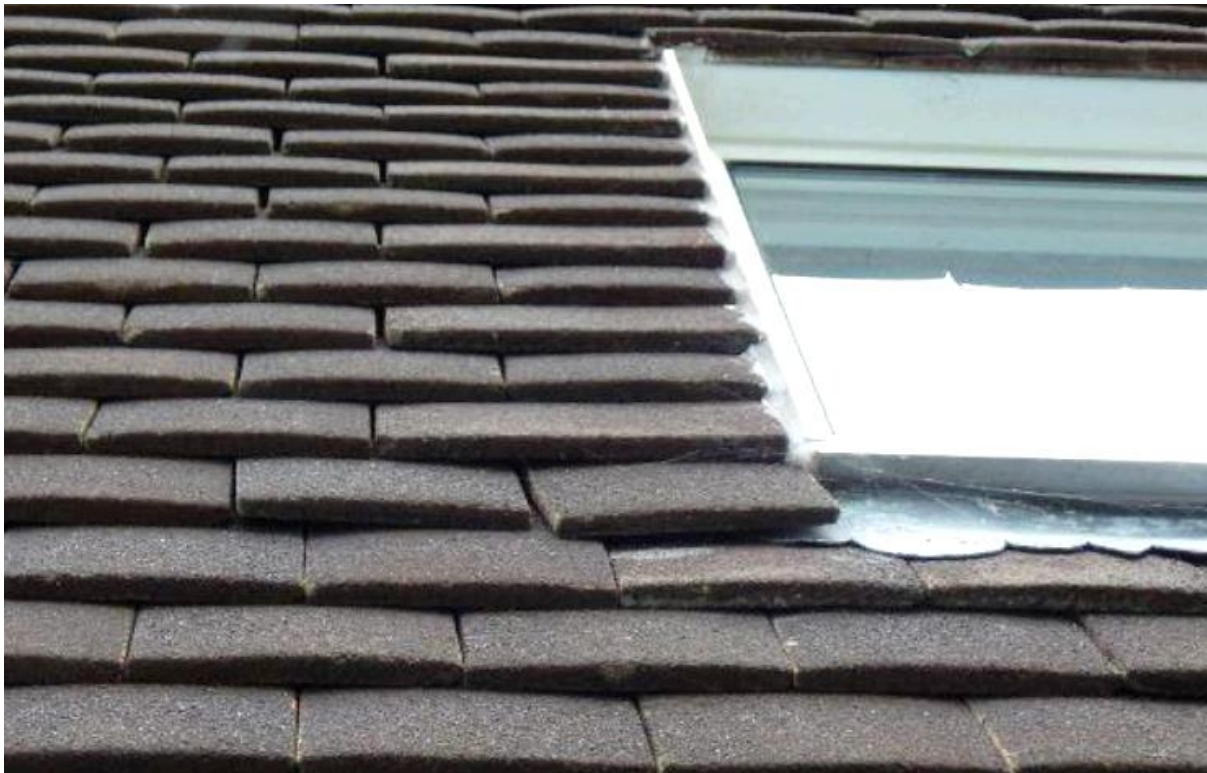
| External | Features of value to bats | Notes |
|---|---|---|
| Vertical hanging tiles | Yes | <p>Both the front and rear facing vertical hanging tiles have demonstrated gaps of adequate proportions to offer likely shelter/ access opportunities for bats.</p> <p>The rear section had demonstrated both slipped and missing tiles.</p> <p>Such features would offer likely daytime roosting habitats of value to crevice dwelling bats which have been observed locally during desk studies.</p> |

Image 2 – Close view of the North facing vertical hanging tiles which has demonstrated minor gaps of potential value to bats within

- 6.4 The main dwelling has evidenced roosting features of value within the front and rear vertical hanging tiles which look to offer likely access and availability to both void & crevice dwelling bats and could not be fully ruled out during the Preliminary Roost Assessment without causing disturbance to materials which in effect may cause disturbance to possible bat roosts within.

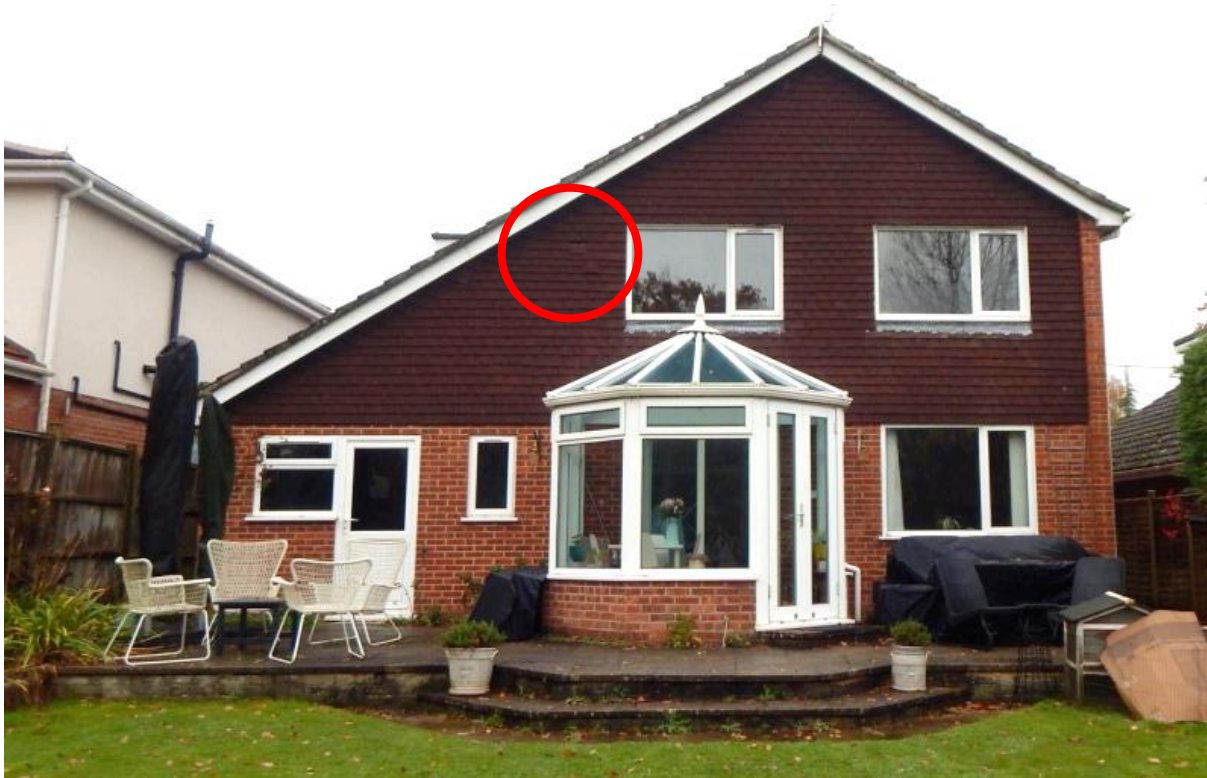
Image 3 – South facing elevation of the property where gaps of accessible proportions to offer likely shelter/access opportunities for bats were observed

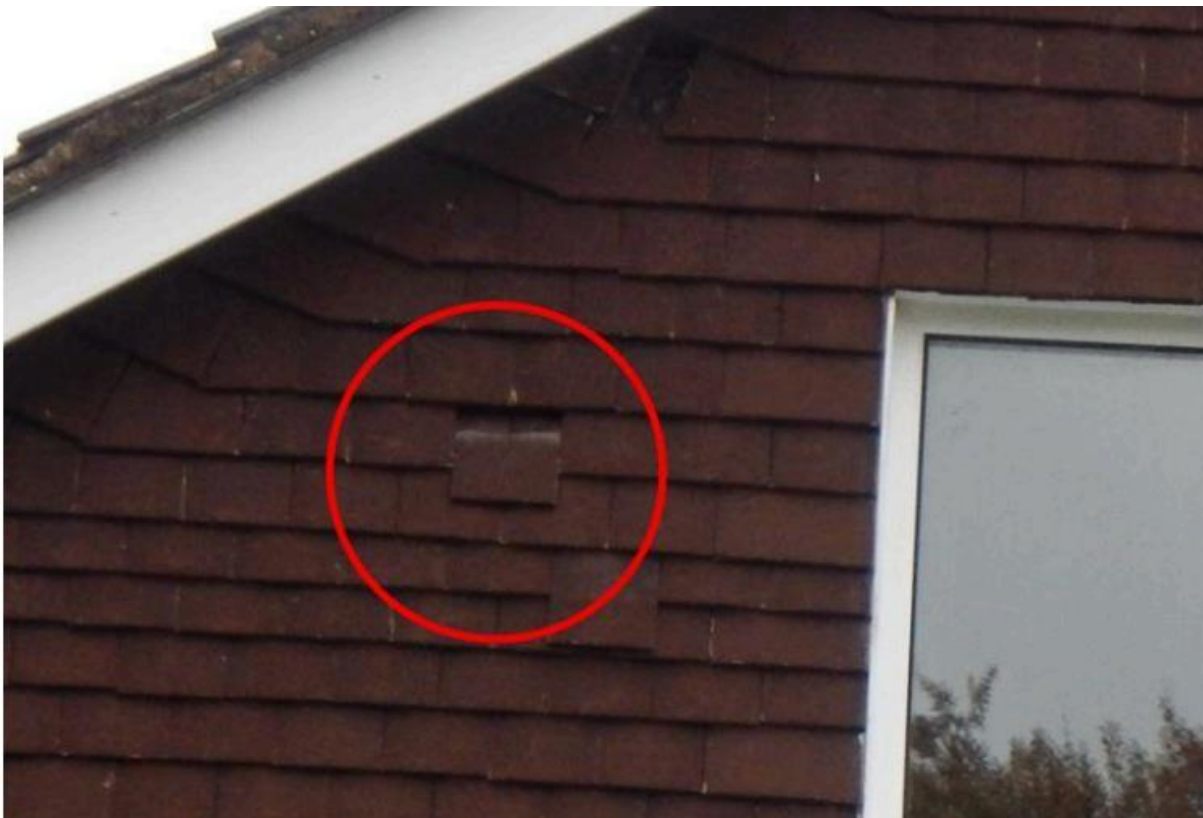
Image 4 – As per image three above

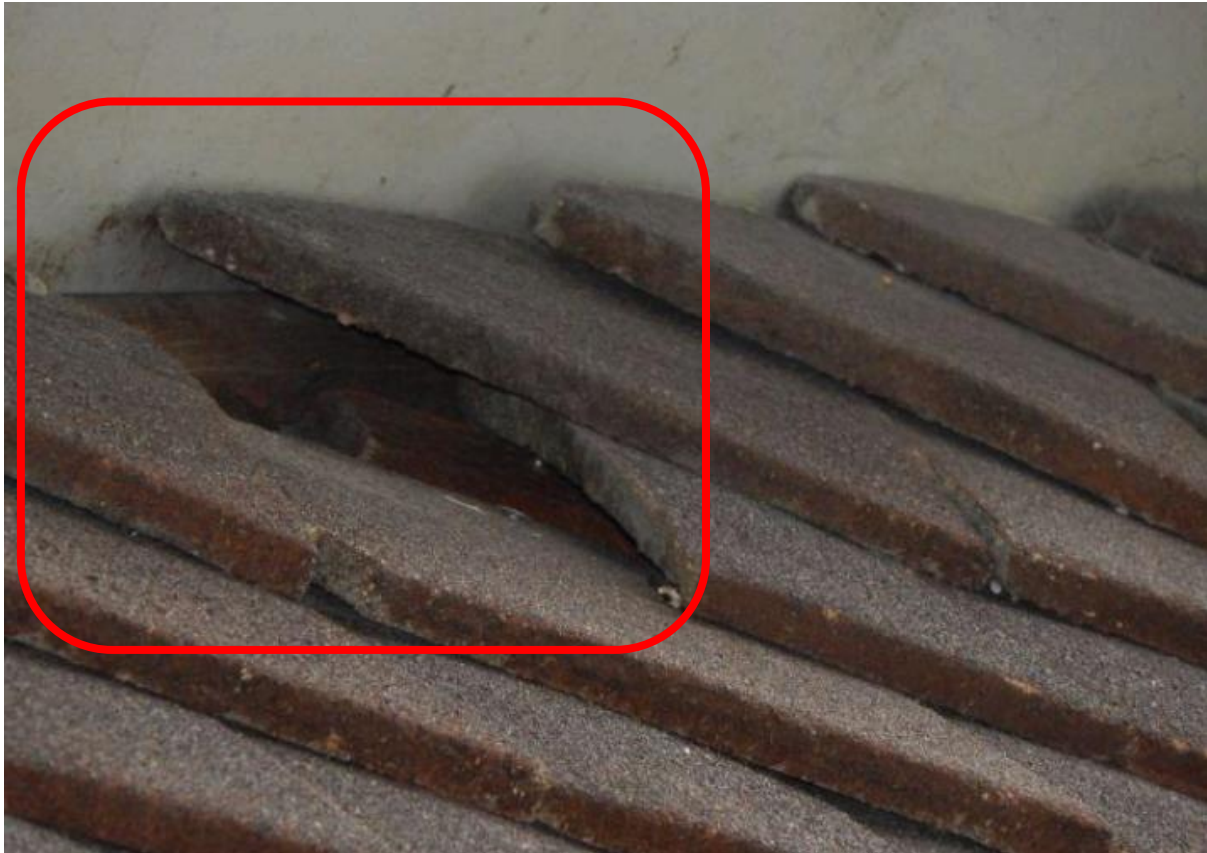
Image 5 – Further missing tiles within the rear South facing elevation which looks to offer further shelter/access opportunities for bats

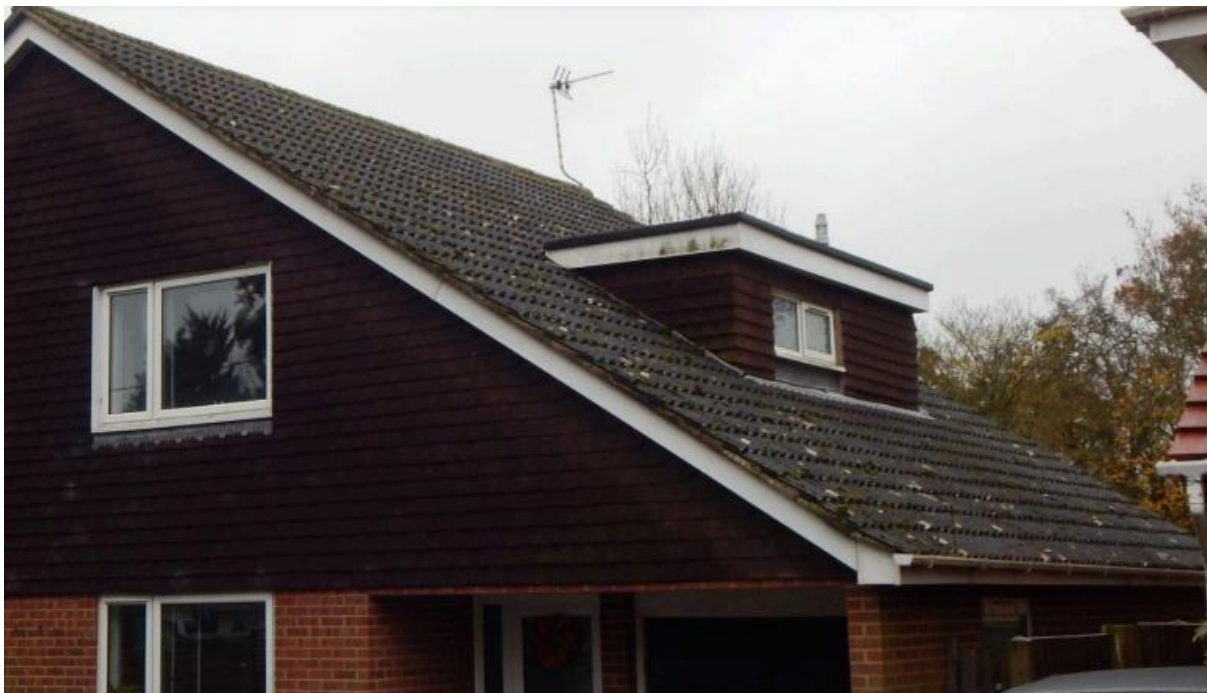
| External | Features of value to bats | Notes |
|---|---|---|
| Roof coverings | Yes | <p>The main roof coverings have demonstrated a fair level of condition.</p> <p>Minor gaps of possible value were observed between the roof coverings and dormer covering to the West facing elevation which may offer further roosting habitats for bats.</p> |

Image 6 – West facing elevation of the property

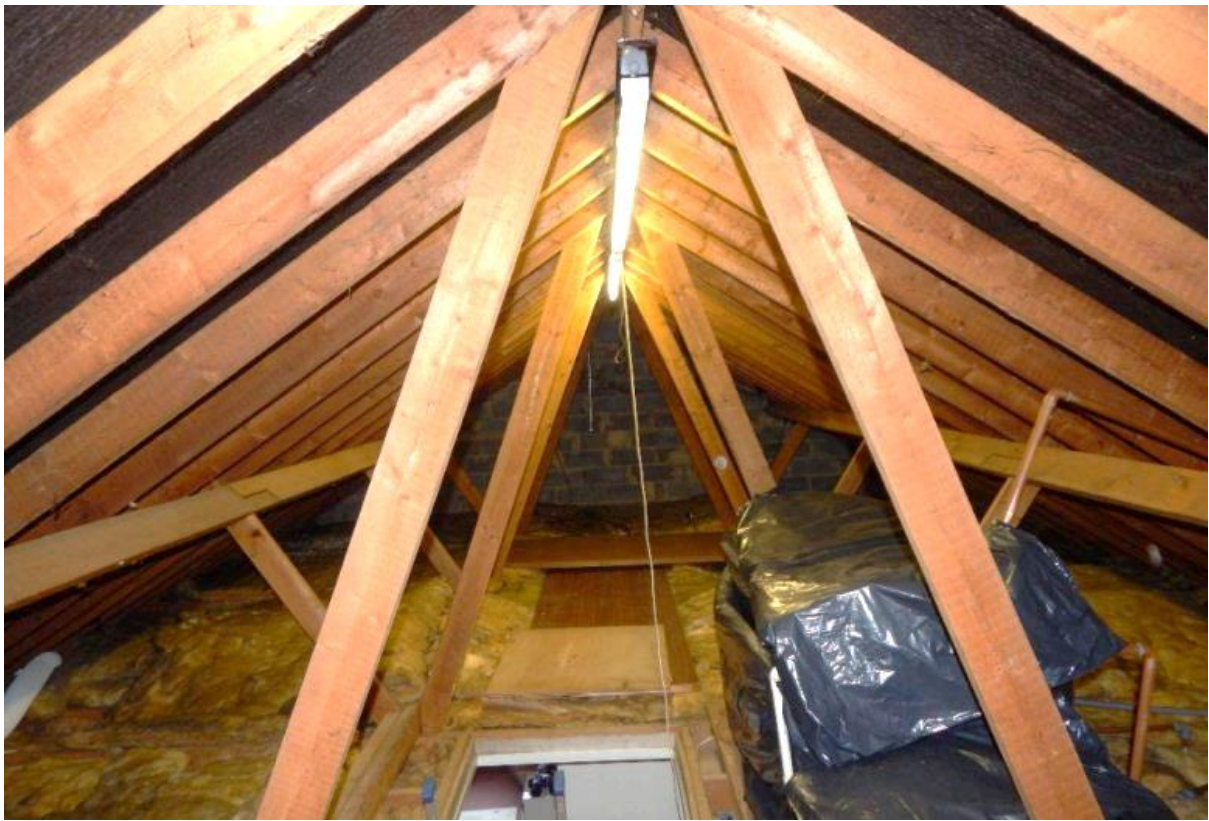
| Internal | Features of value to bats | Notes |
|---|---|---|
| Membrane coverings | Yes | Intact felt membrane coverings observed throughout.<br><br>Such covering would offer further roosting habitats for bats within the gaps between the membrane and tiles where external gaps likely provide access. |

Image 7 – Internal view from within the main roof void spaces of the property

Image 8 – Internal view from within the main roof void spaces of the property

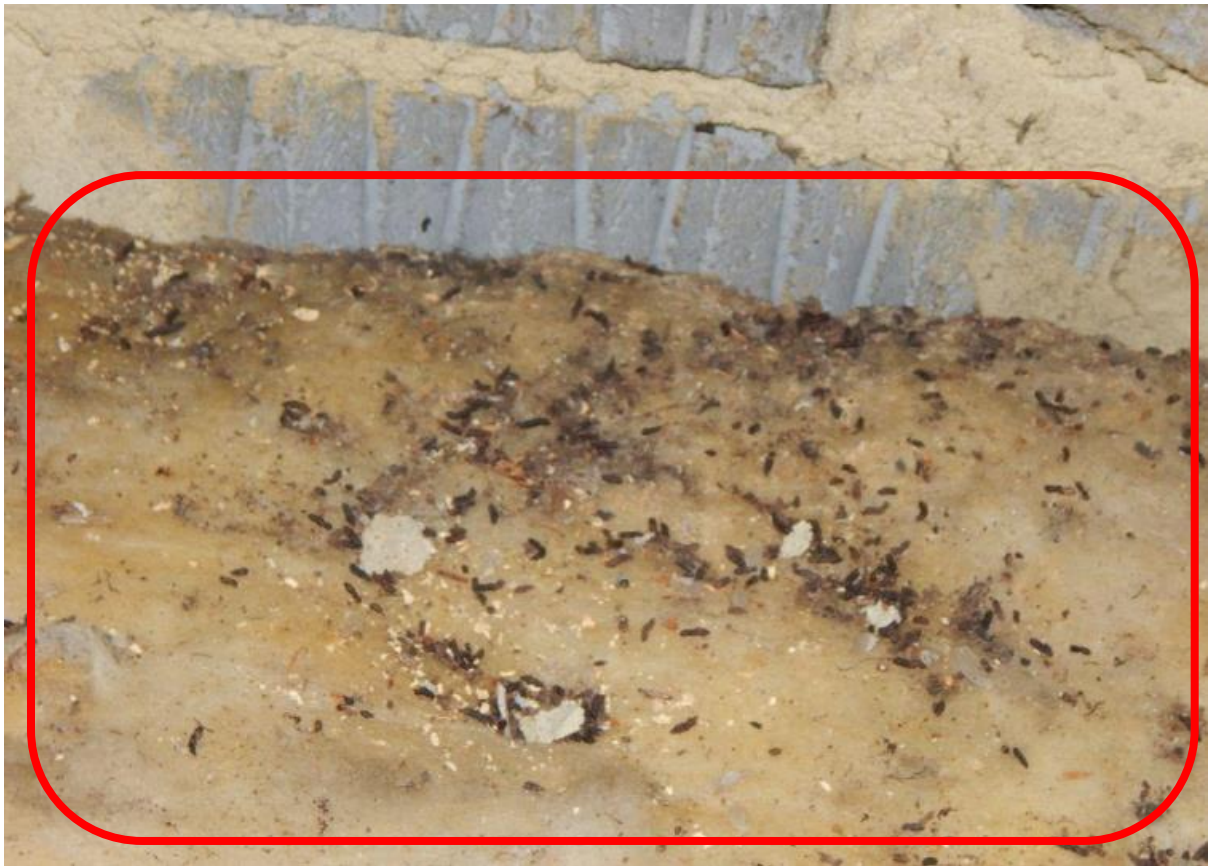
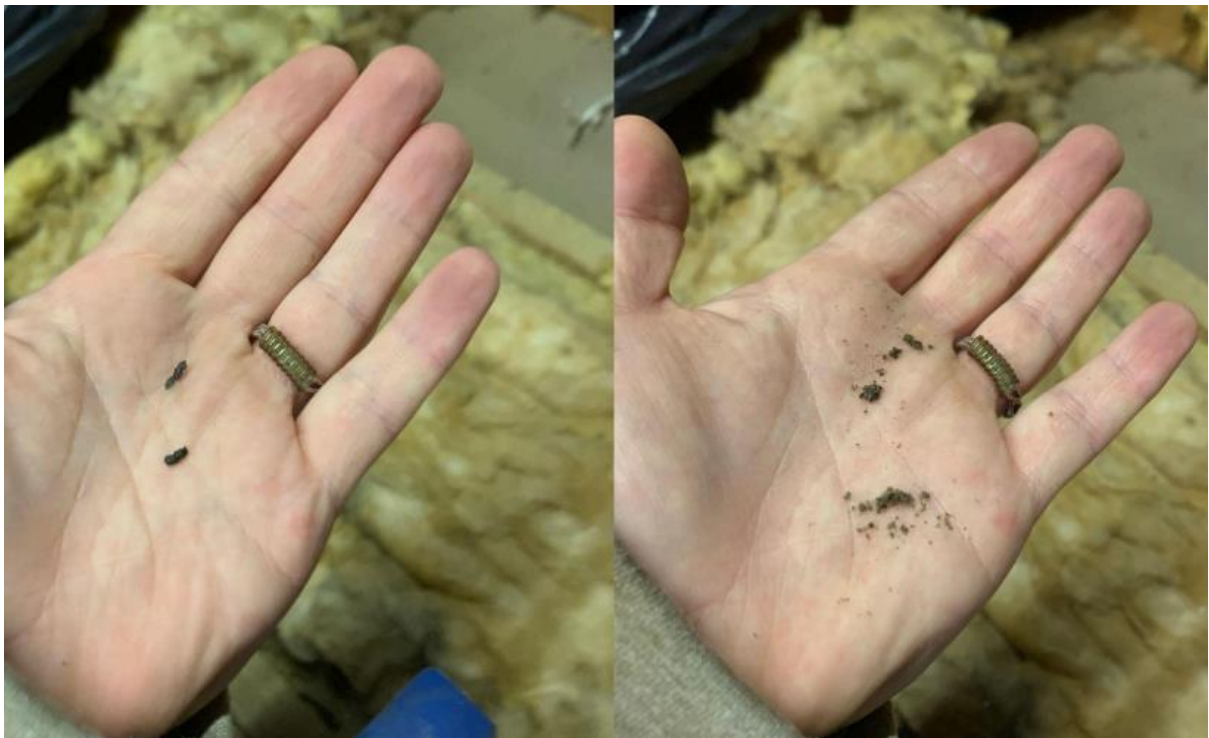
| Internal | Features of value to bats | Notes |
|---|---|---|
| Evidence from bats | Yes | Internally within the main upper roof void spaces of the property, around 200+ bat droppings were observed across the insulated floor coverings close to the front and rear gable elevations confirming roosting activity from bats within. |

Image 9 – Around 200+ bat droppings observed close to the front and rear gable walls within the upper roof void spaces of the property confirming activity from bats

Image 10 – As per image nine above

- 6.7 In line with best practice survey guidelines, a structure that has demonstrated confirmed evidence from bats must have a further three emergence surveys to confirm activity from bats along with species, volume, roost type and locations. These survey should be carried out within the recommended survey season from May to September with at least two of these visits during the optimal time of May to August.

**6.9** It is advised that no further works take place to the identified areas of value to bats at this stage as this may cause disturbance to bats and their roosts. see section 2.0 of this report

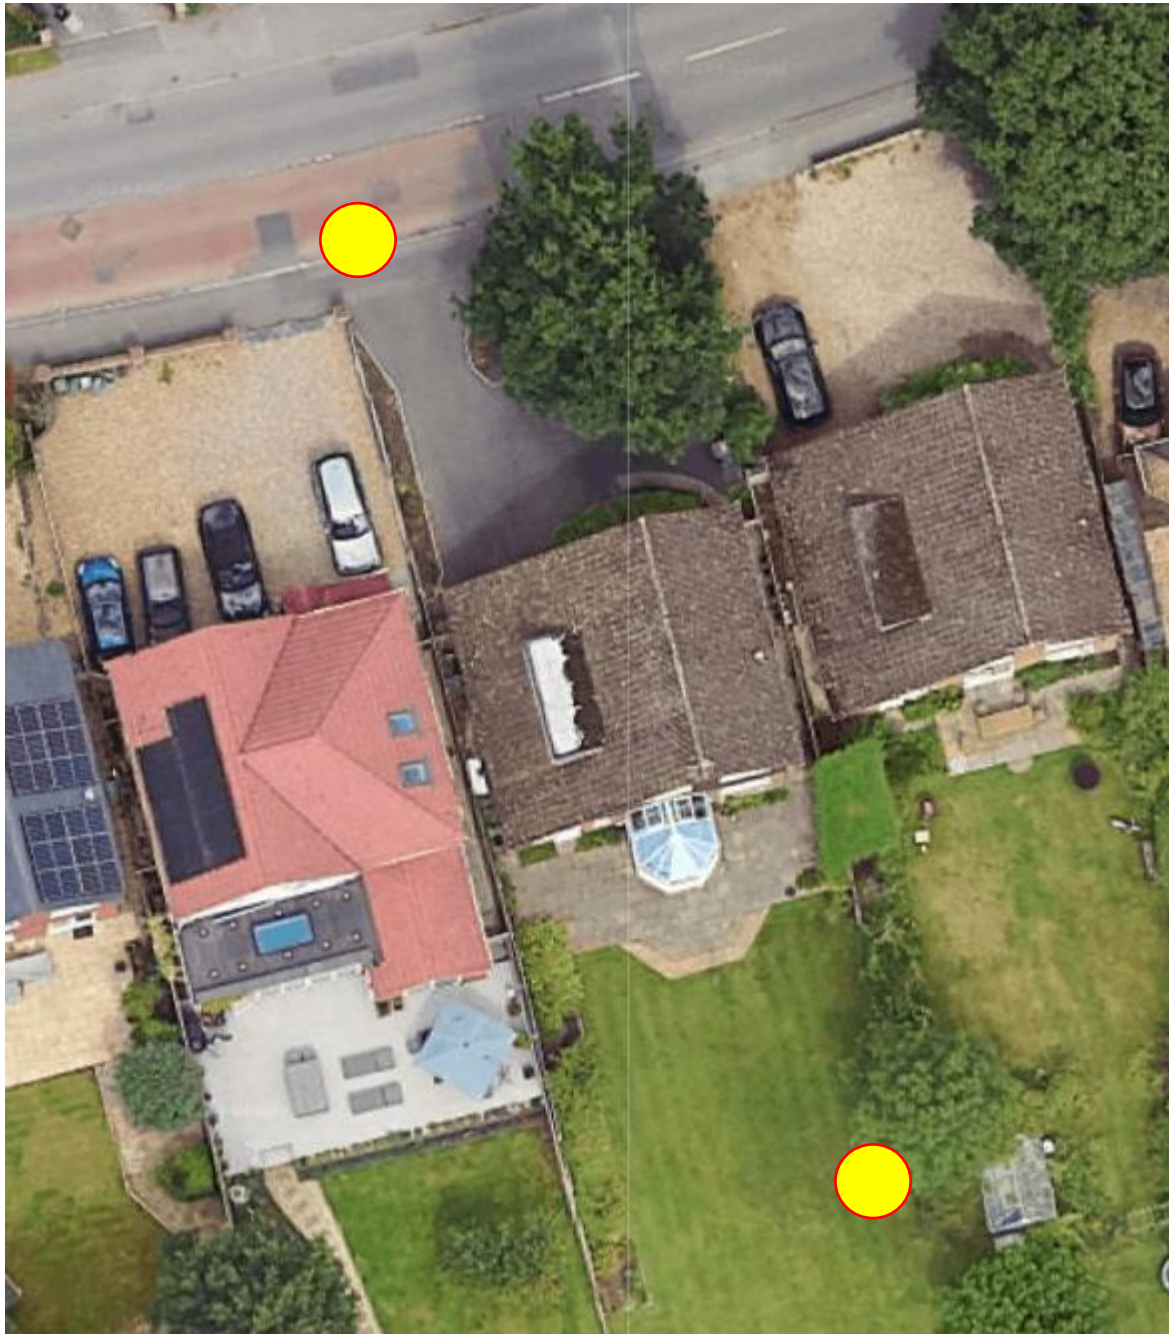
#### Appendix 4: Emergence Survey Location Points

Below site view to show suitable surveyor location points during each emergence survey to maintain visibility of the property.

In line with best practice survey guidelines, a total of two surveyors will be required to visually cover all elevations of the structure during each emergence survey.
