## **PRELIMINARY ECOLOGICAL APPRAISAL (DBW) AT 108 READING ROAD WOODLEY**

**Prepared for:  
Mr R G Ali  
108 Reading Road  
Woodley  
RG5 3AD**

**20 January 2025**

**Ref: SPH/NP/PEA-25/10.01**

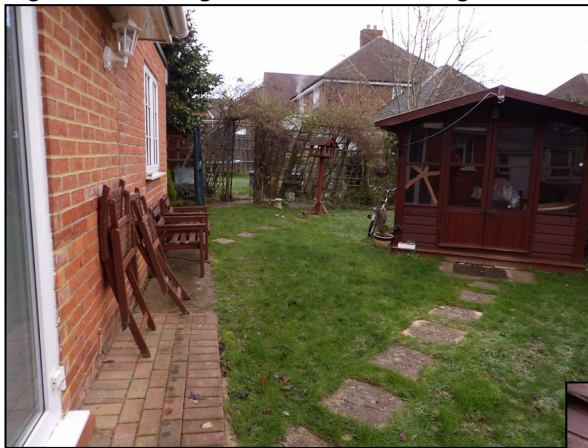
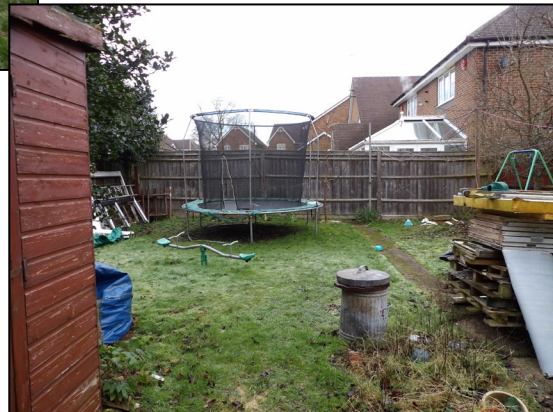
Figure 3. Rear garden. 108 Reading Road, Woodley. 10.01.25

The application site comprises a detached, brick-built bungalow with a detached building in the rear garden. The remainder of the site comprises a front garden that is mainly laid to lawn with occasional trees and shrubs and a paved parking area, see cover photograph. The rear garden, which contains a patio area, a detached brick building, timber summer house and lawn with some shrubs and trees throughout, see Figure 3 below. The site itself offers some foraging and commuting habitat for bats however there is ecological connectivity to nearby allotments and parks.

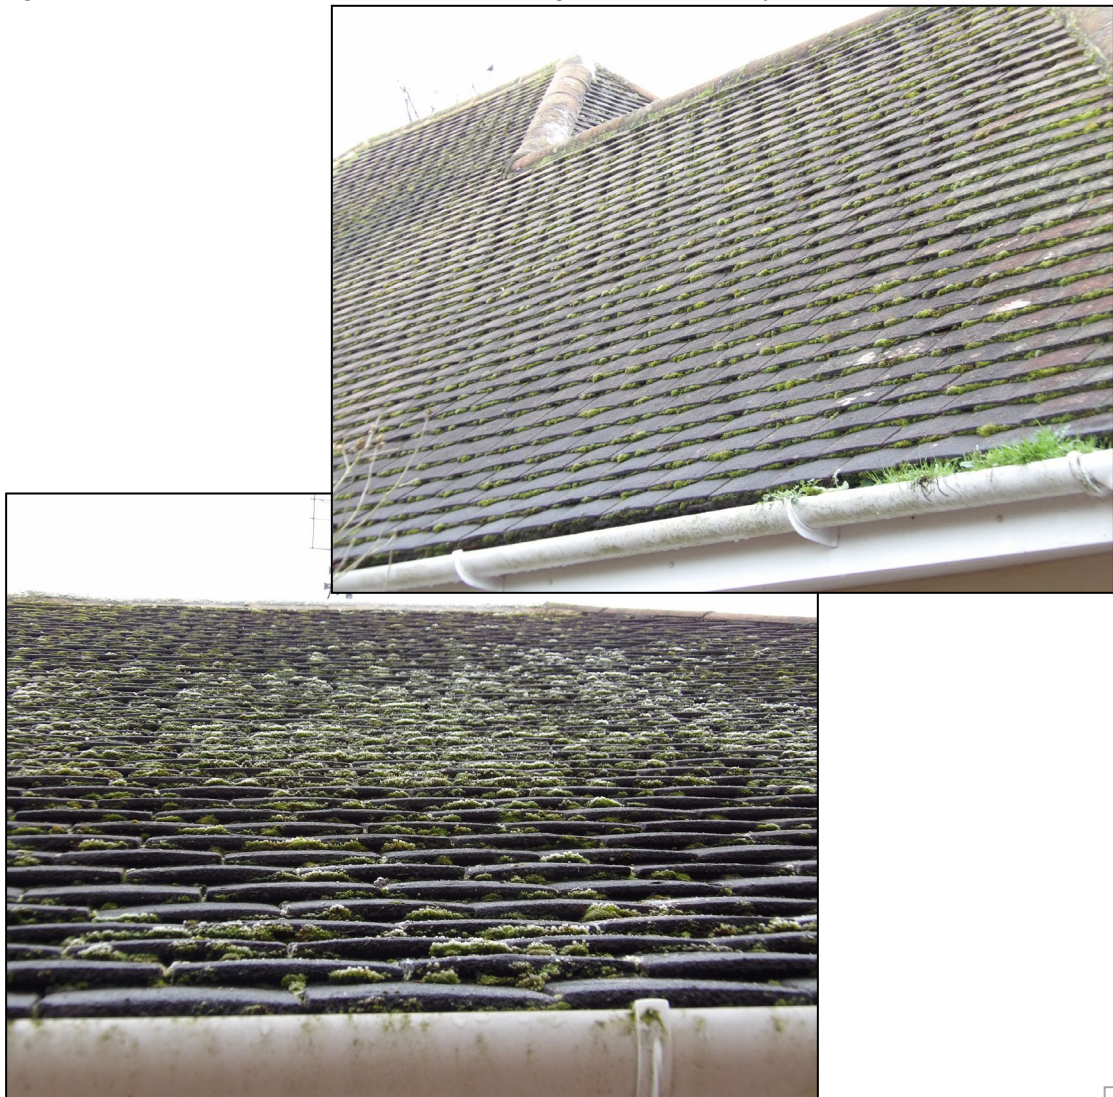
Figure 4. Example of roof tiles. 108 Reading Road, Woodley. 10.01.25

The property is a detached, brick-built and part rendered bungalow that is in a good to fair condition externally. The majority of the multi-pitched roof is covered in close fitting tiles, none of which are missing or broken (see Figure 4 below) however, there is a slipped tile from the bottom of the chimney stack on the east elevation, see Figure 5 on page 9. The ridge/hip tiles and valleys are all in a good condition (see Figure 6 on page 9), as is the lead flashing around the chimney on the west elevation and offers no gaps in which crevice dwelling bats could utilise for roosting, see Figure 7 on page 10. The uPVC soffits and fascias are all tightly fitted to the walls and had no cracks or splits which could be used by roosting bats, see Figure 8 on page 10.

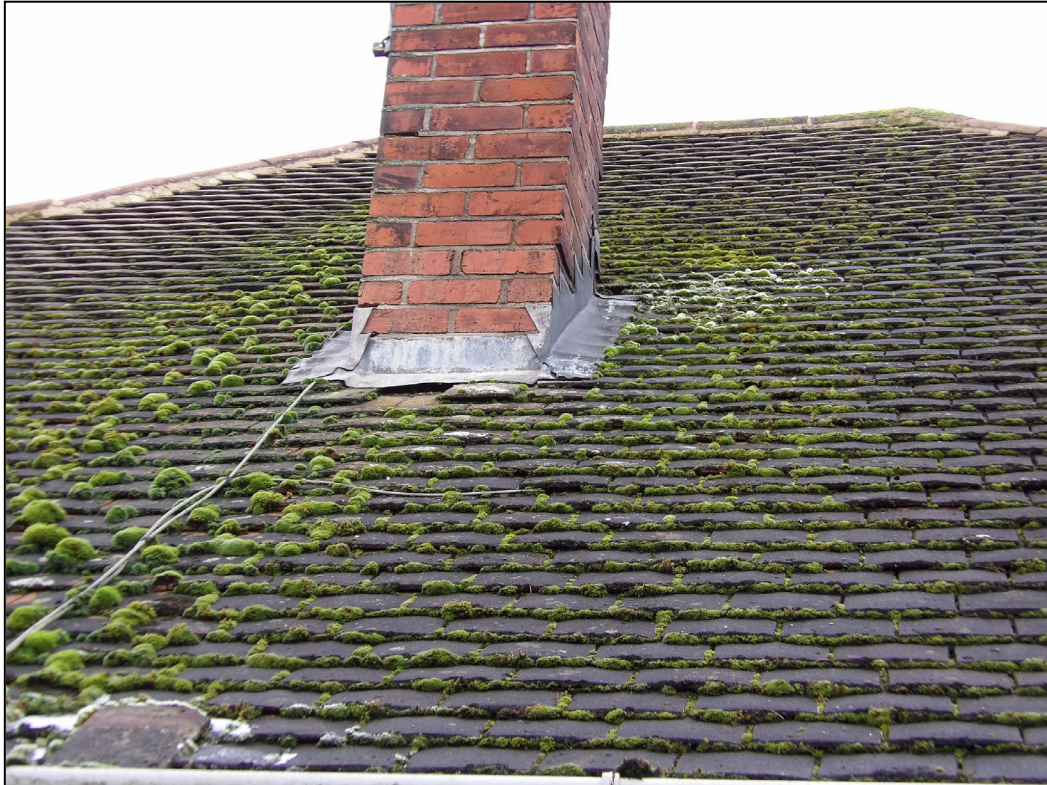
Figure 5. Example of slipped roof tile on east elevation. 108 Reading Road, Woodley. 10.01.25

No bats or evidence of bats was recorded during the external inspection of the property however the slipped tile on the east elevation offers potential roosting opportunities for bats or access into the building for roosting bats.

No bats or evidence of bats was recorded during the survey however a thorough inspection of the loft space was not possible due to a lack of boarding and thick insulation and the presence or absence of bats could not be determined. The missing tile from beneath the chimney stack on the east elevation could provide a crevice like feature suitable for bats to roost and may provide access into the loft of the building for bats.

Based on the Bat Workers Manual and the Bat Surveys Good Practice Guidelines, one dusk emergence survey must be undertaken on the property, between May and August, in order to establish the presence or absence of roosting bats at the property. The feature identified will require 1 survey position equipped with a bat detector and night vision camera in order to cover the potential bat roosting feature.

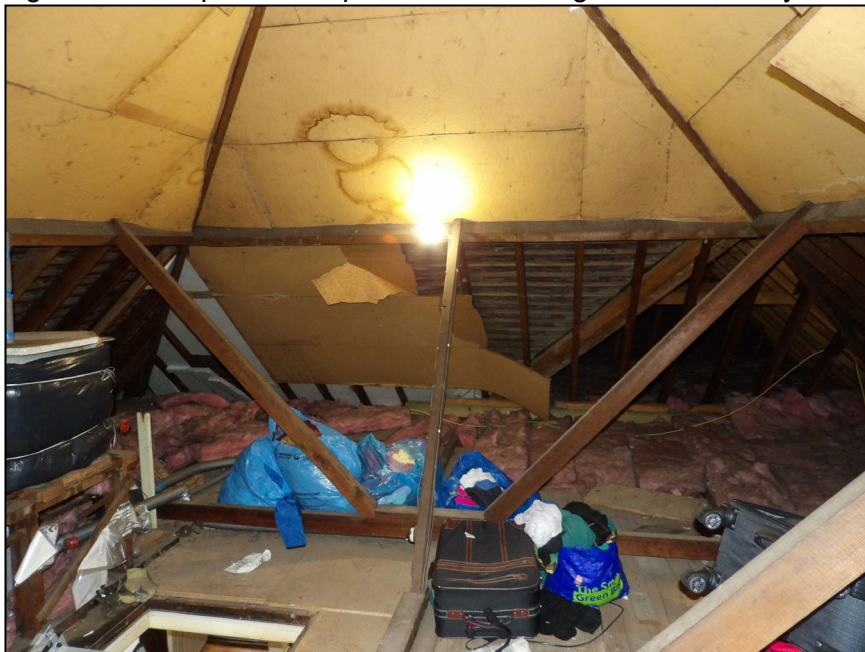
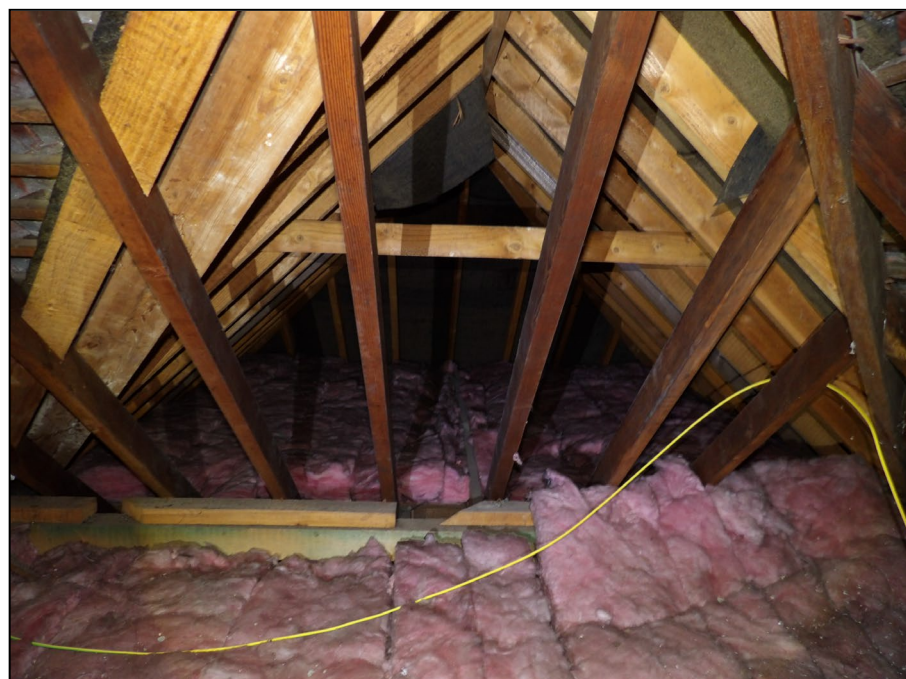
Figure 9. Example of loft space. 108 Reading Road, Woodley. 10.01.25

The loft was accessed through a hatch via a loft ladder and is in a fair condition. The loft is partially lit, partially boarded and deeply insulated, see Figure 9 below. Some of the roof tiles are unlined and some have been boarded, see Figure 9 below and Figure 10 on page 12.

No bats or evidence of bats was recorded during the internal inspection of the loft however roosting internally could not be excluded due to the loft being part lined with hardboard.
