**Sand Martins Golf Club  
Finchampstead Road, Wokingham  
Berkshire**

*Archaeological Evaluation*

CA Project: AN0524  
CA Report: AN0524\_1

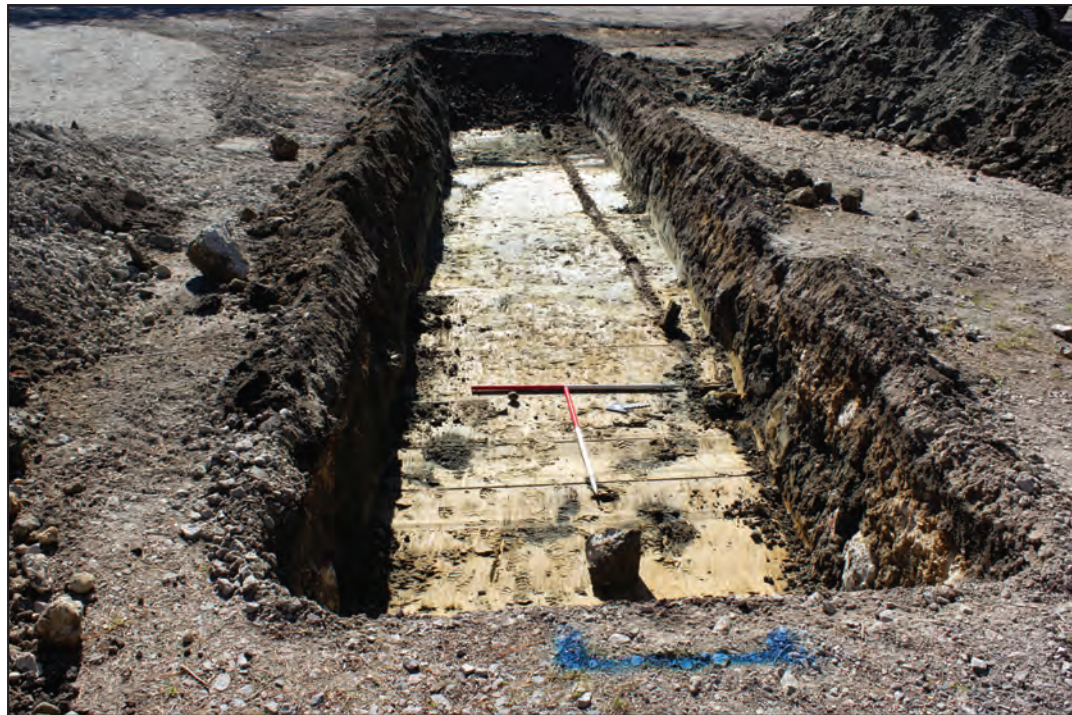
Trench 1, looking south-east (1m scales)

- 5.5. **Trench 1** (Figure 3 and 4) contained five layers of modern made ground to a depth of 0.77m. A modern land drain, on a north-west/south-east alignment, was recorded along the full length of the trench. No archaeological features were observed.

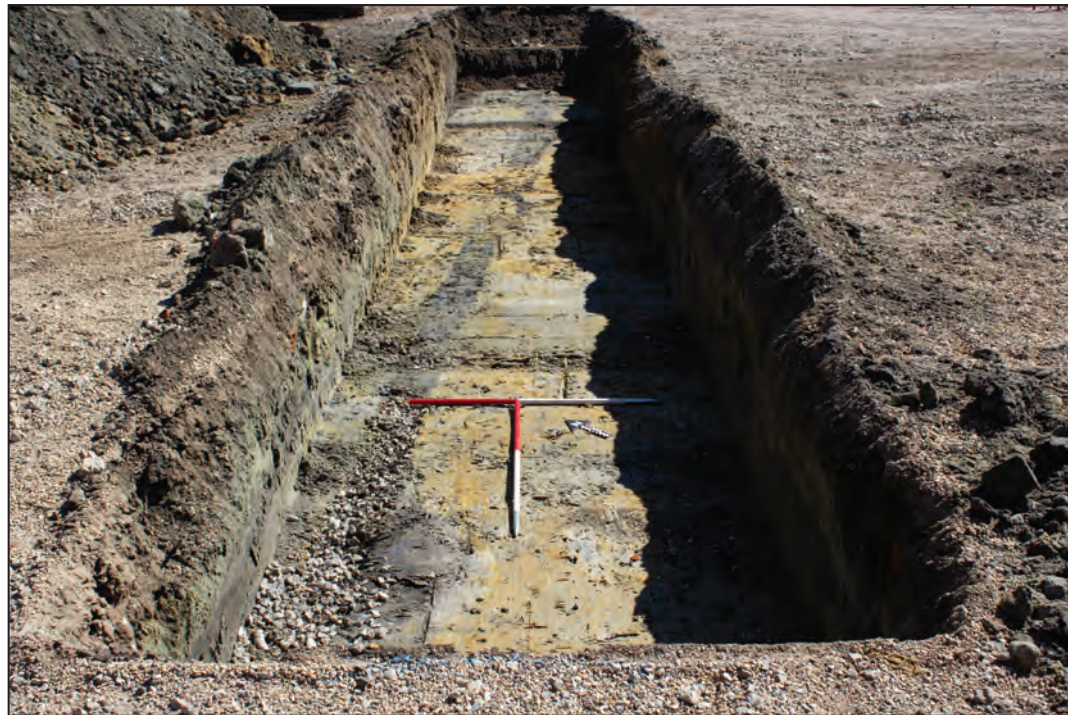
Trench 2, looking north-east (1m scales)

- 5.6. **Trench 2** (Figures 3 and 4) contained three layers of modern made ground to a depth of 0.80m. A modern land drain, on a north-east/south-west alignment, was recorded along the full length of the trench. No archaeological features were observed.

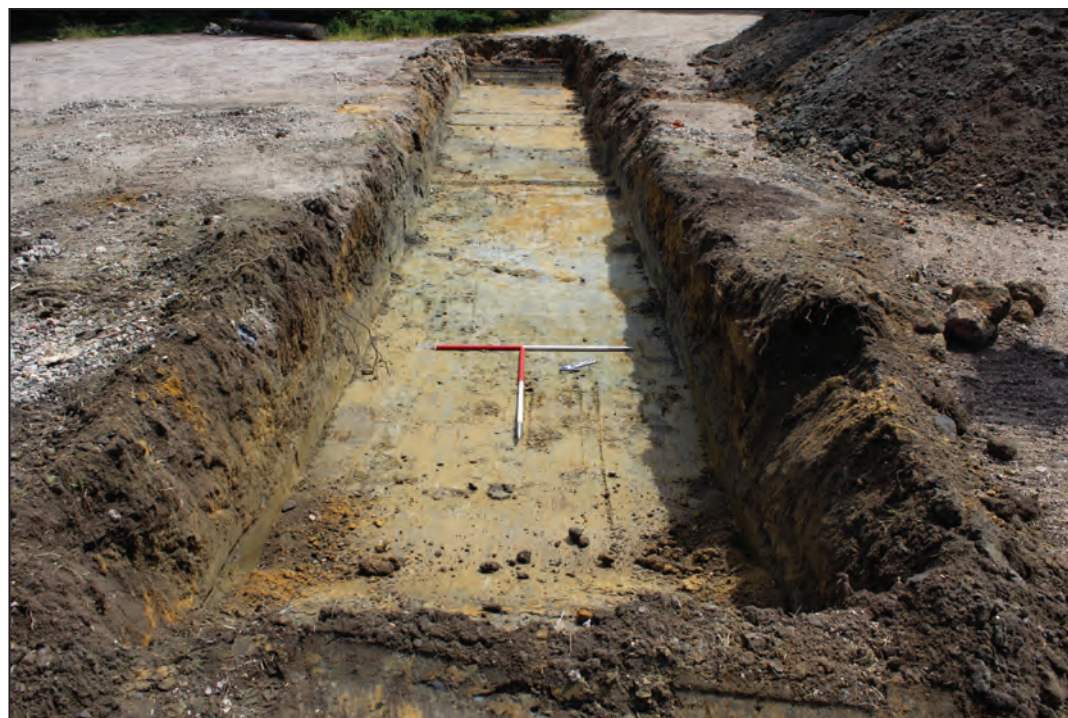
Trench 3, looking south-east (1m scales)

- 5.7. **Trench 3** (Figures 3 and 4) contained three layers of modern made ground to a depth of 0.84m. A modern land drain, on a north-east/south-west alignment, was recorded perpendicular to the trench. A modern pit was found in the south-west end of the trench with tarmac and plastic inclusions. No archaeological features were observed.

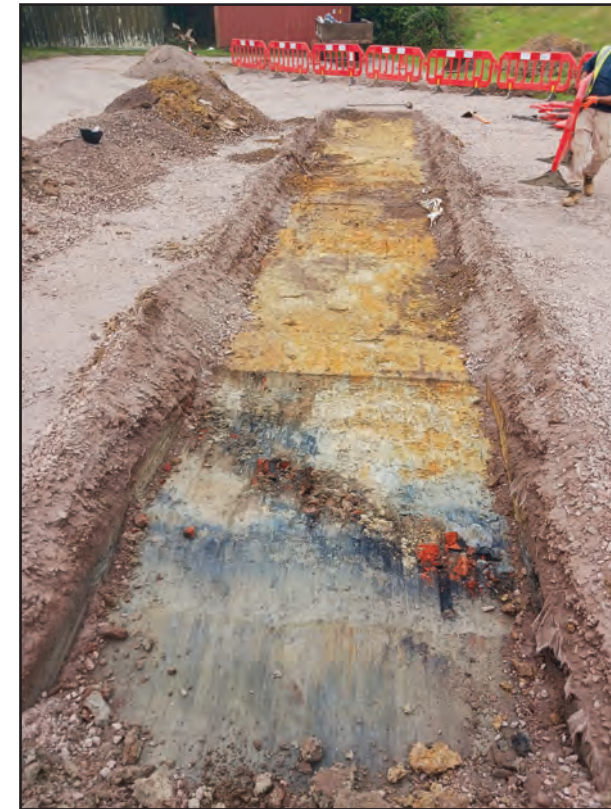
Trench 4, looking south-east

- 5.8. **Trench 4** (Figure 5) contained one post-medieval ditch, **403**. The ditch was aligned north-west/south-east and measured 0.30m wide and 0.25m deep. It had a single intentional backfill deposit of demolition rubble, **402**, possibly used as a basic percolation drainage. Fill **402** contained three sherds of post-medieval pottery and consisted of 50% CBM fragments. A sondage was machine excavated at the south end of the trench to ascertain the depth of imported sand. The excavation reached 1.2m with no substrate change. Hollows and track marks caused by excavators and dumper trucks were visible in the surface of the redeposited natural, and evidence of associated levelling was observed.

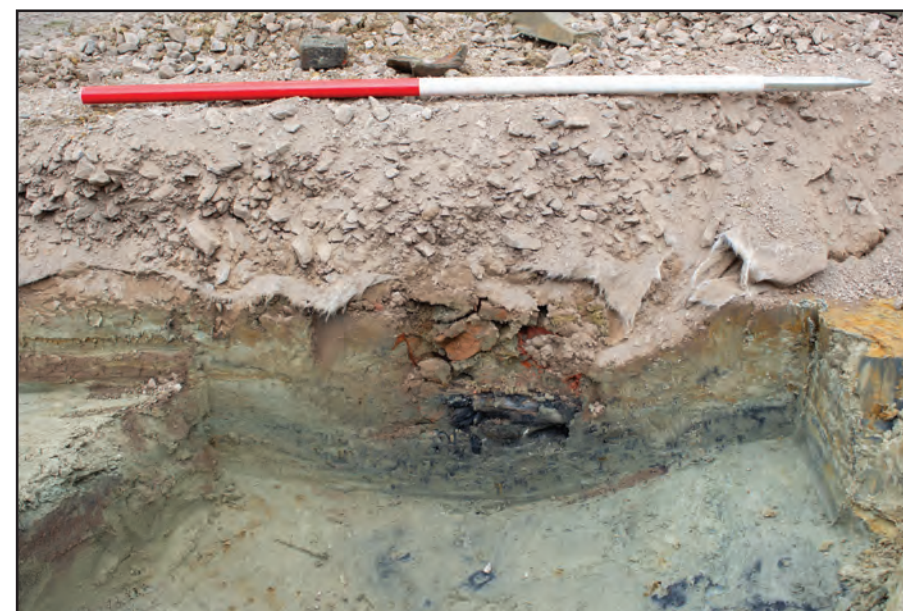
Modern ditch 403, looking north-east (1m scale)

- 7.4. **Trench 4** contained one post-medieval linear, packed with demolition rubble, identified as early percolation drainage. Large areas of imported sands were found in the southern end of **Trench 4**, which was most likely imported during the development of the 1991 golf course to improve drainage. A sondage was machine excavated at the south end of the trench to ascertain the depth of imported sand; excavation reached 1.2m with no substrate change.

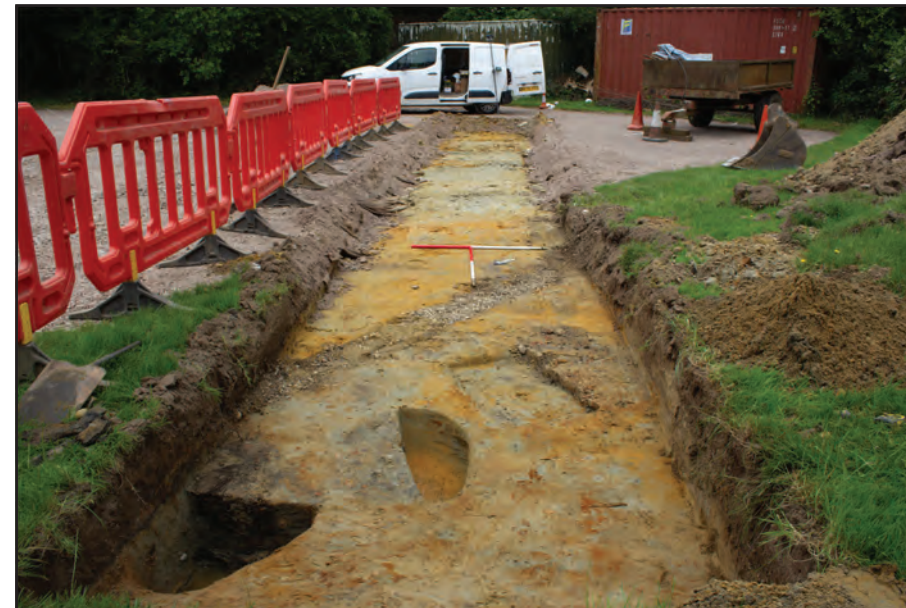
Trench 5, looking south-east (1m scales)

- 5.9. **Trench 5** (Figure 6) contained two post medieval features at its north-east end. Three meters of trench was located outside of the carpark development, within which a post hole **507** and a pit **509** were observed. The features were capped by a levelling deposit, **503**, only observed in the trench outside the car park truncation. Posthole **507** contained three fills, a post pad **506**, a post pipe **505**, and packing fill **504**. An iron nail and 447g of CBM were recovered from **504**. An oval waste pit, **509**, recorded 0.2m to the south of **507**, had a single fill **508** and contained post-medieval pottery and CBM.

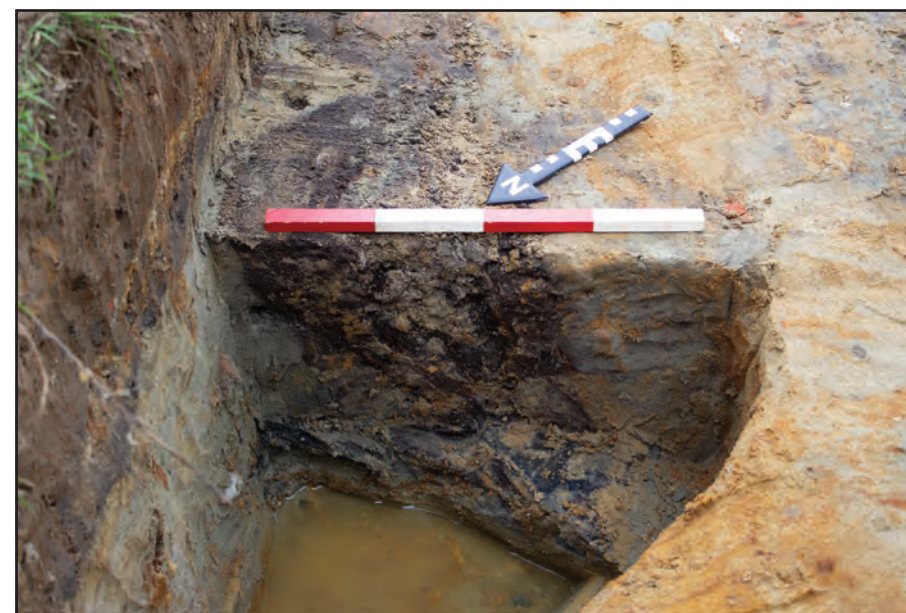
Posthole 507, looking south-east (0.4m scale)

- 7.5. **Trench 5** contained a post-medieval post hole and waste pit interpreted as evidence associated with the farm buildings of Evendon's farm, indicated on the 1898 OS map.

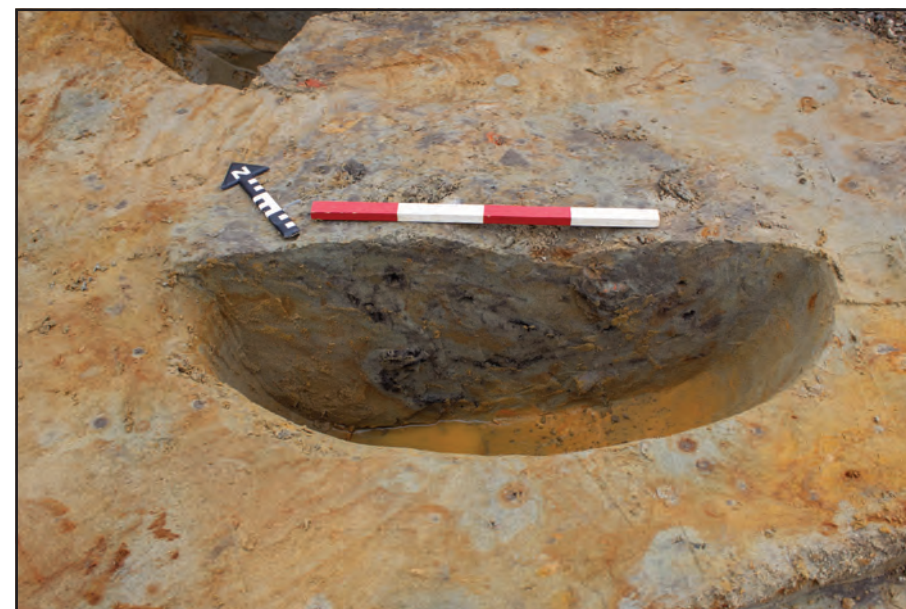
Pit 509, looking north-east (0.4m scale)
