349 Hyde End Road  
Spencer's Wood  
Reading  
Berkshire  
RG7 1DD

## Preliminary Roost Assessment

Report ref.: S2780\_PRA\_a

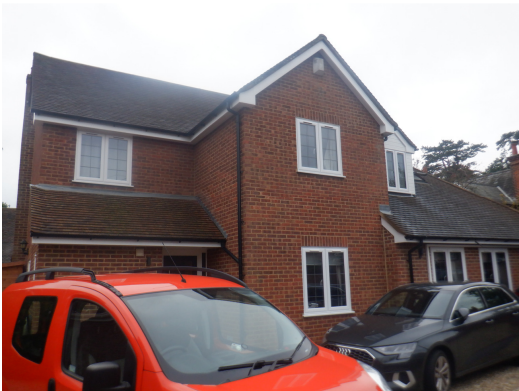
- 5.2.2** The detached brick house had a pitched two-storey roof and front gable, with a single-storey hipped section on the western elevation with a front and rear dormer window, and a sloped roof porch to the front (**Photographs 1 & 2**).

*Photograph 1. Front of property viewed from north.*

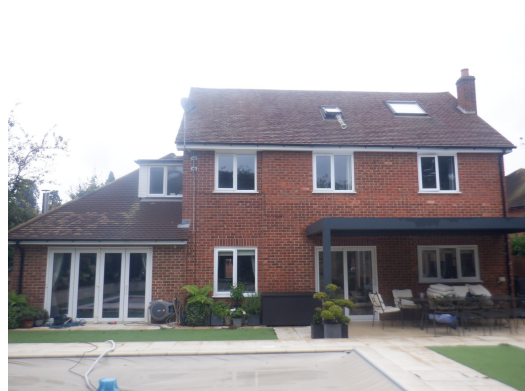
*Photograph 2. Rear of property viewed from south.*

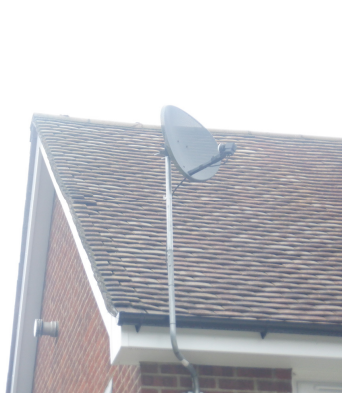
- 5.2.3** The roof was covered with clay tiles that were partially raised along the western verge of the pitched roof and behind the front dormer window (**Photographs 3 & 4; Target notes 1 & 2**). The ridge mortar and verge mortar was mostly intact across the roof; other than a superficial gap in the mortar at the apex of the eastern gable (**Photograph 5**). The mortar was frequently crumbling or missing along the northwest hip of the single-storey section (**Photograph 6; Target note 3**).

*Photograph 3. Raised verge roof tiles along the western verge (rear elevation).*

- Lifted roof tiles along the western verge of the house on the front and rear elevation (**Photographs 3 & 4; Target notes 1 & 2**);
- Crumbling and missing sections of hip mortar on the western section of the roof (**Photograph 6; Target note 3**); and
- Overlapping sections of bitumen felt within the void (**Photograph 13; Target note 5**).

**6.1.2** Whilst the raised roof tiles along the western verge of the house may lead directly inside the roof void, which had sufficient space for internal flight and suitable conditions for supporting void-dwelling bats such as the locally recorded brown long-eared bat (*Plecotus auritus*), no bat droppings were observed and so the presence of void-dwelling bats is considered highly unlikely. The eastern end of the pitched roof was converted into habitable space and the single-storey section had a vaulted ceiling and lacked a suitable void.

- 7.1.2** The development proposals will directly impact all features identified on the single-storey section of the roof and may impact the raised roof tiles along the western verge of the second-storey roof (**Photographs 3, 4, 6, 7, 13; Target notes 1 – 5**; see proposed elevations in **Appendix 4**). The construction activities could therefore lead to direct/indirect disturbance, injury and/or death of bats if bats were found to be using these features.

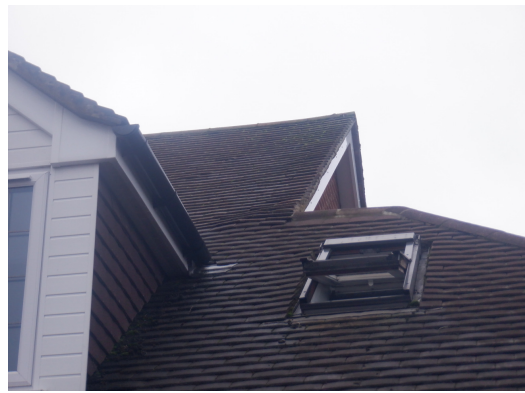
*Photograph 4. Raised verge roof tiles (front elevation).*

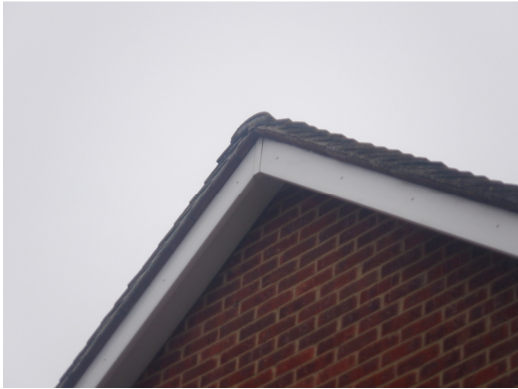
*Photograph 5. Superficial crevice within crumbling verge mortar (eastern elevation).*

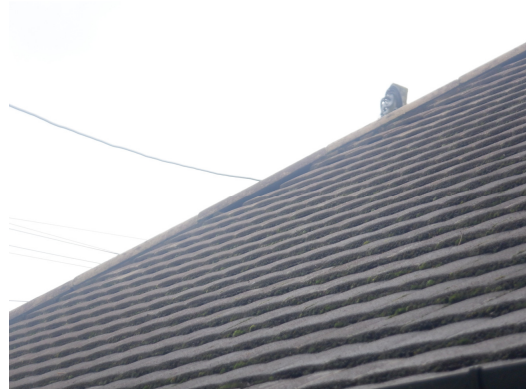
*Photograph 6. Crumbling and missing hip mortar (western elevation).*

**6.1.3** The raised verge roof tiles and crumbling and missing hip mortar on the western elevation offer potential crevice roost sites for small numbers of crevice-dwelling bats such as the locally recorded common pipistrelle (*Pipistrellus pipistrellus*) and soprano pipistrelle (*Pipistrellus pygmaeus*). Evidence of crevice roosting species is typically hidden from view in areas such as gaps between tiles and internal roof linings/insulation.

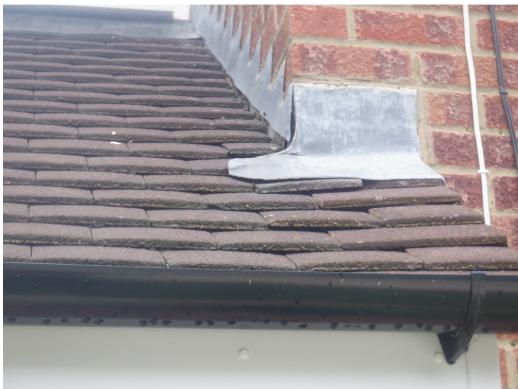
- 5.2.4** The lead flashing was flat to the tiles and brickwork at the base of the chimney, both dormer windows and along the front porch. The lead flashing was slightly lifted at the south-western corner of the house elevation but the gap was superficial (**Photograph 7; Target note 4**). The dormer windows were clad with flat hanging tiles, offering no roosting opportunities for bats (**Photograph 8**).

*Photograph 7. Partially lifted lead flashing (rear elevation).*

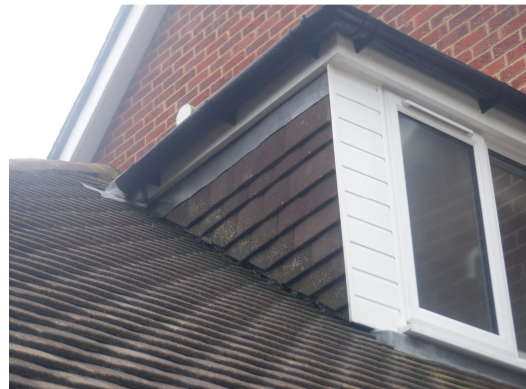
*Photograph 8. Tight hanging tiles on dormer window (rear elevation).*

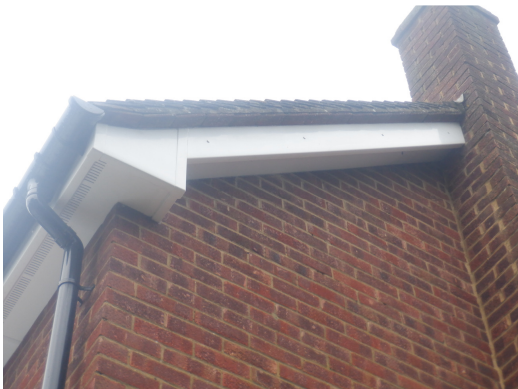
- 5.2.5** The uPVC soffit was fully sealed along the brickwork gables and was tight to the brickwork along all elevations of the house (**Photographs 9 & 10**).

*Photograph 9. uPVC soffit sealed to the brickwork gable (eastern elevation)*

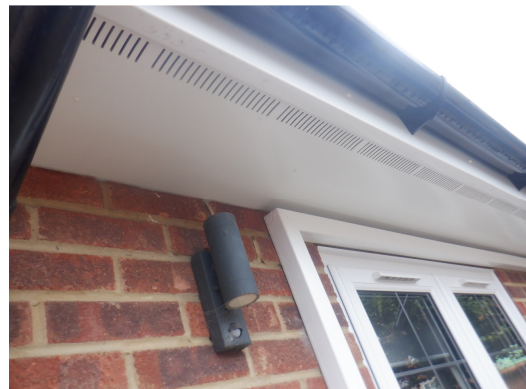
*Photograph 10. uPVC soffit sealed to the brickwork (front elevation).*

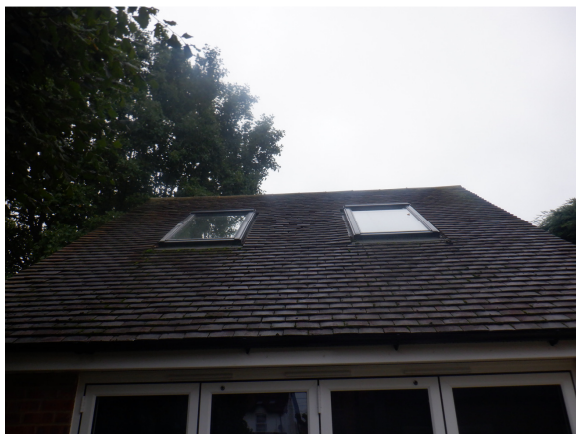
- 5.2.6** The detached garage has been converted into an annexe with a vaulted ceiling and two skylights installed on the roof. The roof tiles were occasionally lifted on the front elevation, while the ridge and verge mortar was fully intact (**Photograph 11**).

*Photograph 11. Raised roof tiles (front elevation of annexe)*

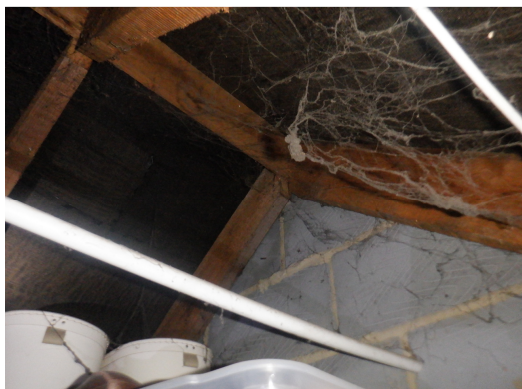
- 5.2.7** There was one roof void within the property. There was a small void at the western end of the pitched roof which was accessible via a door from the converted loft room at the eastern end of the house. The void was of cut and pitch construction with an approximate floor-to-ridge height of 2.5 metres, and the ridge was cobwebbed throughout (**Photograph 12**). The roof was lined with bitumen & hessian felt that was fully intact with slight gaps between overlapping sections of felt (**Photograph 13; Target note 5**).

*Photograph 12. Pitched void cobwebbed throughout.*

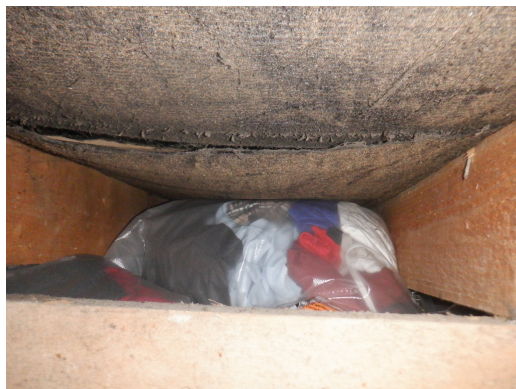
*Photograph 13. Overlapping sections of bitumen felt.*

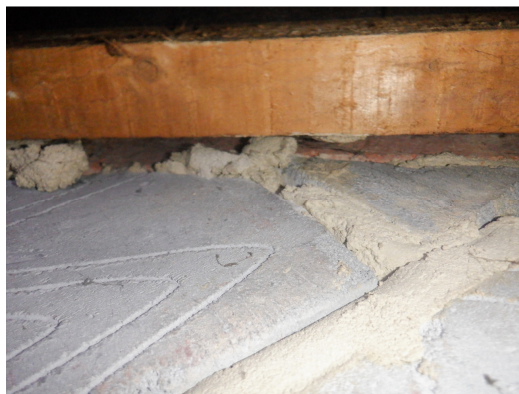
- 5.2.8** The floor was fully boarded over fibreglass insulation which filled the eaves, preventing access to the uPVC soffit (**Photograph 14**). There were slight gaps between the blockwork gable and end rafters which were cobwebbed and filled with mortar (**Photograph 15**).

*Photograph 15. Gaps along gable filled with mortar.*
