Our reference: 16 Copse Drive Bat PRA Report Rev 00

**16 Copse Drive, Wokingham - Bat Preliminary Roost Assessment (PRA)**

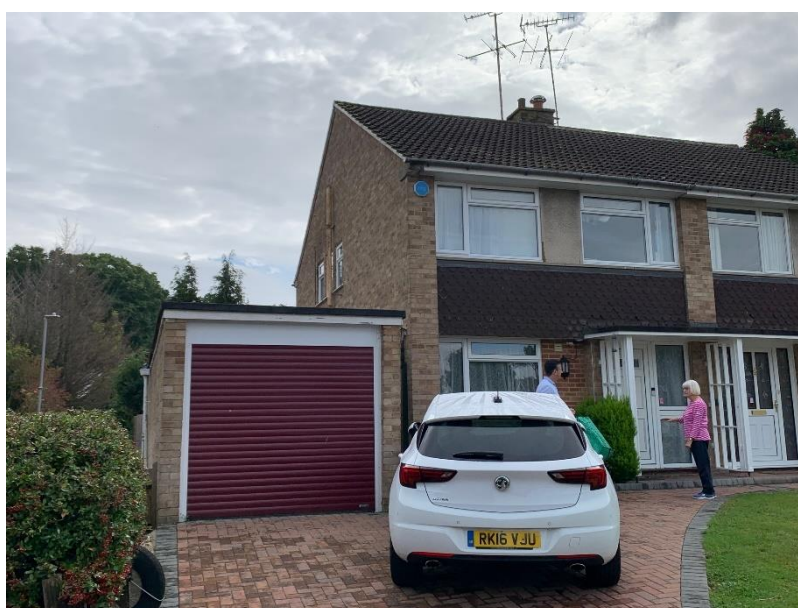
Plate 1 - The building shown from the front

The current house is a two storey, semi-detached, family home with garage, built of typical brick and concrete tile construction. The building appears to have been constructed in approximately 1960s. There appears to have been a single storey rear / side extension previously plus maintenance and upgrades such as replacement UPVC windows. Plates 1 & 2 shows the building from the front and rear.

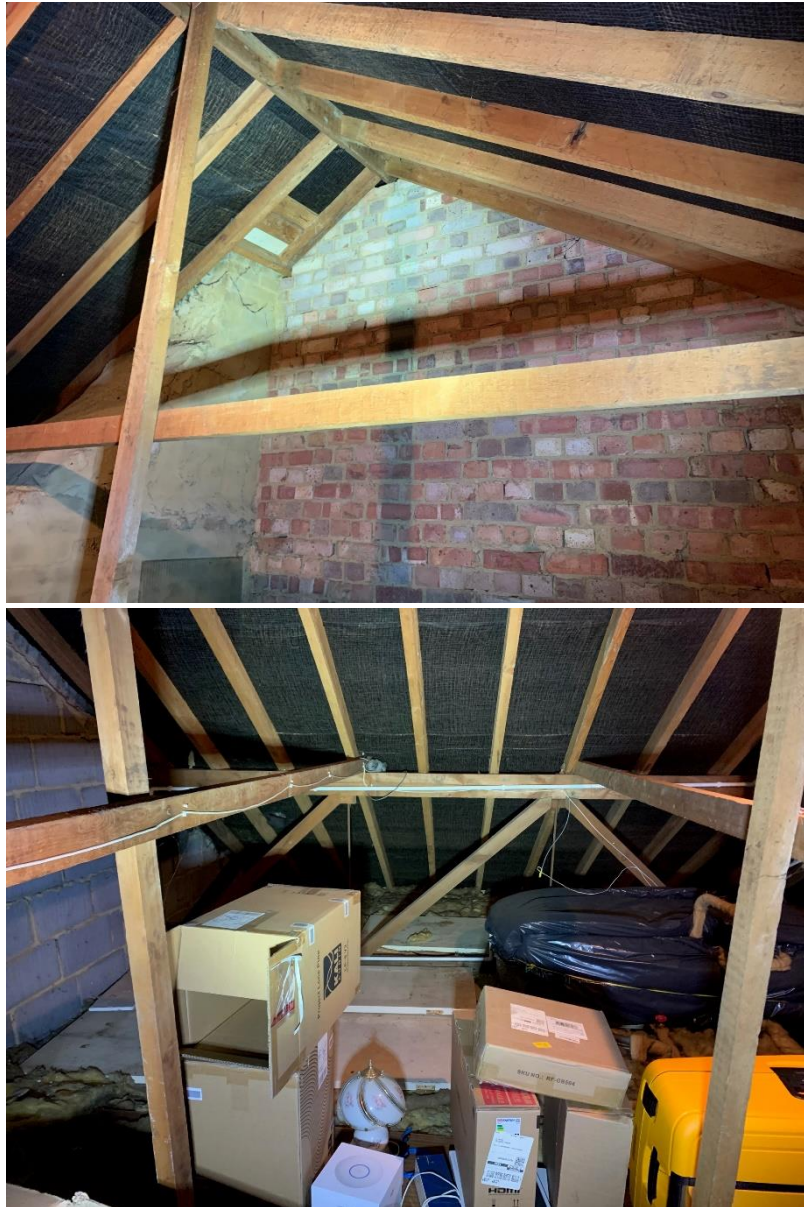
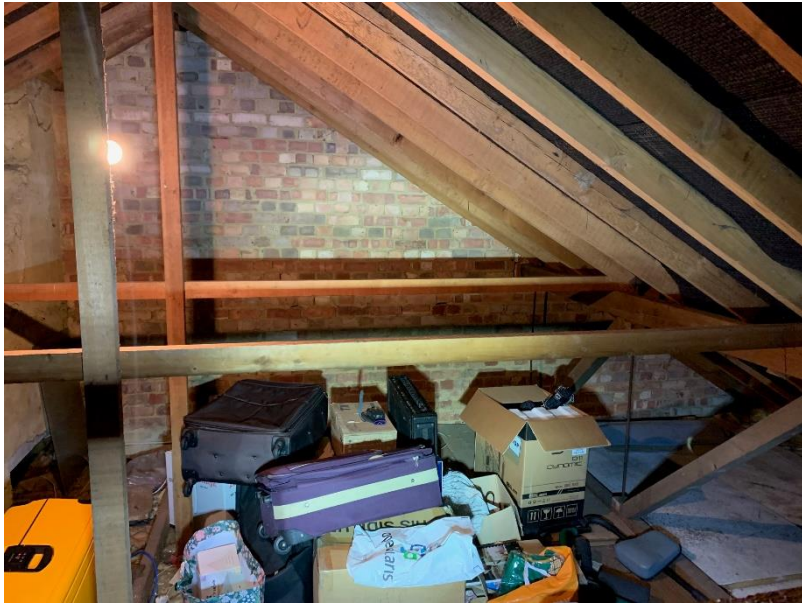
Plates 3-5 - Internal roof images

Based on the development proposals the assessment focused on the house as there are no predicted impacts to trees or other habitats. The house was inspected internally, with access to the entire roof space being possible. The roof is a traditional, cut-timber construction with bitumen felt sarking under interlocking concrete tiles. The timbers and sarking were in good condition with no

tears, holes etc observed. The loft space has had no noticeable prior alteration, with only some additional insulation added.

No evidence of bat presence (e.g. bats present, bat droppings, urine staining or scratch marks) was found during the internal inspection. Plates 3-5 provide photographs of the internal roof space.

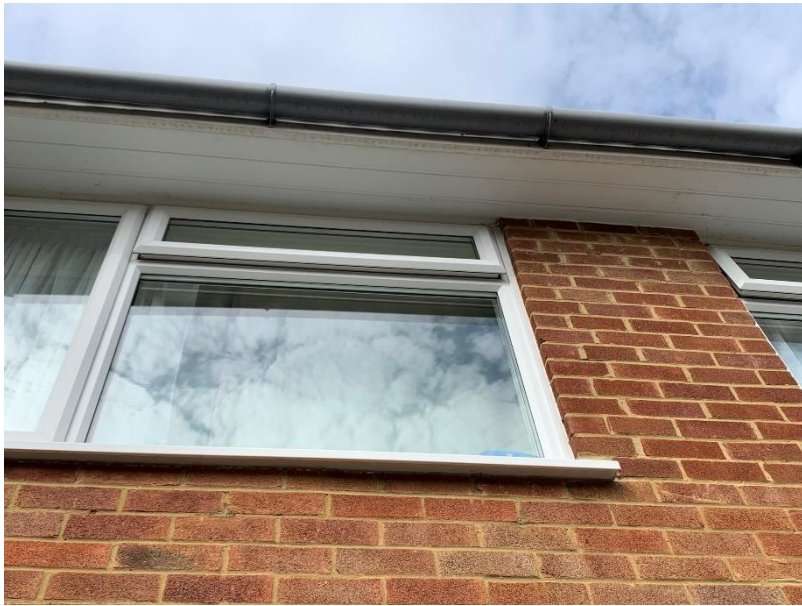
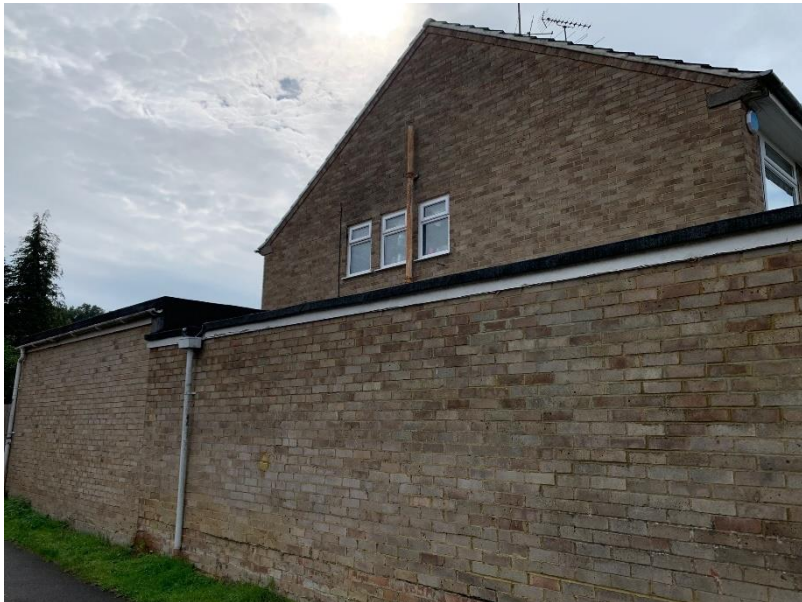
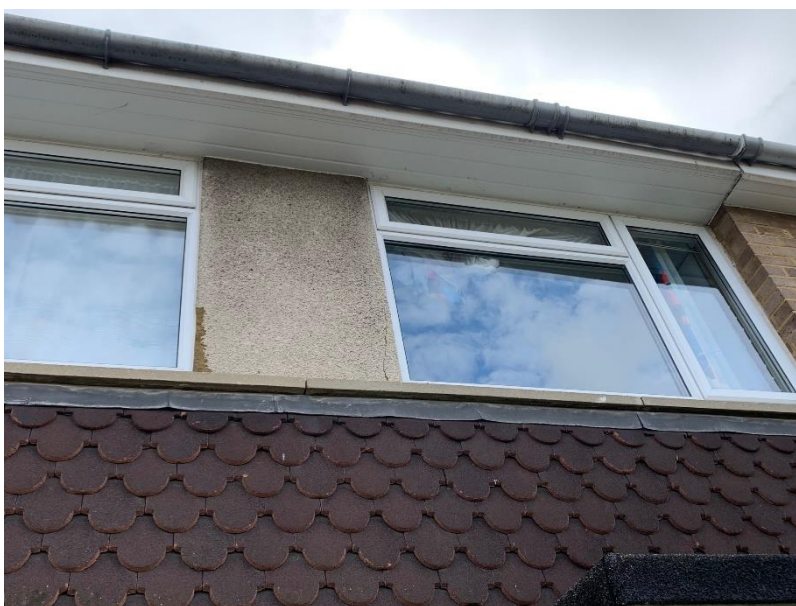
Plates 6-8 - external inspection images

External inspection of the house showed a well maintained and sealed main roof structure. The plates below show how soffit boxes, ridge tiles, general roof tiles and service points were all very tightly sealed with none of the gaps that can be present which provide access for bats. The soffit boxes have clearly been well maintained and have a tight seal around the eaves of the main roof. The roof has no slipped or missing tiles or damaged or lifted flashing (which are typical access points for bats).

In addition to the main roof there is a flat roof over the garage and previous rear / side extension. This was inspected with particular attention paid to the weatherboarding as this can provide a crevice feature for individual and small numbers of bats. The inspection found no warping or other distortion of the weatherboarding and a tight seal to the brick work was consistent throughout. Therefore no entrance or crevice feature for bats was present.

Hanging tiles on the front of the house at ground floor height were checked for evidence of use by bats. No droppings or other obvious signs of bat use were found. However, there were potential access points over the porch to a small void behind the tiles. Due to this area not being affected by the proposed plans this was not investigated further. Recommendations are made regarding this towards the end of this letter report. Plates 6-8 show external views.

However, the gaps in hanging tiles above the porch on the front of the house do provide potential roost space for bats. Based on the location of the house with nearby woodland and records of local bat mitigation licences it is determined that this feature offers moderate bat roost potential (based on criteria in Collins, 2023<sup>1</sup>)

On the basis that all work proceeds as per the drawings provided, no additional bat surveys are recommended. However, **no disturbance to the hanging tiles on the front of the house should take place as part of the proposed work.** If any change to the proposals requires disturbance of these tiles then further surveys will be required (at least two dusk emergence surveys with bat detectors and night vision aids in the period of May to August).
