Our ref: 233044/JDT

## **CAMP MOHAWK, CRAZIES HILL**

| Rev. | Details | | Drawn | Date |
|---|---|---|---|---|
| Photograph Record Sheet | | | | |

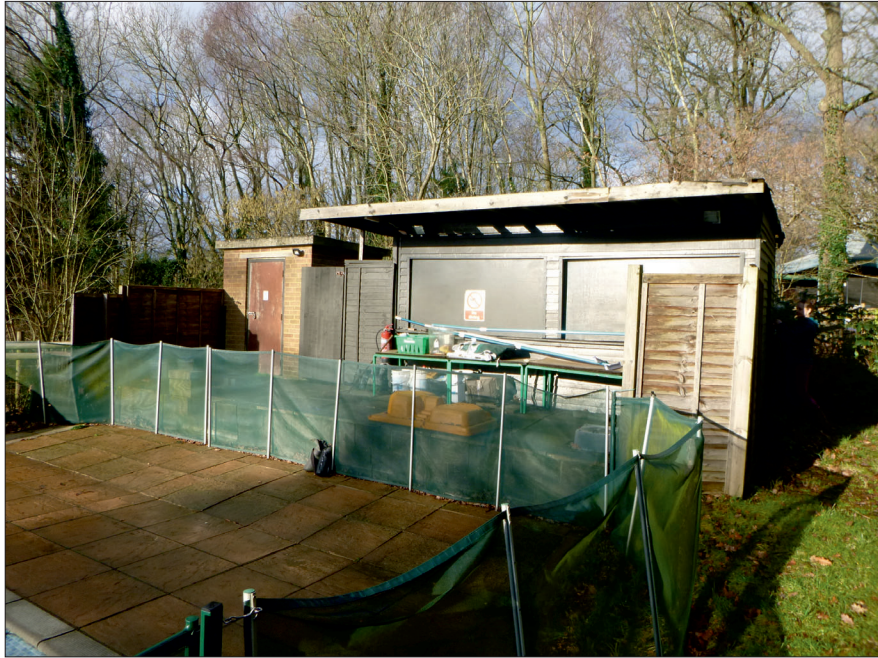
The existing changing room facility was a single-storey, timber-framed and clad garden shed type structure with a flat, felt covered roof. Internally the building was unlined with no separate roof void present. Externally the timber cladding was in good condition and tightly fitting and any restricted gaps present at the roof line heavily cobwebbed. The pump house was of masonry construction with a concrete flat-roof, which was well-sealed. A wooden/metal shelter had been constructed to house additional equipment for the swimming pool.

Photograph 1: Showing the front of the buildings.

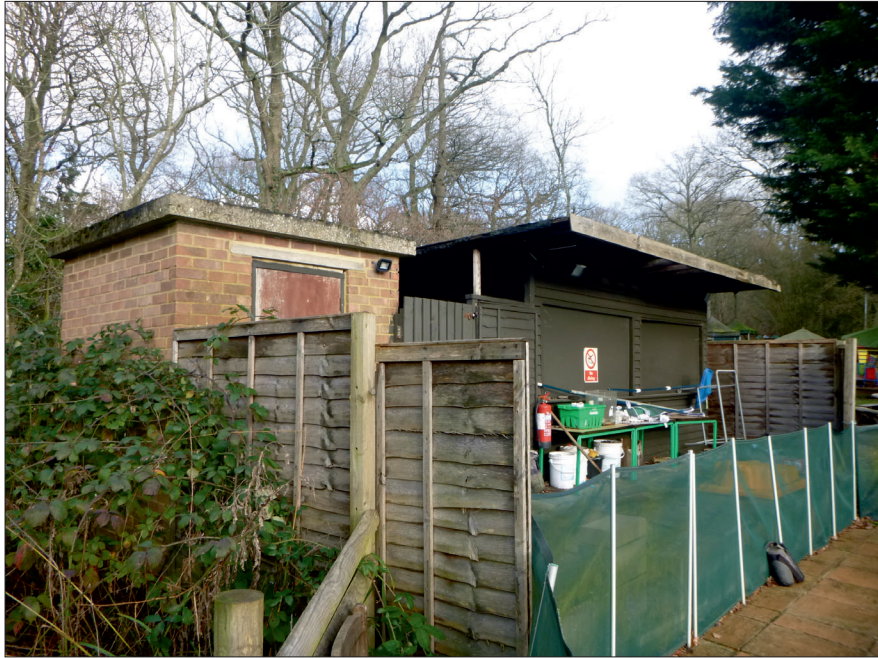
Photograph 2: Showing the front and side of the buildings.

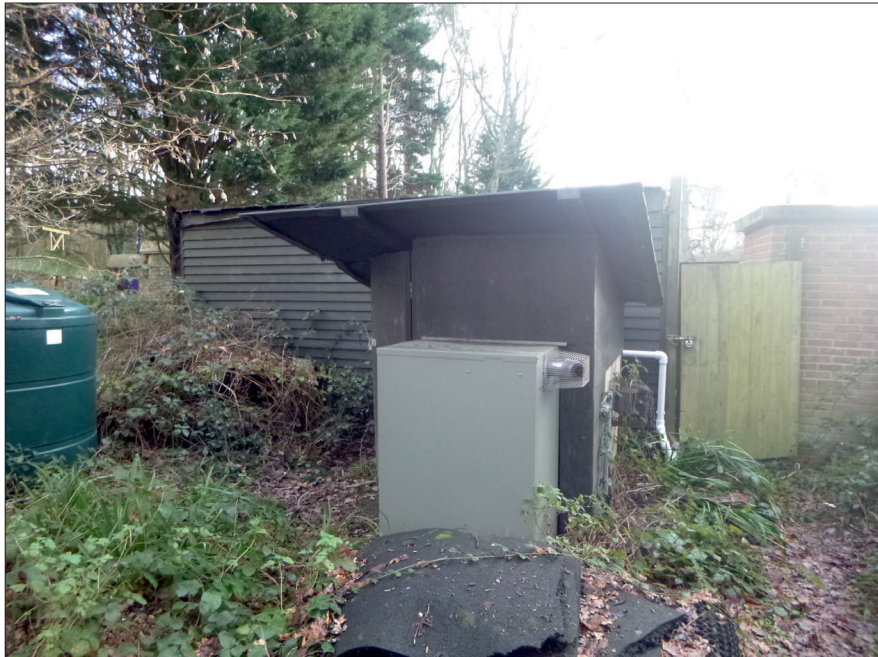
Habitat to the rear of the buildings comprised some bramble (*Rubus fruticosus* agg.) scrub, with blackthorn (*Prunus spinosa*), hazel (*Corylus avellana*), dandelion (*Taraxacum* agg.), cleavers (*Galium aparine*), Yorkshire-fog (*Holcus lanatus*), spurge (*Euphorbia* sp.) and cow parsley (*Anthriscus sylvestris*) also recorded. There were a few ash (*Fraxinus excelsior*) and sycamore (*Acer pseudoplatanus*) saplings and a young oak (*Quercus* sp.) which had a thin covering of ivy (*Helix hedera*). The area to the front of the changing rooms was dominated by the swimming pool and hardstanding with a restricted perimeter of well-maintained amenity grassland also present. Species recorded within the amenity grassland included perennial rye-grass (*Lolium perenne*), Yorkshire-fog, annual meadow-grass (*Poa annua*), creeping buttercup (*Ranunculus repens*), daisy (*Bellis perennis*) and dandelion.

Photograph 3: Showing the rear of the buildings.

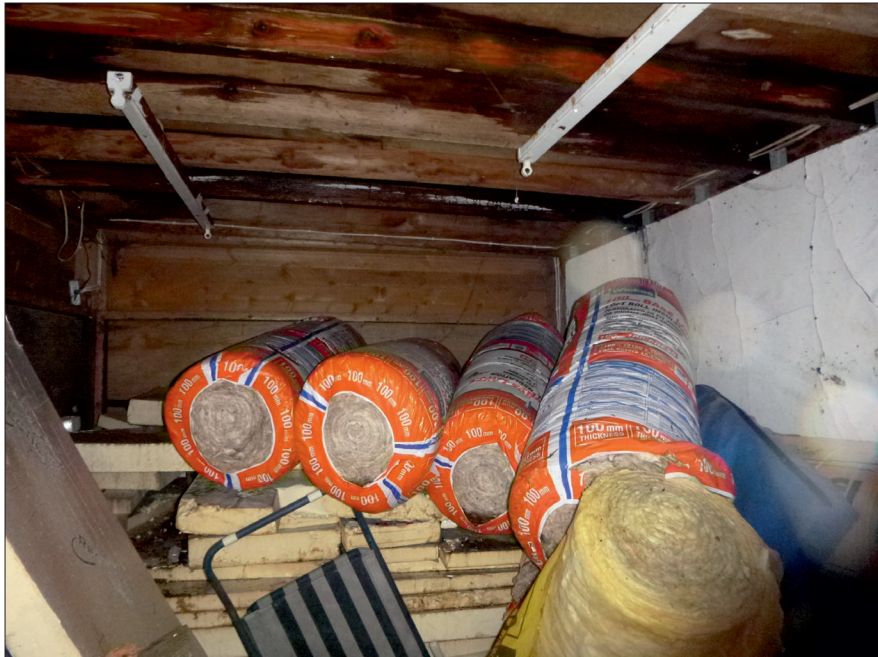
During the follow-up inspection of the buildings, no evidence of bats was recorded and found to be in a similar condition as previously recorded. No evidence of bats was recorded during the careful internal or external inspection of the changing rooms or pump house. Internally the changing rooms were heavily cobwebbed, with no separate roof voids, and the gaps at the roof line created high light levels and exposed the building to the elements. Externally the timber cladding was tightly fitted and where minimal gaps were recorded these were heavily cobwebbed. The pump house was well-sealed with no separate roof voids or suitable crevices which could provide roosting opportunities. All of the buildings were assessed to provide **negligible** roosting opportunities for bats.

Photograph 4: Showing the interior of the changing room facility.
