**Report prepared at**  
Ladds Garden Village  
Bath Road  
Hare Hatch  
RG10 9SB

**On behalf of**  
Westbourne Homes Limited

**Report reference**  
24-304.01

Report Quality Management			
<b>Project Name</b>	Ladds Garden Village, Bath Road, Hare Hatch, RG10 9SB		
<b>Project Title</b>	Preliminary Risk Assessment and Site Investigation		
<b>Client</b>	Westbourne Homes Limited		
<b>Project Number</b>	24-304.01		
<b>Version</b>	2 (updated Proposed Development Plan)		<b>Date</b>
<b>Prepared by</b>	Vanessa Bell BSc (Hons), MSc	Geo-Environmental Consultant	05/06/2025
<b>Prepared by</b>	Orlando Blackwell BEng (Hons) MSc (Eng)	Principal Engineer	06/06/2025
<b>Prepared and Approved by</b>	James Burkitt BEng (Hons) CEnv MRICS	Managing Director	12/09/2025

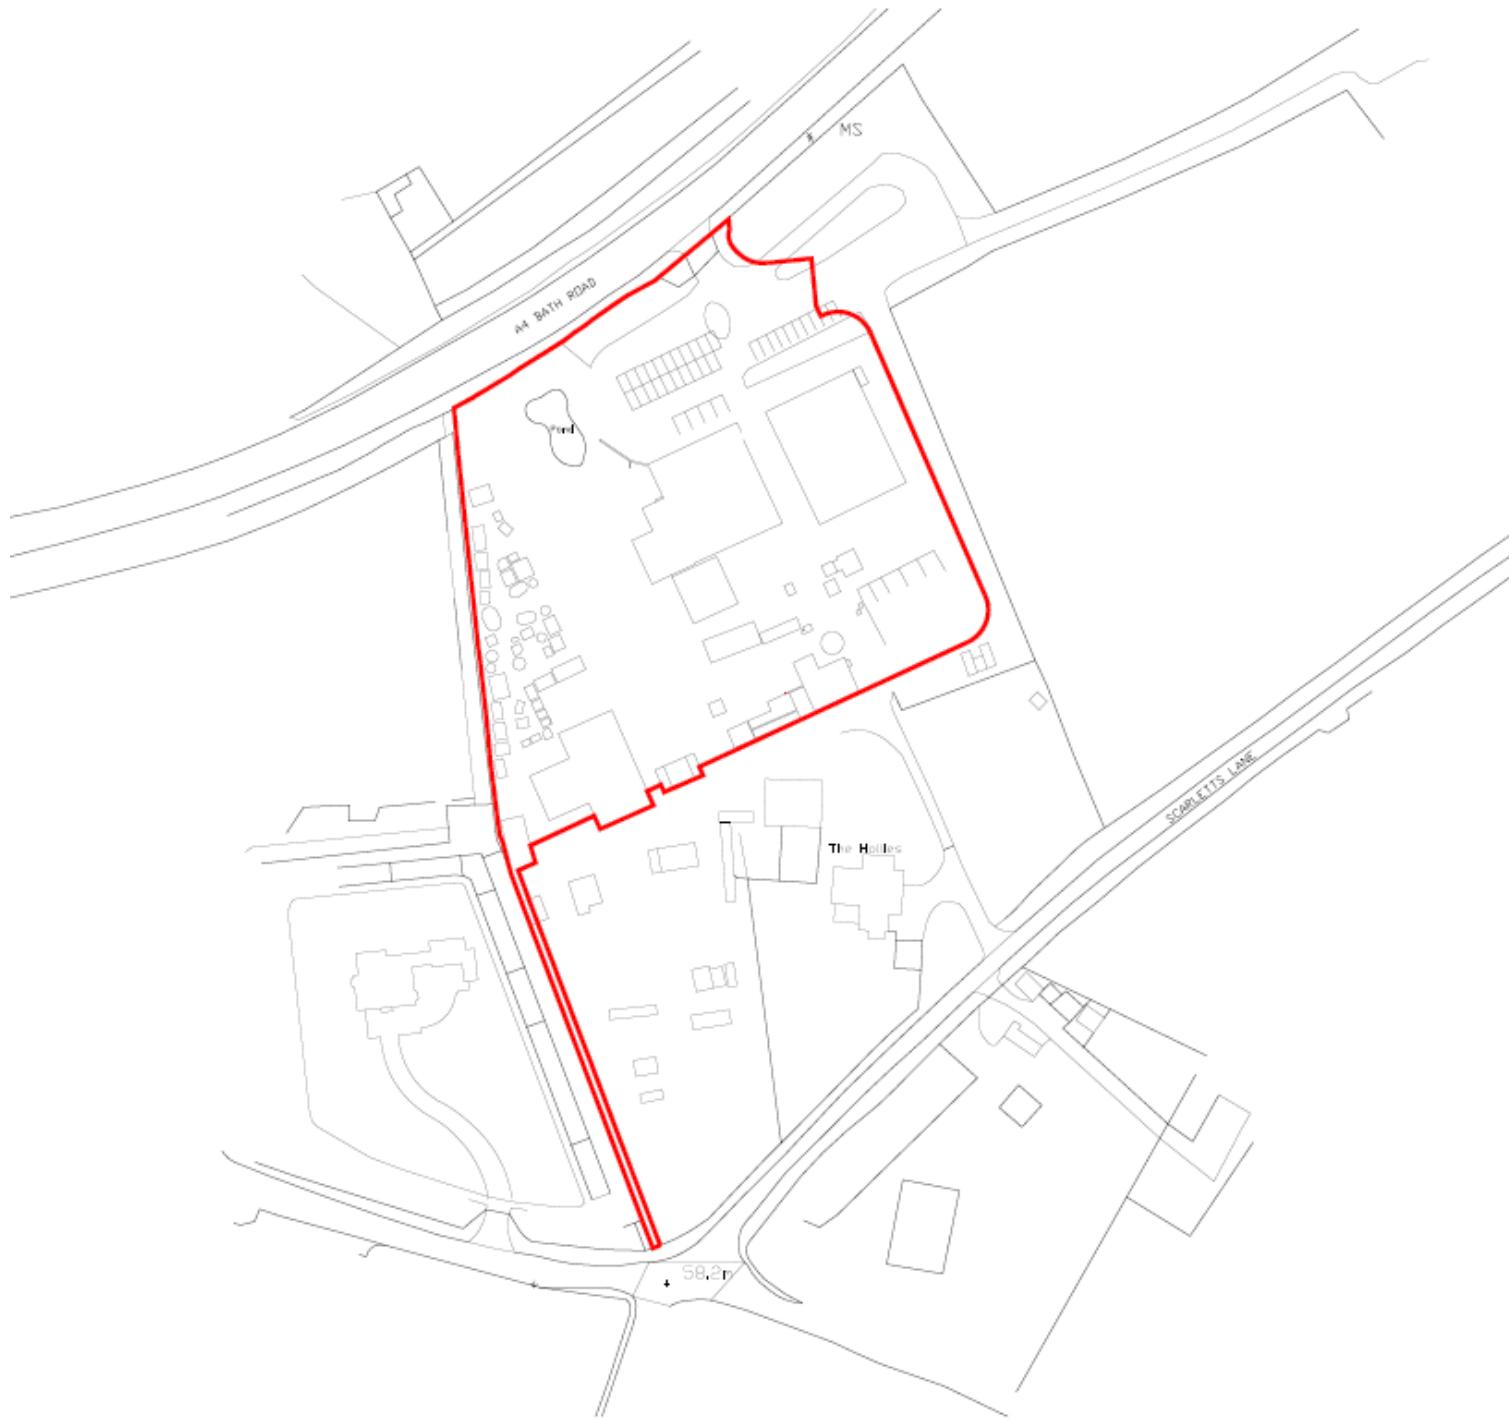
**Figure 1**

<b>Table 1.2: Site Details</b>	
<b>Site Location</b>	The site is located on Bath Road (A4), in Hare Hatch, approximately 10 kilometres (km) to the north-east of Reading. <b>Figure 1</b> is presented as the Site Location Plan.
<b>National Grid Ref.</b>	Centred at approximately 480680, 177930.
<b>Current Land Use</b>	The site comprises the commercial premises of Ladds Garden Village. River Sand and Gravel Limited operates at the site, supplying sand, gravel and other aggregates along with Turf Supplies, supplied rolls of turf. <b>Figure 2</b> is presented as the Existing Site Layout Plan.

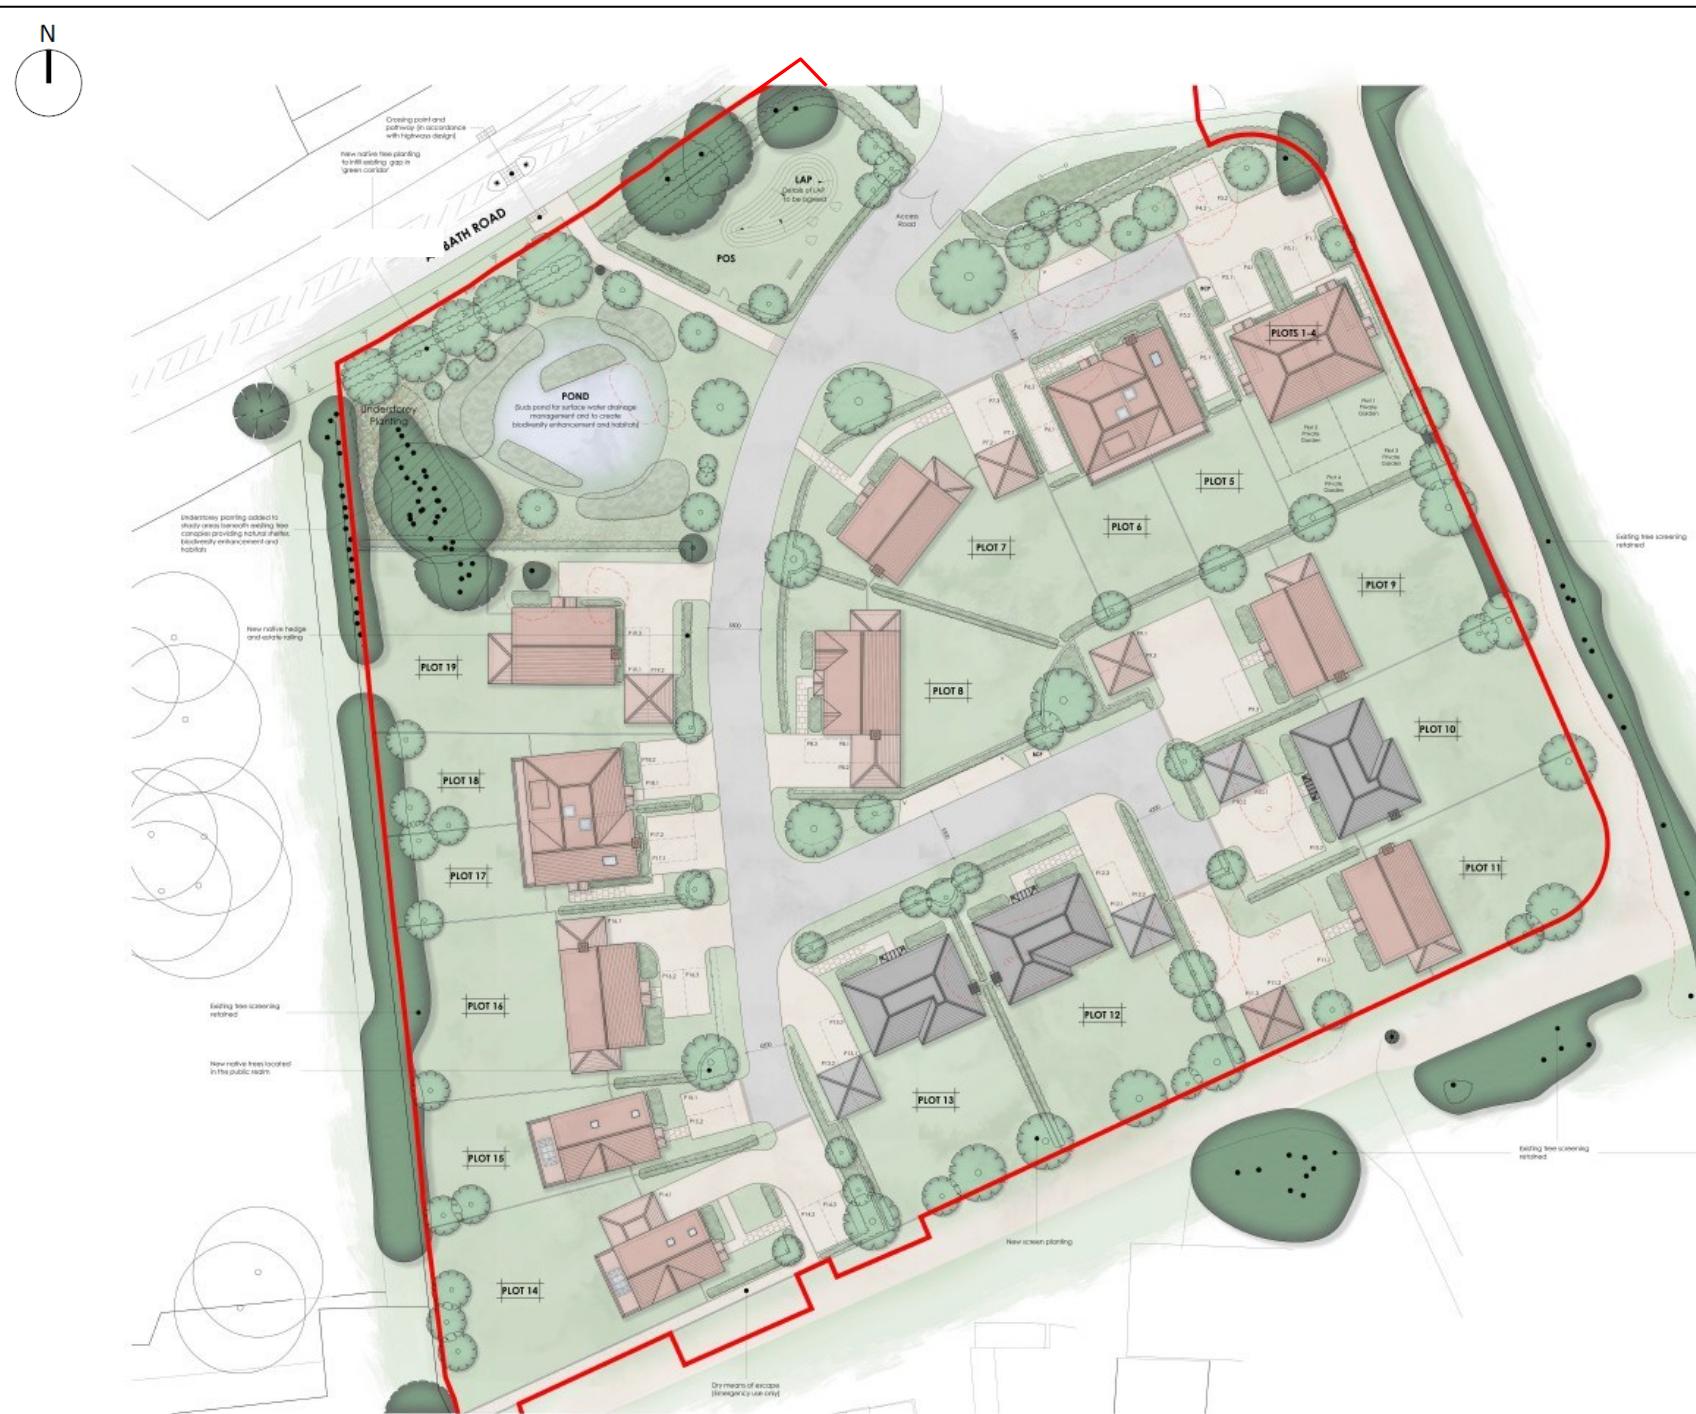
**Figure 4**

<b>Figure 3</b> is presented as the Site Photographs.
<b>Surrounding Land Use</b>	The site is located on the north-eastern outskirts of Hare Hatch, with Bath Road forming the northern site boundary.  Landuse in the immediate surrounding area comprises the grounds of Hare Hatch House to the north-west, open fields to the east, The Hollies and Scarleets Lane to the south-east, and a residential development site under construction to the south-west and west.
<b>Proposed Land Use</b>	The proposed development comprises the demolition of the existing buildings and the construction of nineteen detached and semi-detached dwellings with private gardens, garages and parking as well as associated access drive and communal amenity space.  <b>Figure 4</b> is presented as the Proposed Development Plan.

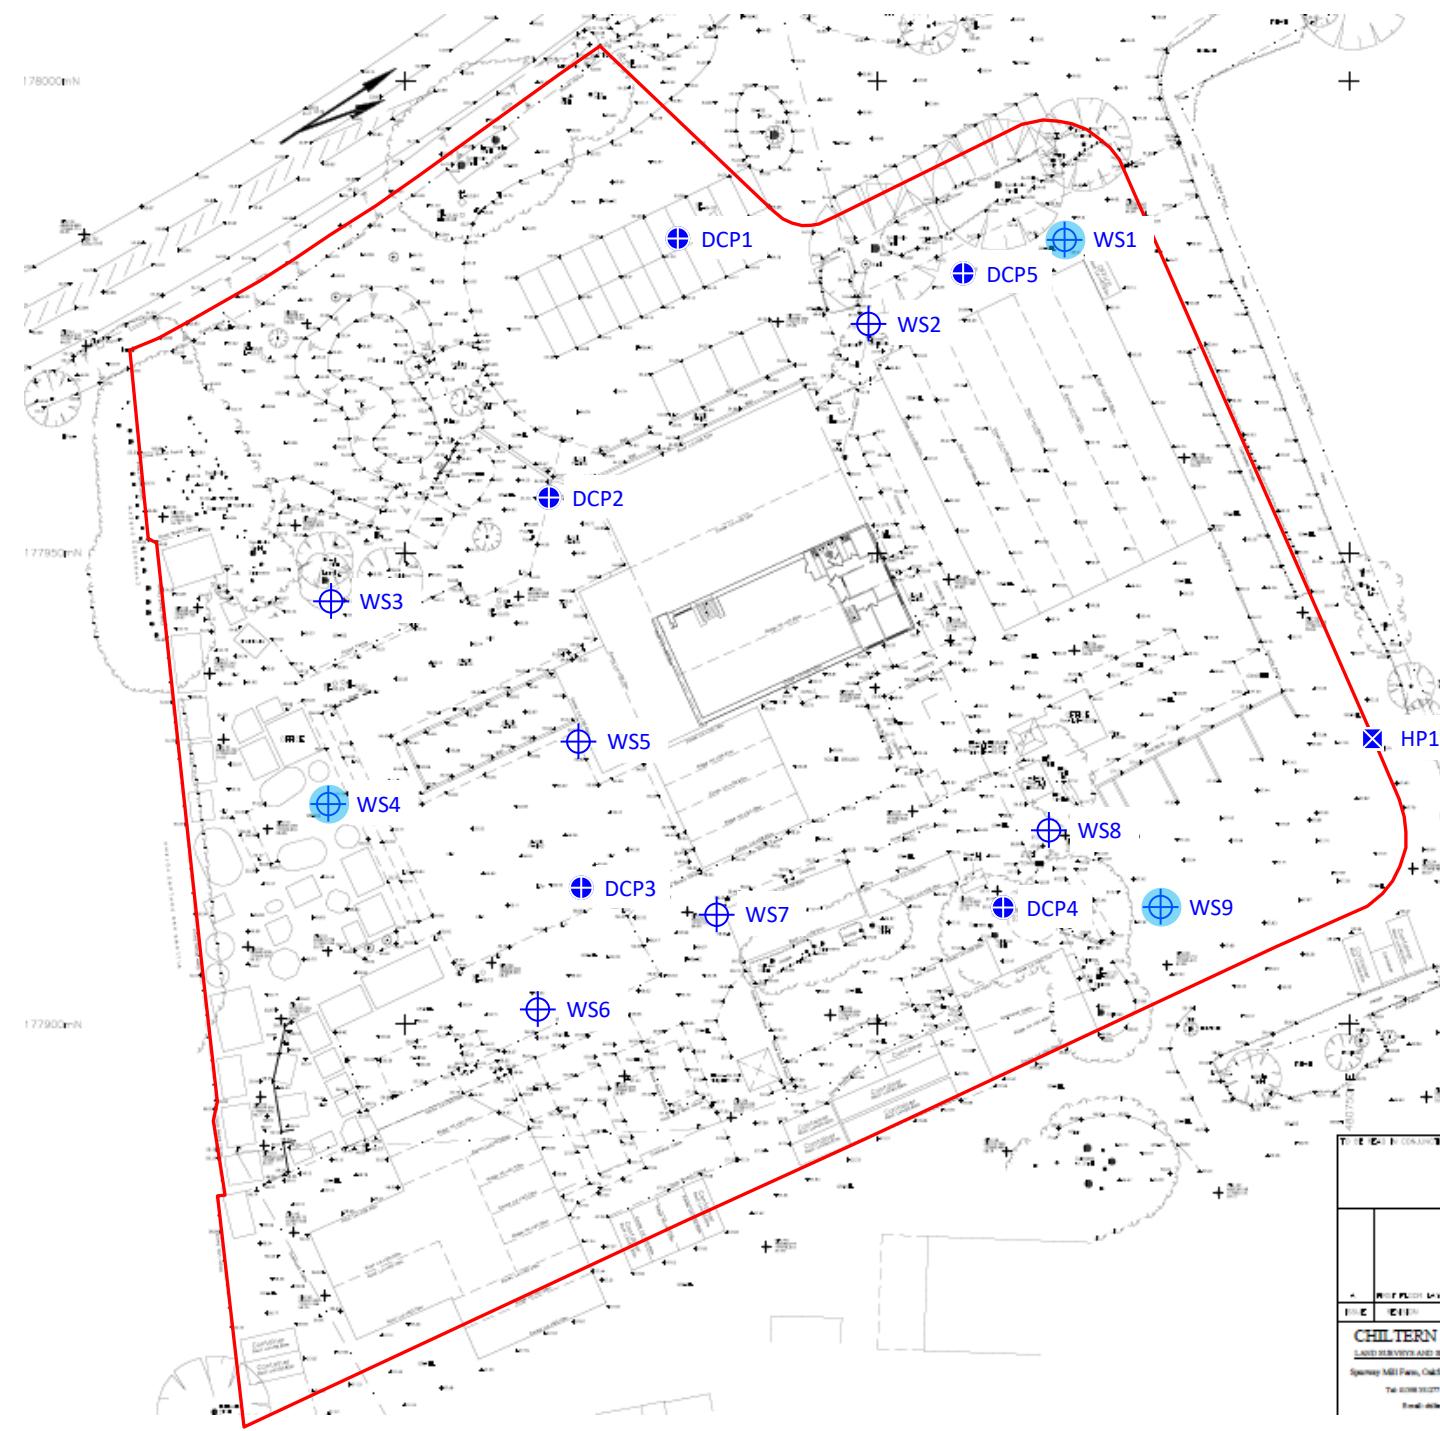
- Window Sample Location
- Monitoring Well
- Hand Trial Hole
- CBR by DCP

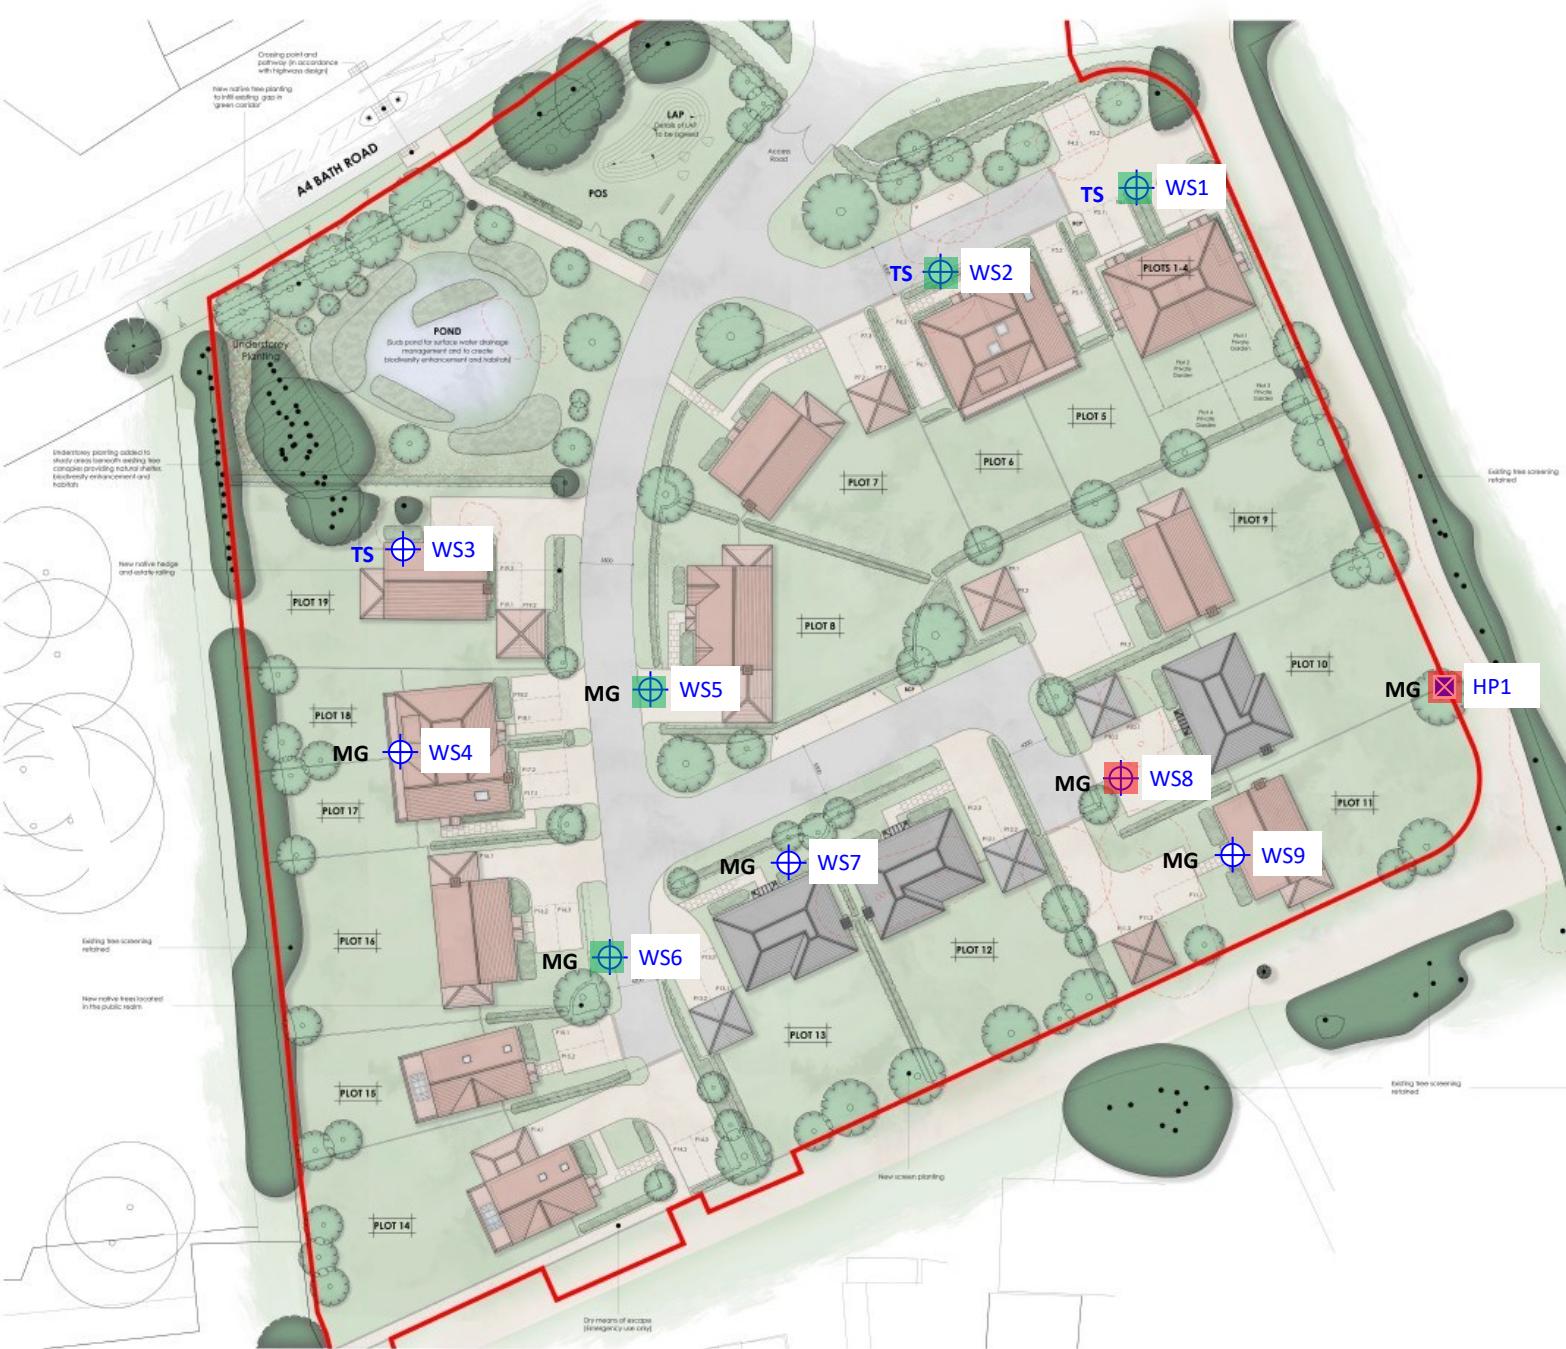
- Window Sample Location
- Hand Trial Hole
- CBR by DCP
- 'Contaminated' Location
- 'Uncontaminated' Location

Benzo(b)fluoranthene, Benzo(a)pyrene and Dibenzo(ah)anthracene has been recorded above their respective GACs in the Made Ground of positions HP1 and WS8 in the south-east corner of the site where a yard is currently located and broadly surfaced with road plainings. PAH is typically found within ash or ashy products and the discovery of shallow PAH contamination within the yard area is most likely attributed to bituminous road plainings in the south-east corner of the site.

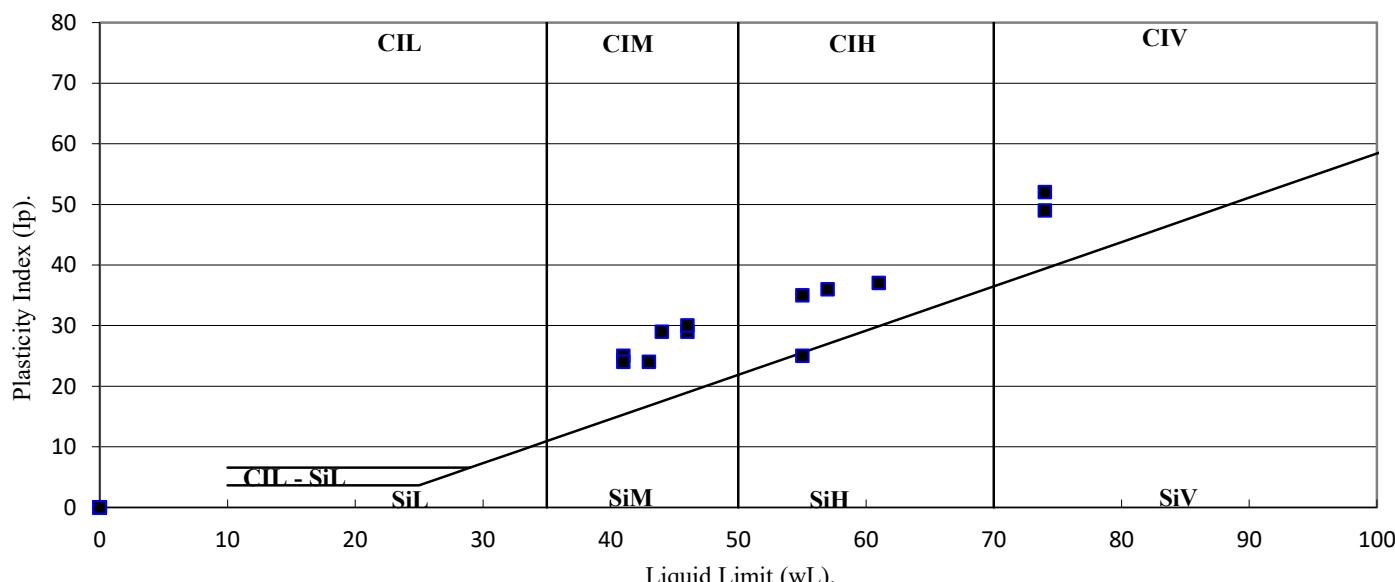
**NB: All liquid limits are 4 point and wet sieved**

PLASTICITY CHART  
BS EN ISO 14688-2:2018 Clause 4.4

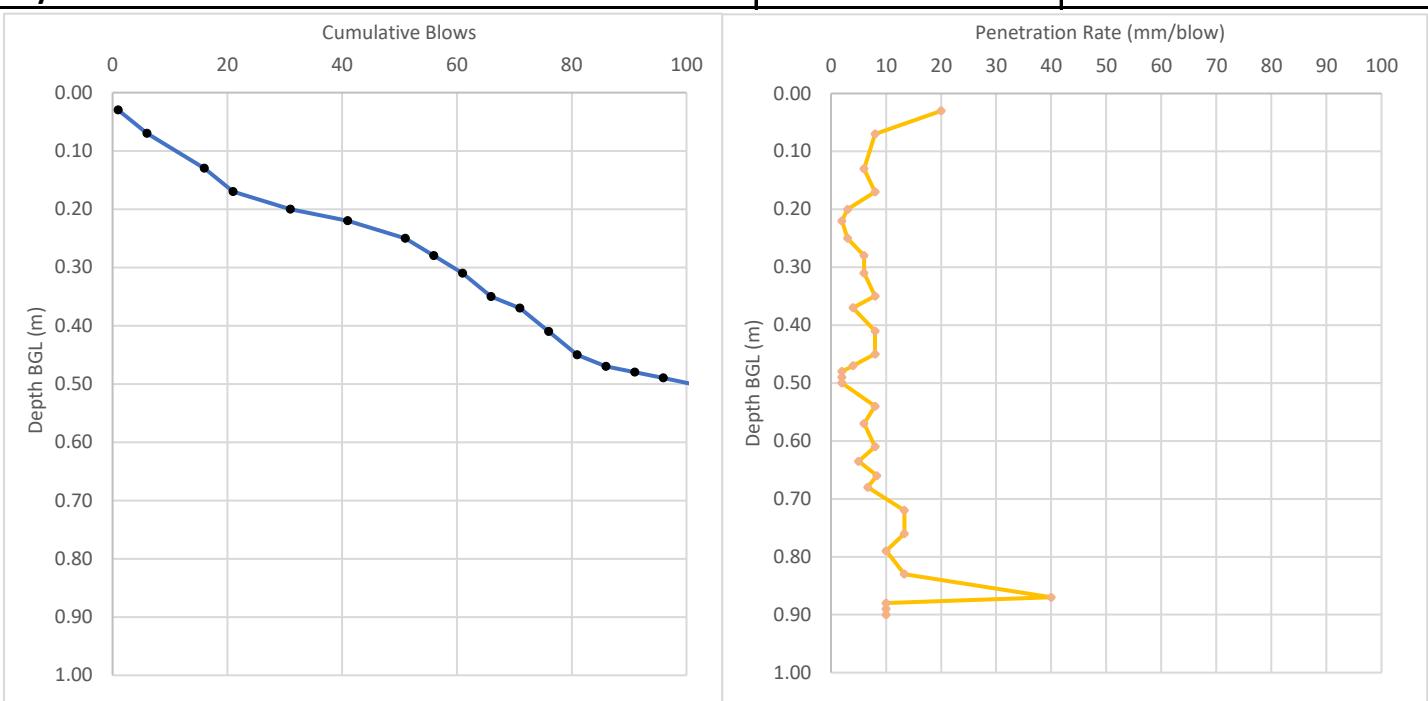
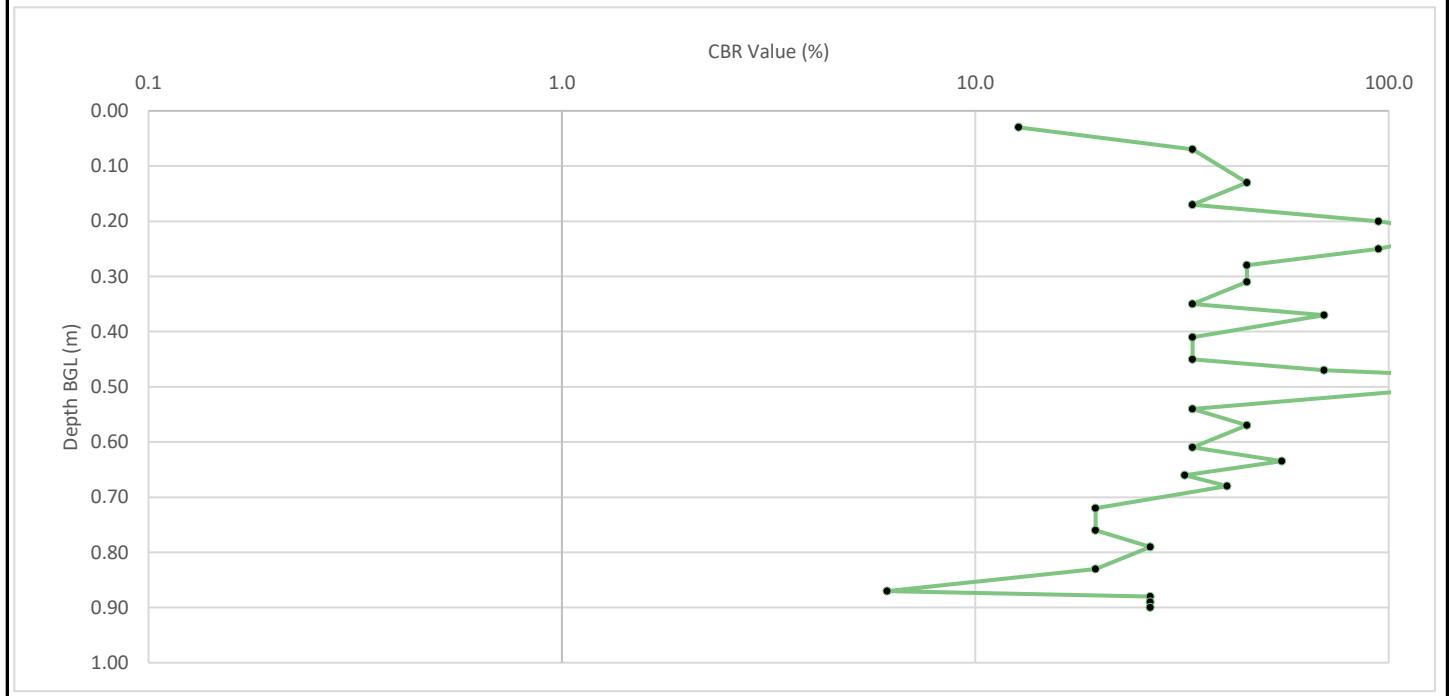
Project: <b>Ladds Garden Centre, Bath Road, Hare Hatch, RG10 9SB</b>	Project No: <b>24-304.01</b>	DCP Location: <b>DCP1</b>
Client: <b>Westbourne Homes Limited</b>	Operator: <b>OC</b>	Date: <b>22/05/2025</b>
Surface Conditions & Observations: <b>Dry</b>	Zero Error (mm): <b>30</b>	Approx AOD (m):

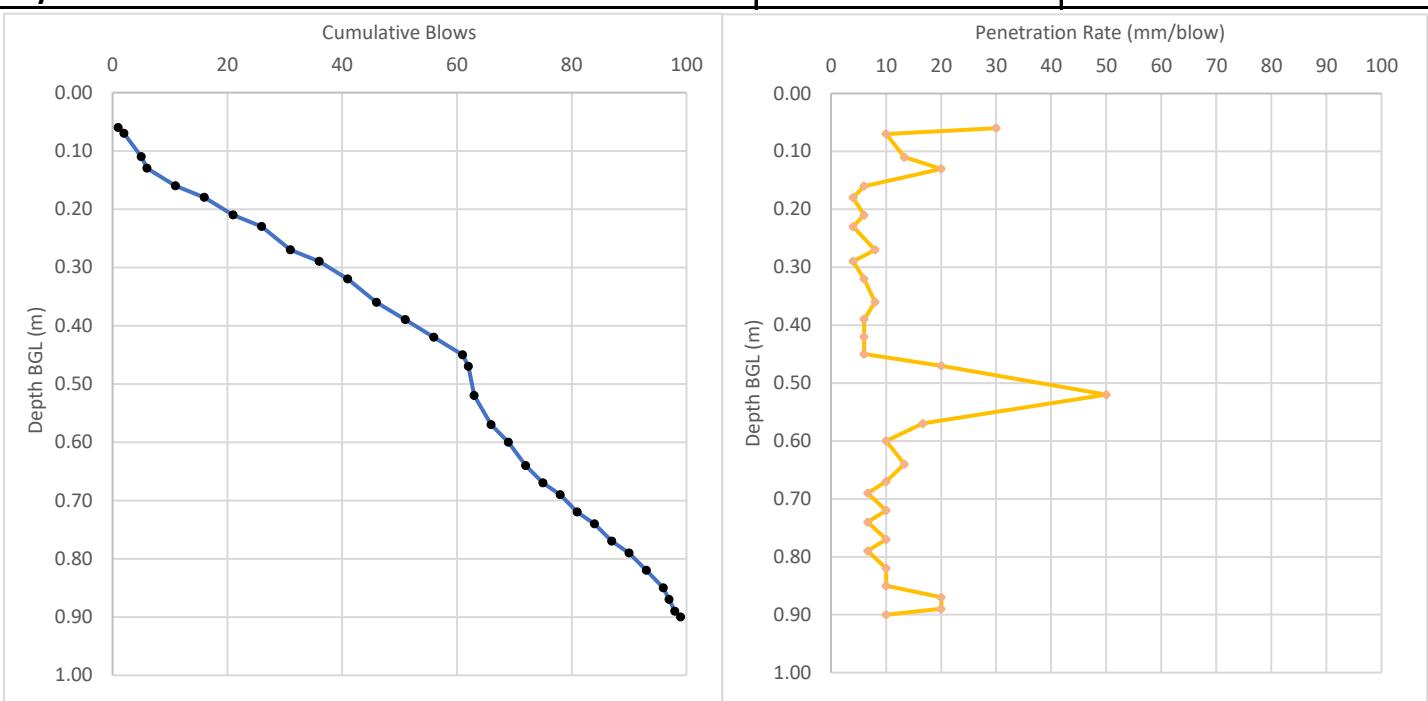
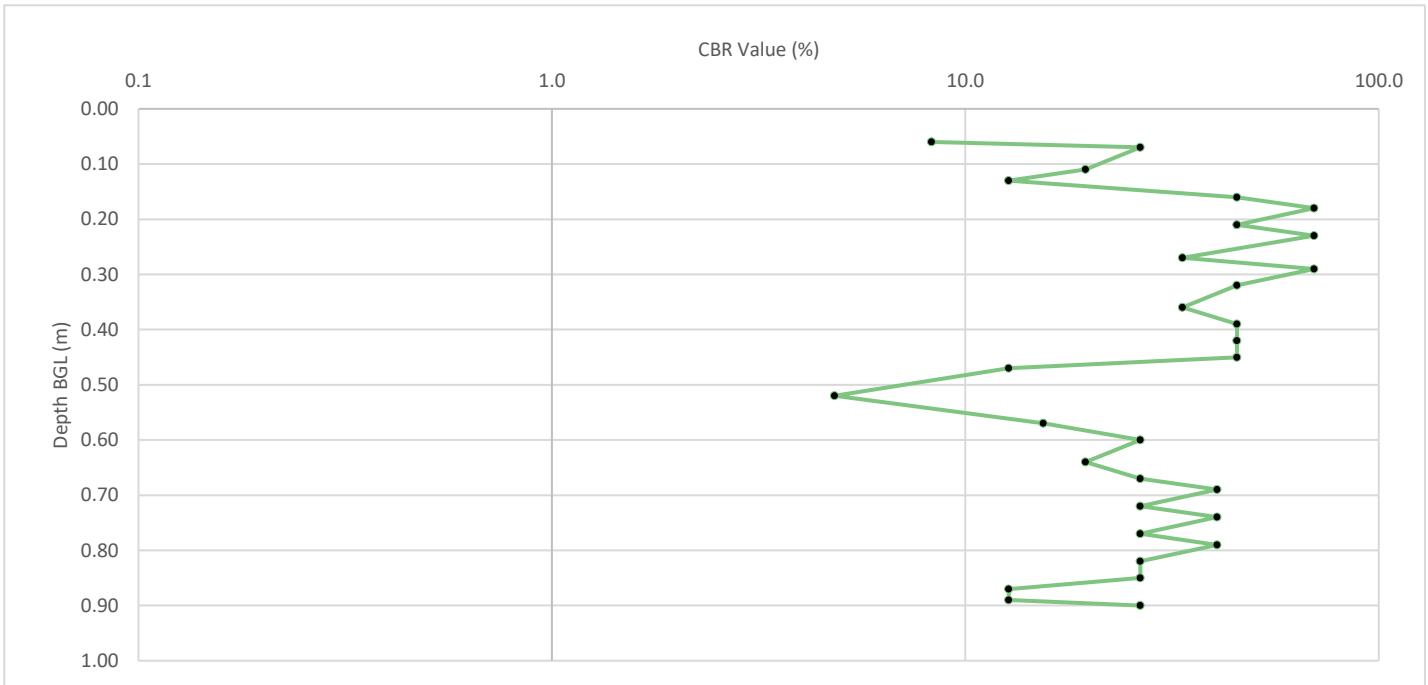
Project: <b>Ladds Garden Centre, Bath Road, Hare Hatch, RG10 9SB</b>	Project No: <b>24-304.01</b>	DCP Location: <b>DCP2</b>
Client: <b>Westbourne Homes Limited</b>	Operator: <b>OC</b>	Date: <b>22/05/2025</b>
Surface Conditions & Observations: <b>Dry</b>	Zero Error (mm): <b>30</b>	Approx AOD (m):

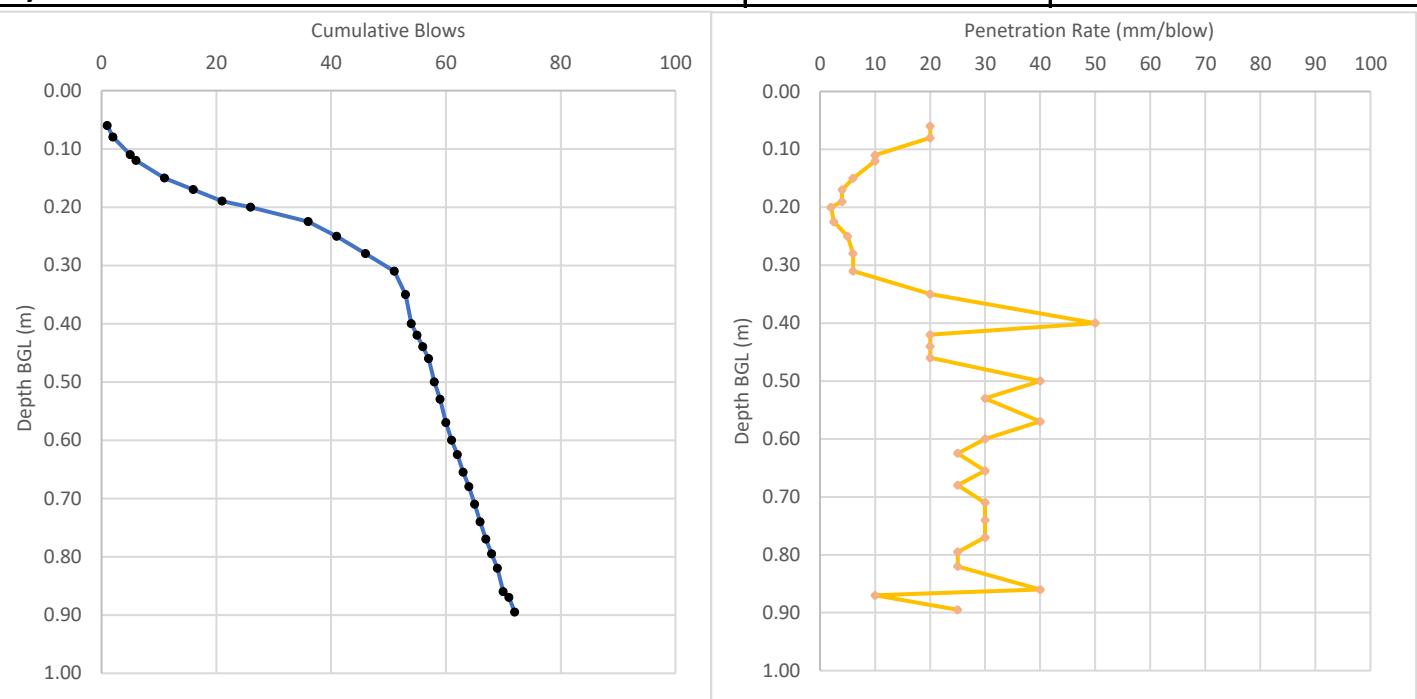
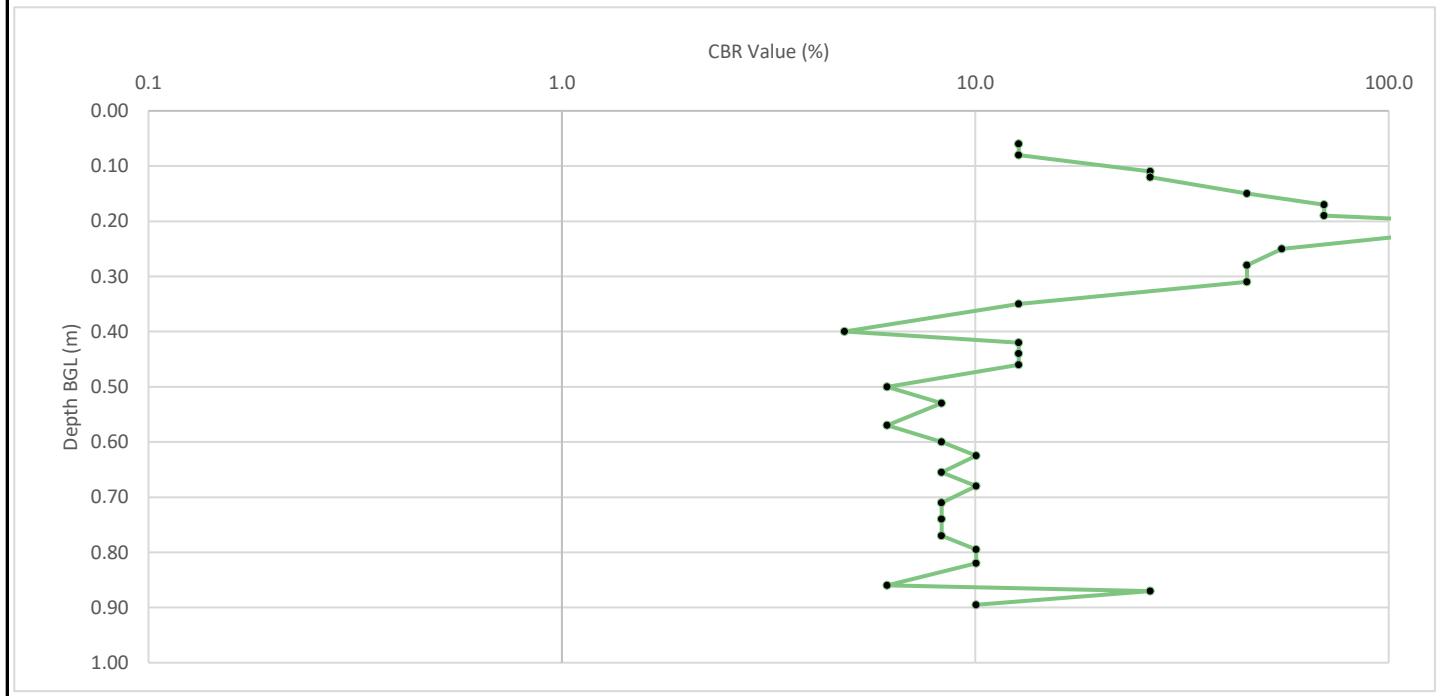
Project: <b>Ladds Garden Centre, Bath Road, Hare Hatch, RG10 9SB</b>	Project No: <b>24-304.01</b>	DCP Location: <b>DCP3</b>
Client: <b>Westbourne Homes Limited</b>	Operator: <b>OC</b>	Date: <b>22/05/2025</b>
Surface Conditions & Observations: <b>Dry</b>	Zero Error (mm): <b>30</b>	Approx AOD (m):

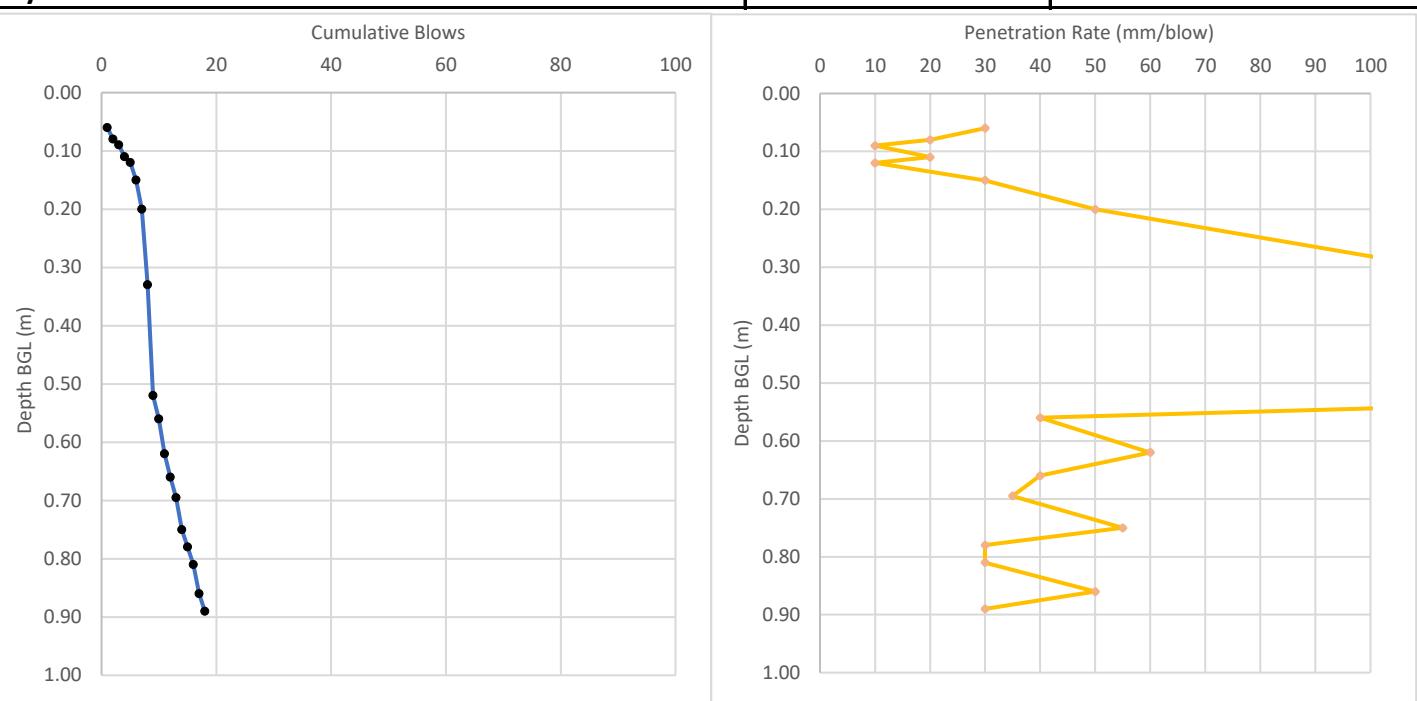
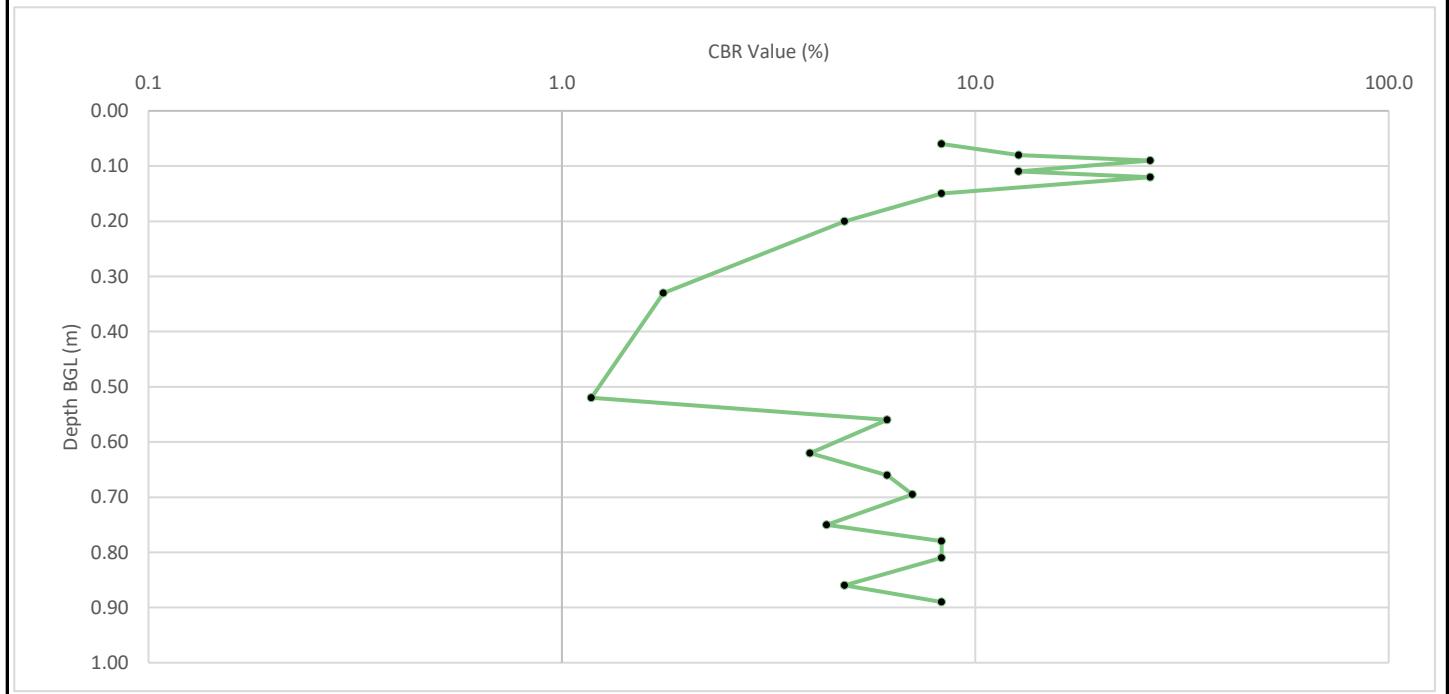
Project: <b>Ladds Garden Centre, Bath Road, Hare Hatch, RG10 9SB</b>	Project No: <b>24-304.01</b>	DCP Location: <b>DCP4</b>
Client: <b>Westbourne Homes Limited</b>	Operator: <b>OC</b>	Date: <b>22/05/2025</b>
Surface Conditions & Observations: <b>Dry</b>	Zero Error (mm): <b>30</b>	Approx AOD (m):

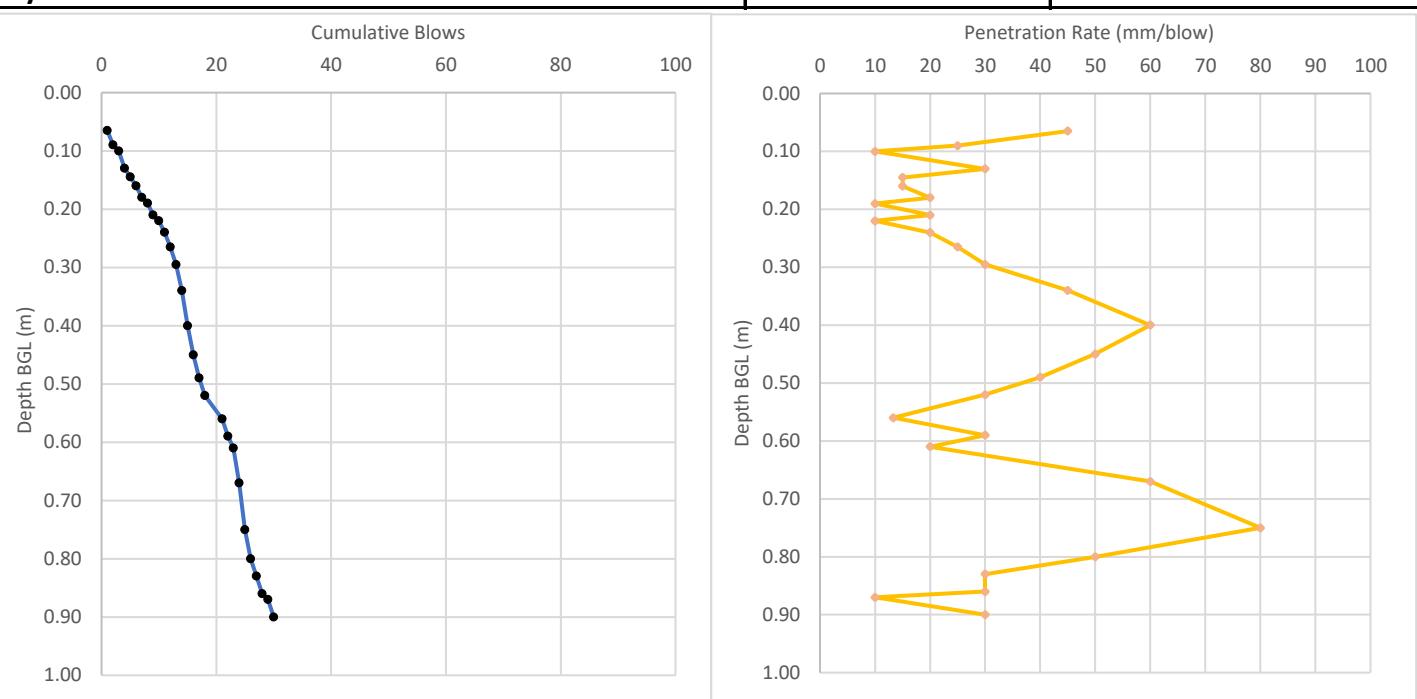
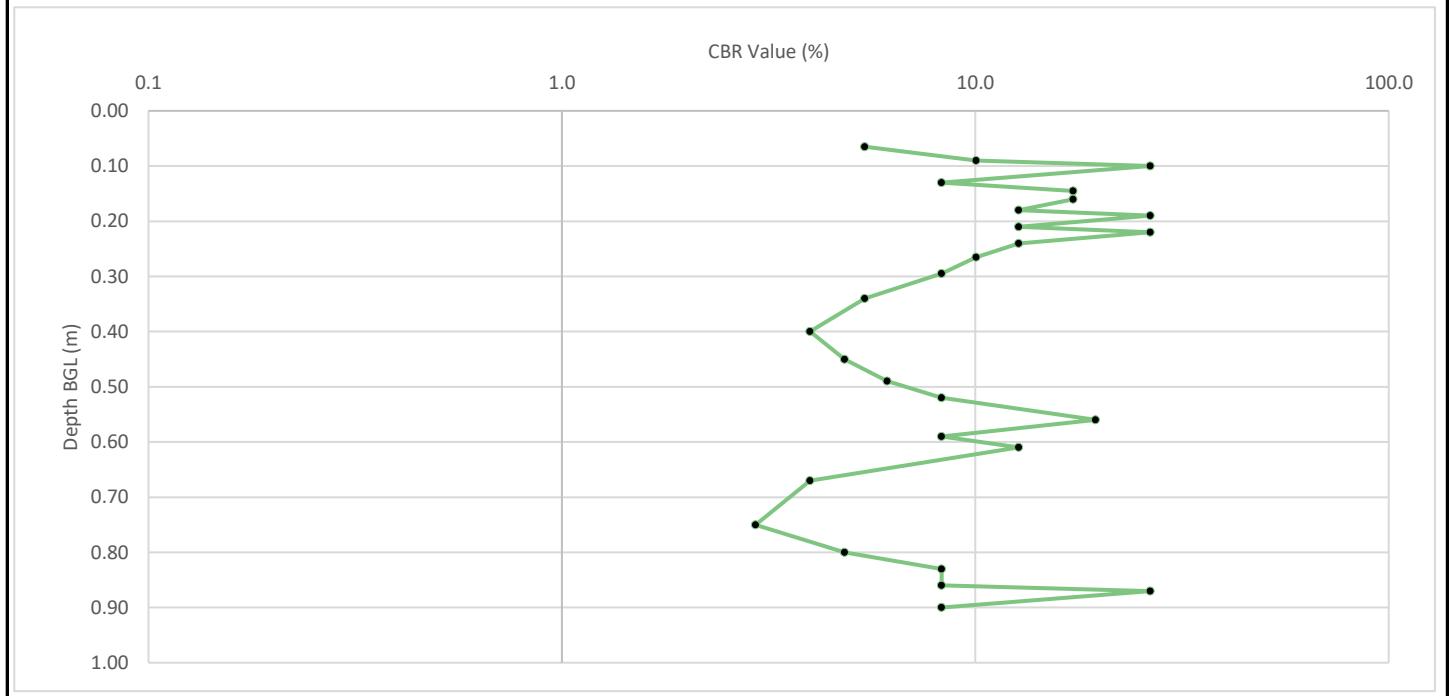
Project: <b>Ladds Garden Centre, Bath Road, Hare Hatch, RG10 9SB</b>	Project No: <b>24-304.01</b>	DCP Location: <b>DCP5</b>
Client: <b>Westbourne Homes Limited</b>	Operator: <b>OC</b>	Date: <b>22/05/2025</b>
Surface Conditions & Observations: <b>Dry</b>	Zero Error (mm): <b>30</b>	Approx AOD (m):
