## Preliminary Roost Assessment

**Survey site:** 65 Evendons Lane, Wokingham, Berkshire, RG41 4AD

This report is prepared to inform a planning application for a rear extension and construction of an additional storey.

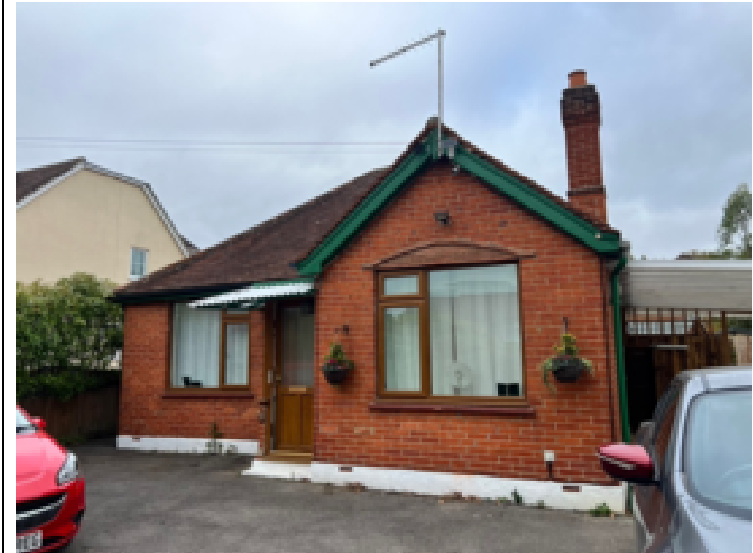
B1 is a detached dwelling with a combination pitched, hipped, and gabled roof structure constructed with clay roofing tiles. The walls are constructed with brick and mortar. The windows and doors are timber-framed. The soffits and fascias are constructed with timber.

**Due to the presence of missing tiles, lifted tiles, lifted ridge tiles, and gaps behind soffit boxes, B1 has been described as having 'moderate' habitat value for roosting bats.**

| <i>Recommendations</i> | <p>Two bat emergence and re-entry surveys are required during the active bat season (optimal May to August, suboptimal September) to confirm presence or likely absence of a bat roost in the building. Both of the surveys should be completed during the optimal survey period mid-May to August inclusive.</p> <p>Infra-red cameras should be used as an aid. Surveys should be a minimum of three weeks apart.</p> |

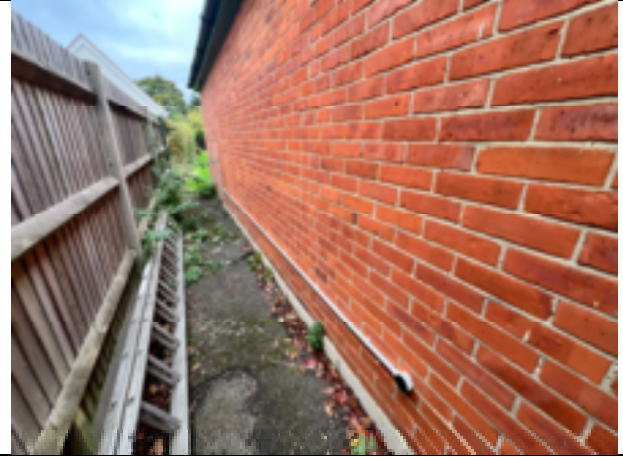
| Feature | Materials | Condition/description | Suitability/access/evidence of bats | Photos |
|---|---|---|---|---|
| Walls | Brick and mortar | <p>The brickwork and mortar pointing were in a uniformly good condition.</p> <p>No gaps or cracks were observed.</p> | <p>No roosting habitat observed.</p> <p>No evidence of bat use found.</p> | |

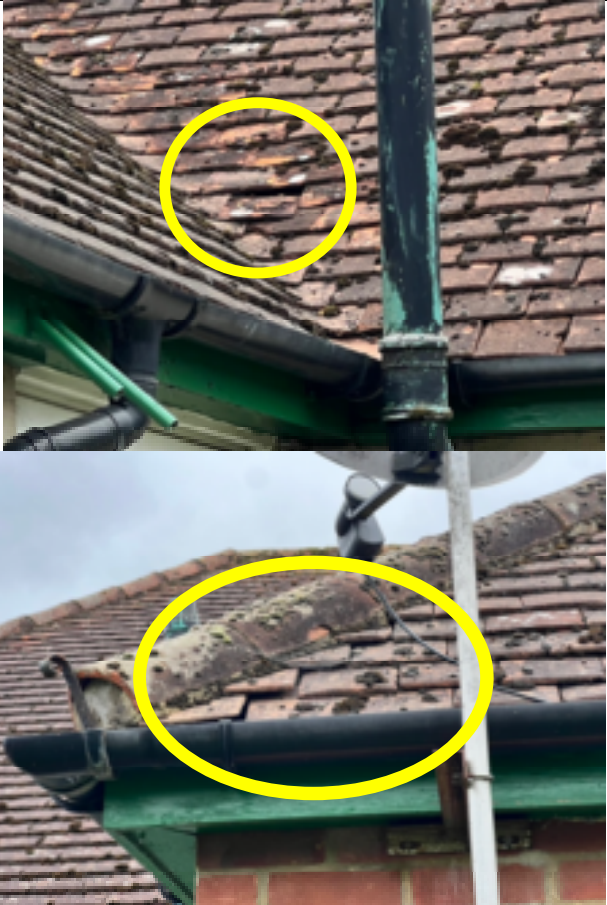
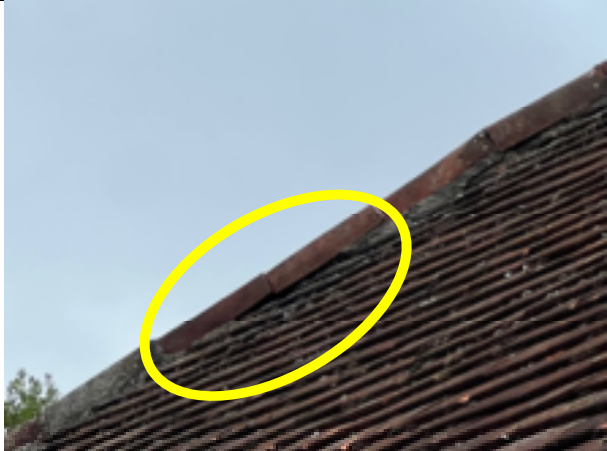
| Roof | Slate | <p>The clay tiles were in a weathered condition, featuring moss growth.</p> <p>Missing tiles were observed on the eastern elevation.</p> <p>Lifted tiles were observed on the southern, eastern, and northern elevations.</p> <p>Raised ridge tiles were observed on the eastern roof elevation.</p> | <p>There is opportunity for crevice-dwelling bats to roost in the space where there is a missing tile, under the lifted tiles, and under the lifted ridge tiles.</p> <p>No evidence of bat use found.</p> | |

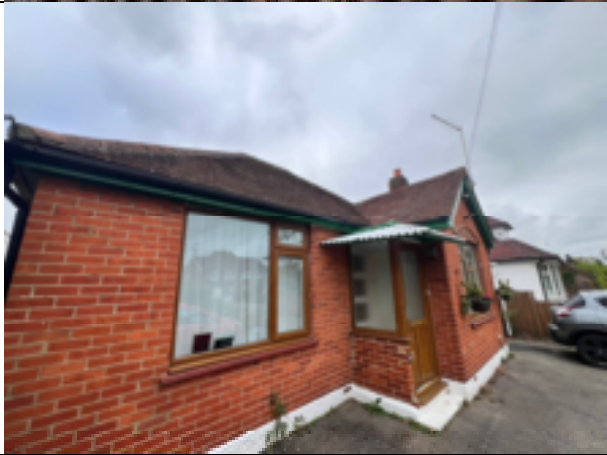
| Windows and doors | Timber | <p>The windows and doors were in a uniformly good condition.</p> <p>No gaps or cracks were observed.</p> | <p>No roosting habitat observed.</p> <p>No evidence of bat use found.</p> | |

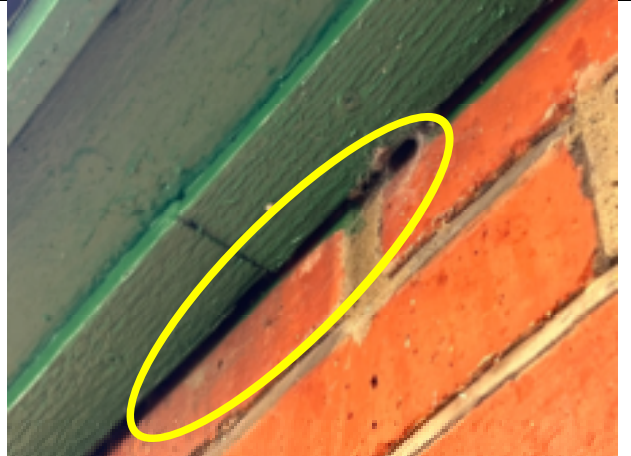
| Soffits and facias | Timber soffit boxes | <p>Small gaps were present between the soffit boxes and the adjoining brickwork.</p> | <p>There is opportunity for crevice-dwelling bats to roost in the gaps between the soffit boxes and adjoining brickwork.</p> <p>No evidence of bat use found.</p> | |

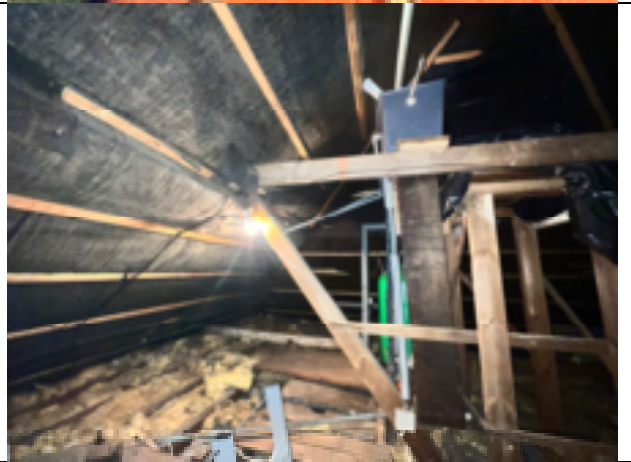
| Internal voids | Timber beams and joists, bitumen lining | <p>The bitumen lining was in a good condition.</p> <p>The timber frames were in good condition.</p> <p>No access points or areas of light ingress were observed.</p> <p>Temperature: 21.4°C<br/>Relative humidity: 65.3%</p> | <p>Suboptimal for void dwelling bats due to the small size.</p> <p>No bat evidence or access points noted.</p> | |

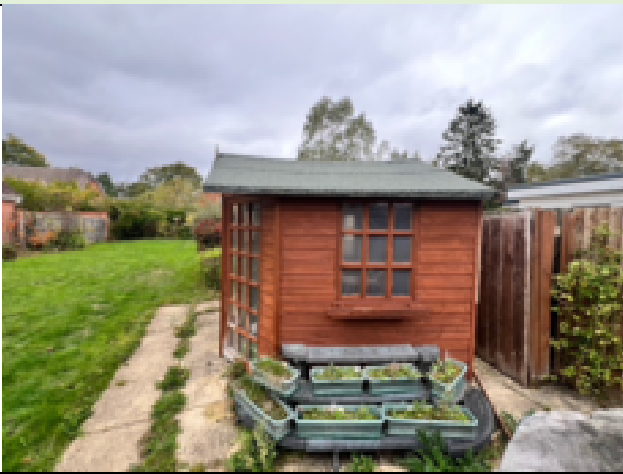
| <i>B2 Building description</i> | <i>Photographs</i> |
|---|---|
| <p><i>Summary</i></p> <p>B2 is a timber shed located adjacent to the eastern site boundary. The shed is well sealed, with no areas of roosting habitat available for crevice dwellers. B2 is assessed to have negligible habitat value for roosting bats due to the single-skinned nature of the Building and the presence of large windows, leaving the internal space subject to frequent fluctuations in temperature and humidity as a result.</p> <p>B2 is <b>negligible</b> for roosting bats.</p> | |

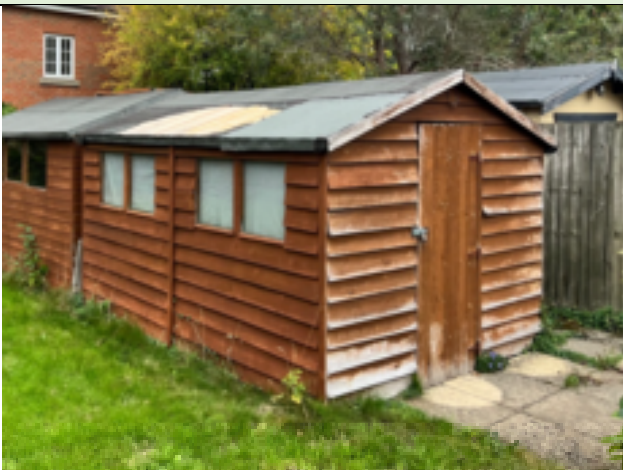
| <i>B2 Building description</i> | <i>Photographs</i> |
|---|---|
| <p><i>Summary</i></p> <p>B3 is a timber shed located adjacent to the eastern site boundary. The shed is well sealed, with no areas of roosting habitat available for crevice dwellers. B3 is assessed to have negligible habitat value for roosting bats due to the single-skinned nature of the Building and the presence of large windows, leaving the internal space subject to frequent fluctuations in temperature and humidity as a result.</p> <p>B3 is <b>negligible</b> for roosting bats.</p> | |

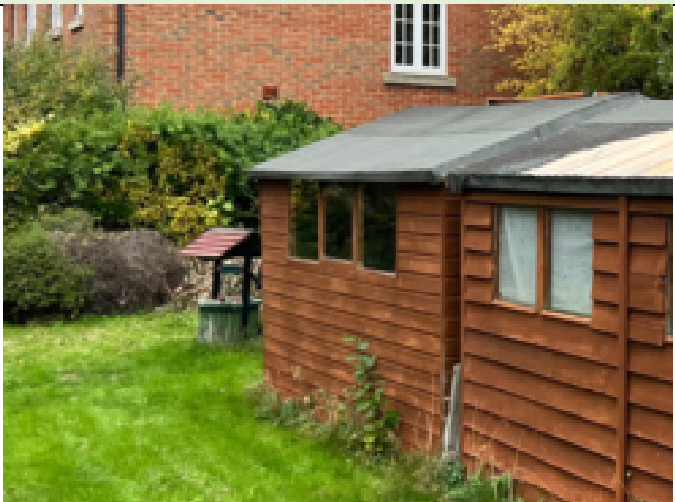
| <i>B4 Building description</i> | <i>Photographs</i> |
|---|---|
| <p><i>Summary</i></p> <p>B4 is a timber shed located adjacent to the eastern site boundary. The shed is well sealed, with no areas of roosting habitat available for crevice dwellers. B4 is assessed to have negligible habitat value for roosting bats due to the single-skinned nature of the Building and the presence of large windows, leaving the internal space subject to frequent fluctuations in temperature and humidity as a result.</p> <p>B4 is <b>negligible</b> for roosting bats.</p> | |
