# Preliminary Roost Assessment

18 Collins Drive, Earley, Reading RG65AD

This report is prepared to inform a planning application with Wokingham Borough Council. loft conversion and rear extension.

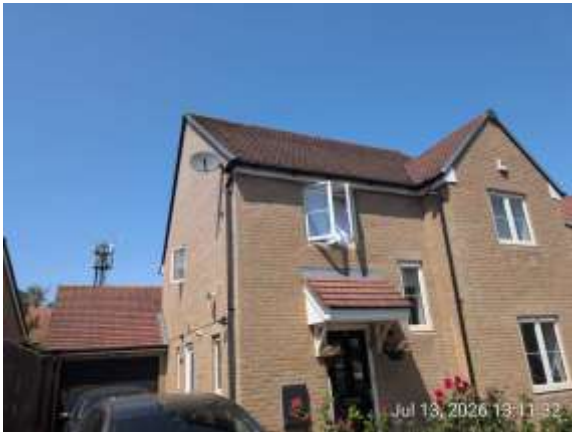
The building is a new build residential dwelling located within the site. It offers no accessible voids or suitable crevice-like features that would support bat roosting. The building has negligible habitat value.

Building B1 southern elevation

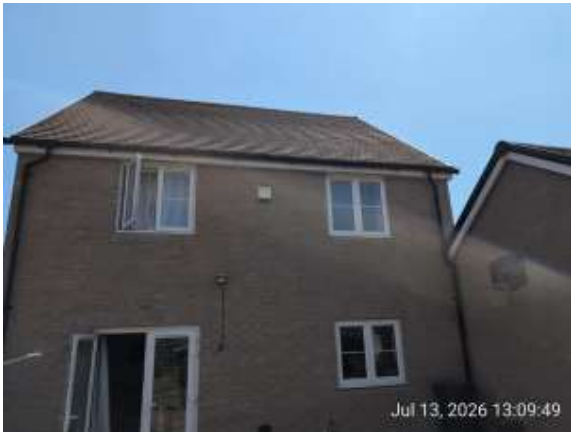
Building B1 northern elevation

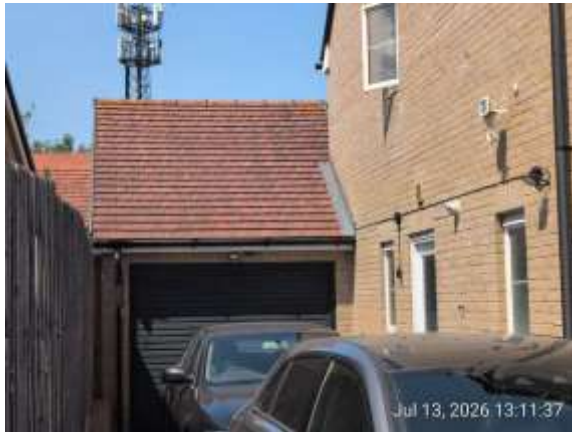
Building B1 side single-storey garage extension

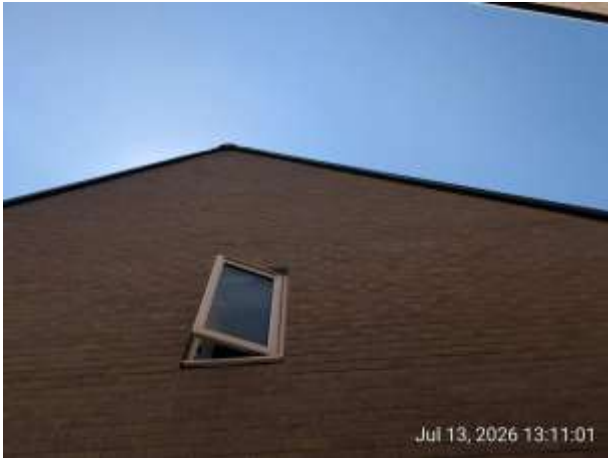
| Feature | Materials/Details | Condition / description / suitability | Photograph |
|---|---|---|---|
| Walls | Brick | <p><b>Condition/description</b></p> <p>The walls appear in good condition with no significant gaps or cracks.</p> <p><b>Suitability/access/evidence of bats</b></p> <p>No access points were noted.</p> | <p>B1 walls</p> |

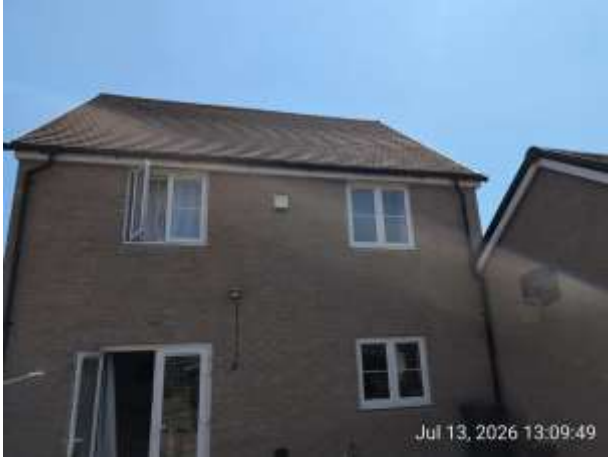
| Roof | Clay tiles | <p><b>Condition/description</b><br/>The roof of B1 is in good condition with no slipped or missing tiles.</p> <p><b>Suitability/access/evidence of bats</b><br/>No suitability or access points for bats was noted.</p> | <p><i>B1 roof</i></p> |

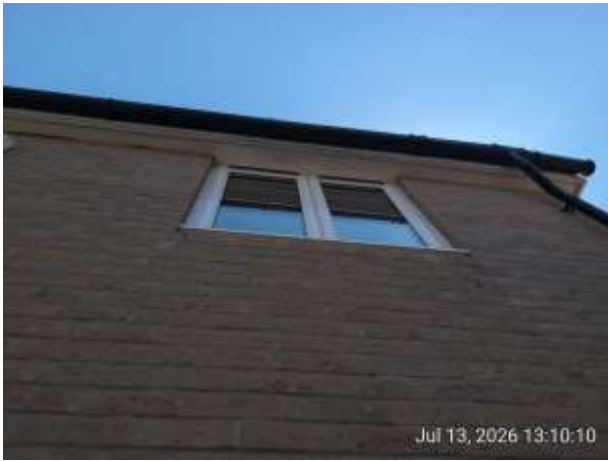
| Windows | uPVC | <p><b>Condition/description</b><br/>The windows and door frames are in good condition.</p> <p><b>Suitability/access/evidence of bats</b><br/>No access points for bats were noted.</p> | <p>Jul 13, 2026 13:10:10</p> <p><i>B1 window / doors frames and lintels</i></p> |

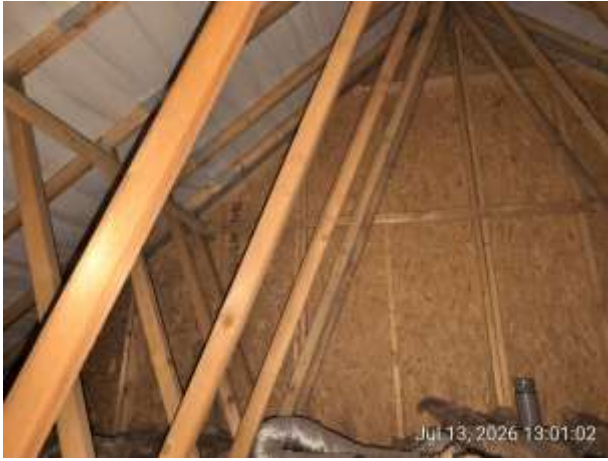
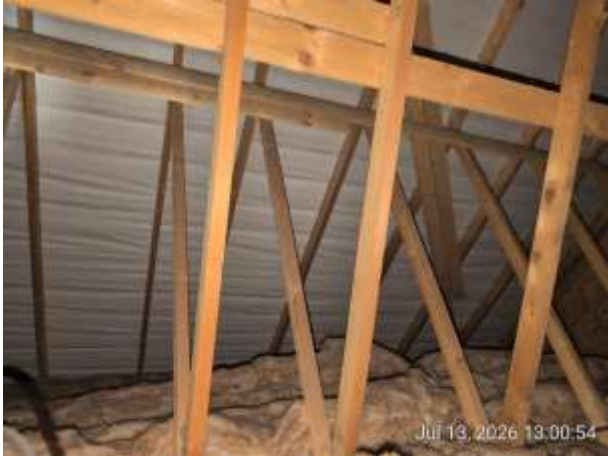
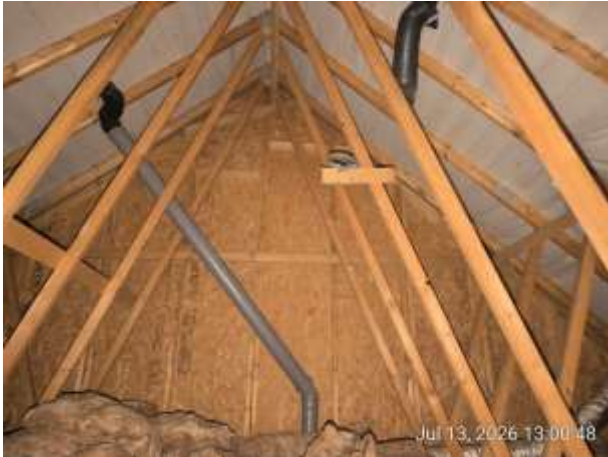
| Internal void 1 | Timber rafters. Mineral wool insulation, breathable roof membrane lining. | <p><b>Condition/description</b><br/>The internal void is in good condition, with a modern construction consisting of timber beams, breathable roof membrane lining and mineral wool insulation. Plywood boards cover the gable ends. No evidence of bats was found. A small number of rodent droppings were noted. Dimensions (approx): 8.5m x 8m</p> <p><b>Suitability/access/evidence of bats</b><br/>No access points or other suitable bat features were noted.</p> | <p>Jul 13, 2026 13:01:02</p> <p><i>B1 internal void 1</i></p> |

| | | | <p><i>B1 internal void 1</i></p> <p><i>B1 internal void 1</i></p> |
