**The Granary  
Wick Hill Lane  
Finchampstead  
Wokingham  
Berkshire  
RG40 3SB**

## **Preliminary Roost Assessment**

Report ref.: R3150\_PRA\_a

**March 2026**

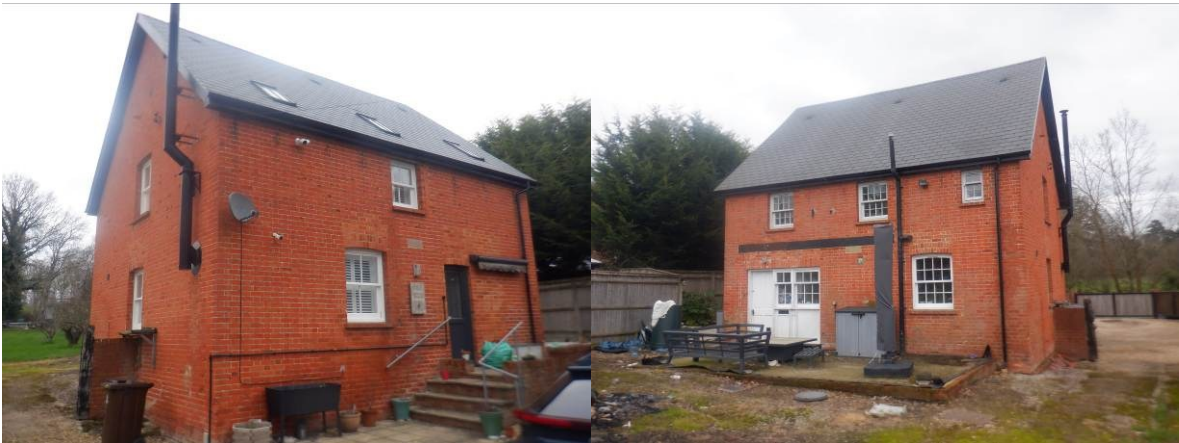
- 5.2.2** The property was a detached house of brick construction with a pitched roof and the roof was covered in flat slate roof tiles (**Photograph 1**) – re-roofed with skylights in 2021. A single storey extension had been removed from the rear of the house (**Photograph 2**).

*Photograph 1. Front of property viewed from south.*

*Photograph 2. Rear of property viewed from north.*

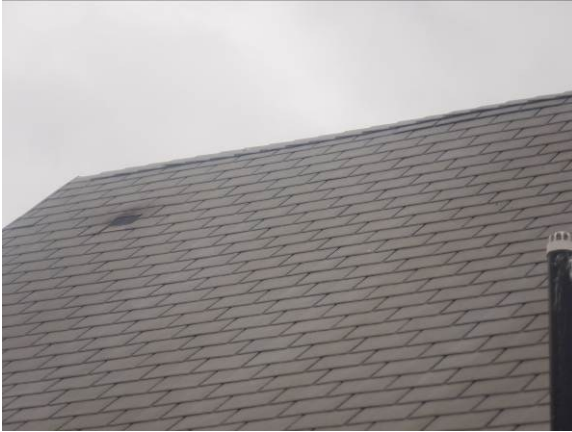
The house's roof was covered with flat overlapping slate tiles which were all in place and tight (**Photograph 3**). Six vents which were covered with a grill were present across the roof and three skylights were present on the front roof elevation (**Photograph 4**). The eaves were tightly sealed with uPVC soffits and the verges were tight to the fascia with a plastic trim (**Photographs 5 & 6**). A slight gap was visible at the eastern end between the uPVC soffit and brickwork wall (**Photograph 7; Target note 1**). Guttering was present at the base of the roof. There were no visible gaps suitable for access by bats and no evidence of bat activity was found on the exterior of the house during the survey.

*Photograph 3. Tightly fitted roof tiles (Rear elevation).*

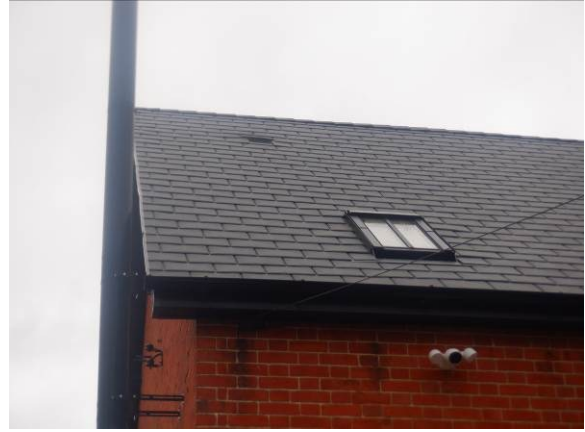
*Photograph 4. Vents and skylights on the front roof elevation.*

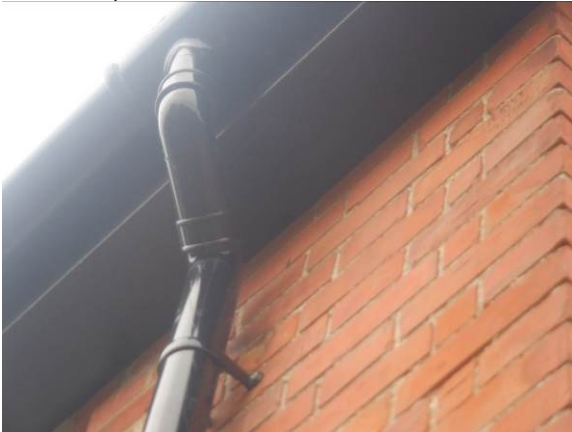
*Photograph 5. Eaves tightly sealed with uPVC soffits.*

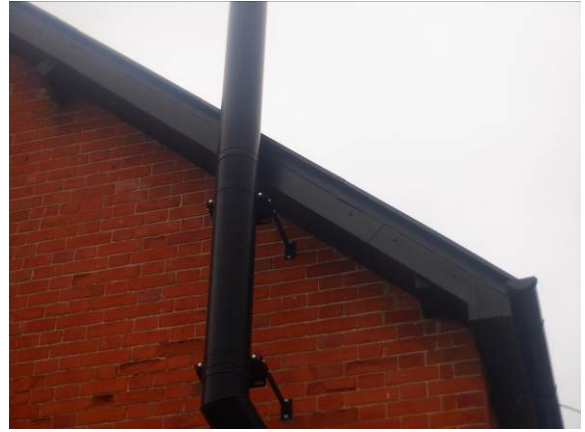
*Photograph 6. Verges tightly sealed with a plastic trim.*

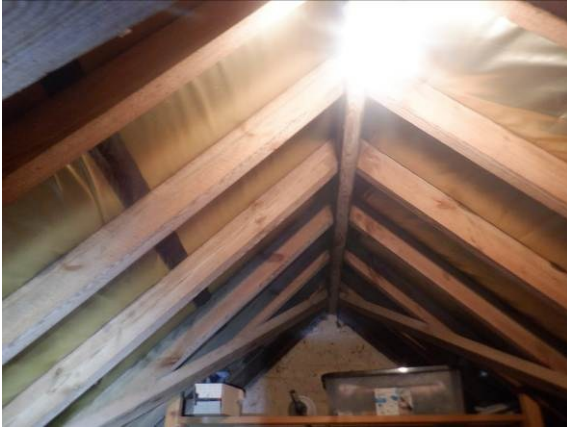
- 5.2.3** The roof void was accessible via a first floor loft hatch. The void had an approximate floor-to-ridge height of 2 m and was of 'cut and pitch' construction. The roof was lined with TLX Gold breathable roofing membrane with some patches of the older bitumen roof lining visible at the ridge which was heavily cobwebbed (**Photographs 8 & 9**). The roofing membrane was tightly fitted apart from around the ventilation pipes (**Photograph 10**).

*Photograph 8. Lined roof of cut and pitch construction with gold TLX BRM.*

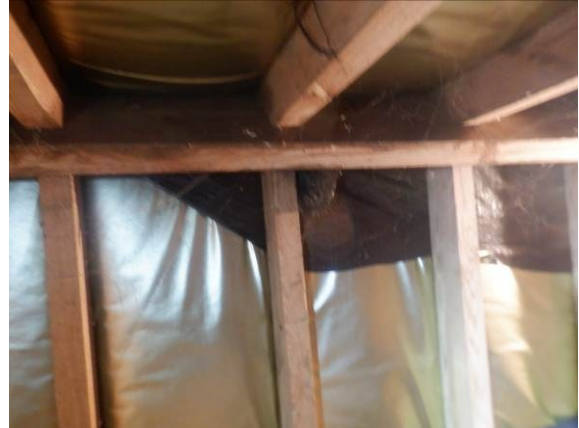
*Photograph 9. Heavily cobwebbed ridge and bitumen visible along the ridge in places.*

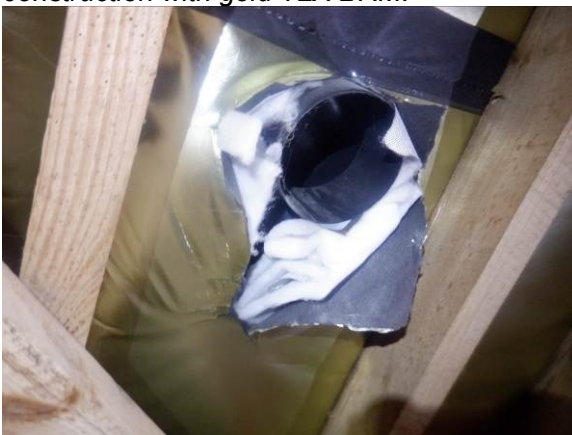
*Photograph 10. Gaps around the ventilation pipes in the roof void.*

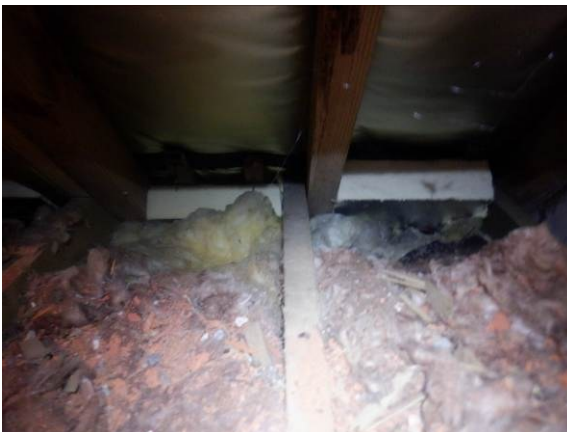
- 5.2.4** The floor was part-boarded centrally and filled with fibreglass insulation throughout. The eaves were filled with foil covered insulation boards (**Photograph 11**).

*Photograph 11. Foiled covered insulation boards filling the eaves.*

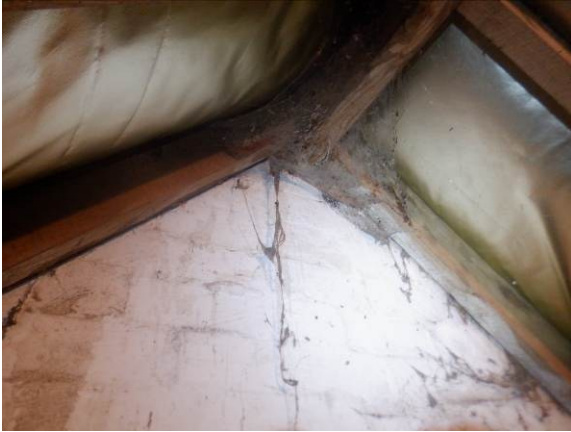
- 5.2.5** The gable ends were of brickwork construction with cobwebbed gaps present between the end rafter and the undersides of the roof tiles were visible, however no daylight was visible (**Photographs 12 & 13**).

*Photograph 12. Gable end of brickwork construction which was heavily cobwebbed.*

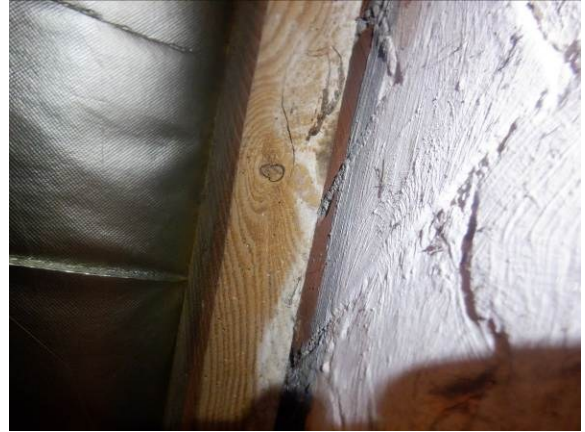
*Photograph 13. Gaps between end rafter and brickwork at gable end.*

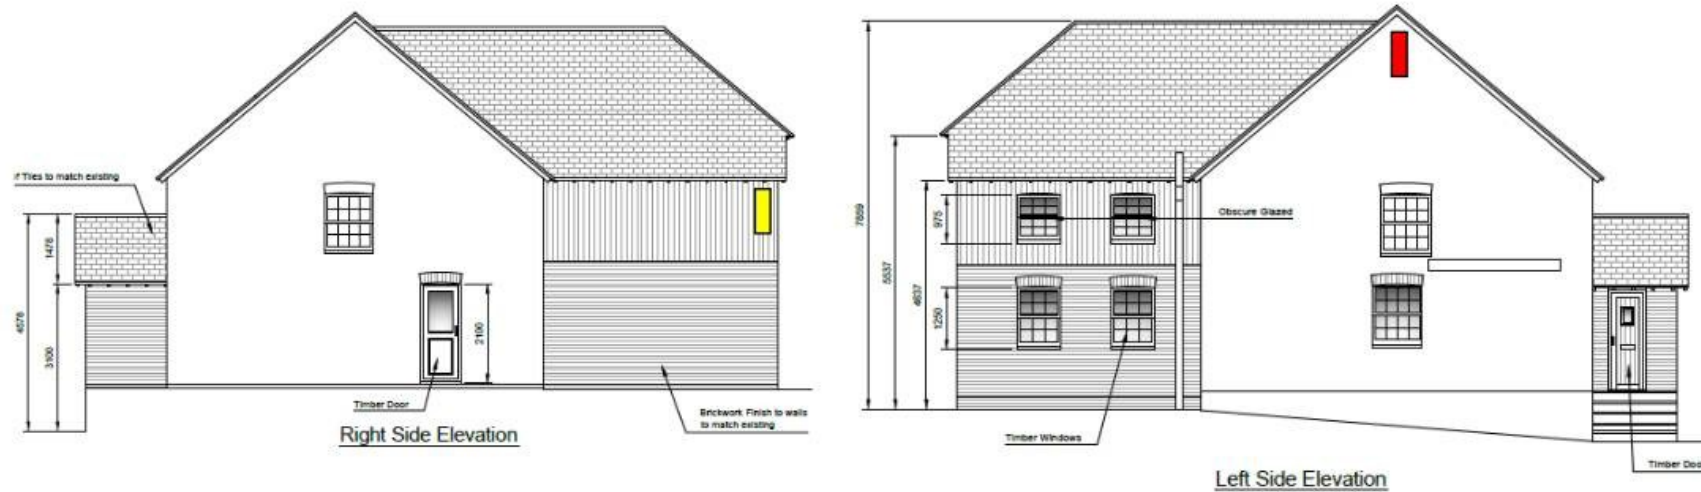
| VP | March 2026 | Not to scale | Figure 2 - New Integrated Bat Box Location Plan (side elevation) | |

Vivara Pro Build-In Bat Tube
  Beaumaris Woodstone® Wall Mounted Bat Box

- 6.3.2** The previous work to replace the roof has resulted in the loss of a common pipistrelle day roost identified during surveys in 2014, therefore to reinstate opportunities for roosting bats and enhance the house for wildlife, an integrated bat box (Vivara Pro Build-In Bat Tube) should be installed in the extension on the eastern side of the rear elevation and a wall mounted bat box should be attached to the existing western gable end wall to replicate the orientation of previously observed bat roosts as illustrated in **Figure 2** below.
