**Project:** 263 Nine Mile Ride, Finchampstead, Wokingham, RG40 3NS  
**Reference:** BWE\_PRA\_ 263RG403NS  
**Prepared by:** Myles Philip-Brinkley **Date:** 01/05/2026  
**Approved by:** Rita Smoldareva MSc  
**Subject:** Preliminary Bat Roost Assessment Report

## INTRODUCTION

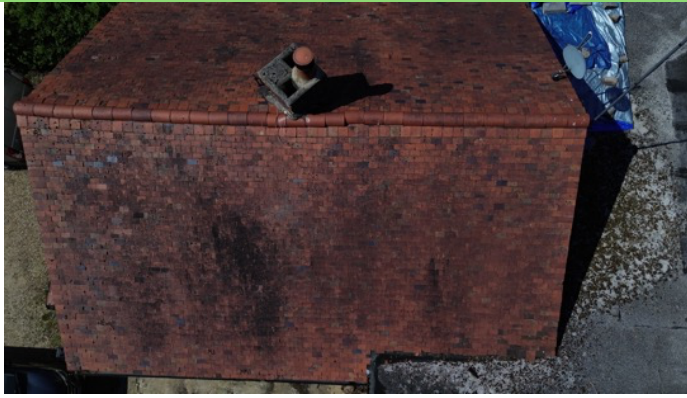
Roof overview

The coverings of the pitched roof were found to be in good condition, with no lifted, slipped or missing tiles observed. Ridge lines, verge details and roof-wall junctions appeared intact and well-sealed, with no visible gaps, lifted flashing or defects that would provide bat access.

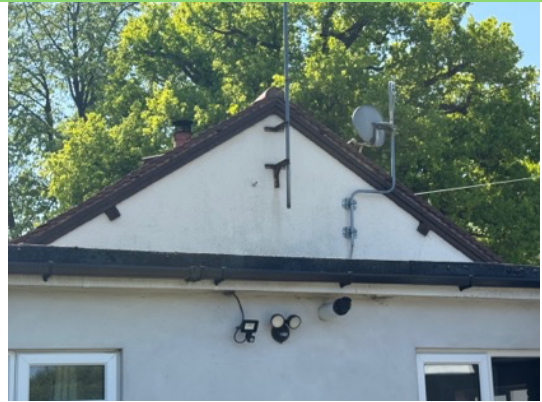
Rear elevation

Soffits, fascias and bargeboards around the property were in good condition and appeared well fitted, with no visible cracks, crevices or gaps capable of facilitating bat entry. External wall finishes and render were also in good condition, and no significant defects were identified in service penetrations, flashing or around window and door frames.

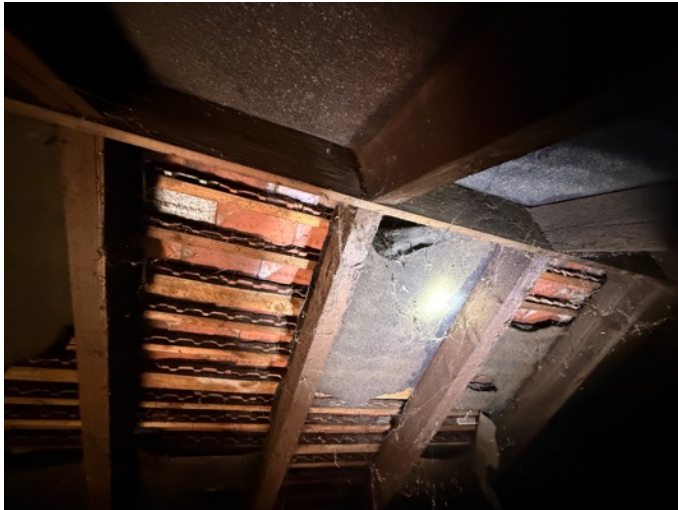
Inside the loft

The loft space comprised a conventional pitched roof structure with timber rafters and joists. Roof coverings were supported by timber battens, with roofing felt present beneath the tiles, consistent with the age and construction of the building.

The roofing felt and internal roof fabric were found to be in poor condition, with several gaps, large tears as well as loosely hanging sections which have potential to allow bat entry into the loft void from the external roof covering. Daylight ingress was also observed at the apex of the front-facing gable wall, where several large gaps were present in the brickwork. Overall, the roof structure was deemed generally poorly sealed, with several potential entry points.

As a precautionary approach, and to provide additional certainty prior to works affecting the roof structure, one evening emergence survey using Night Vision Aids (NVAs) is recommended during the active bat season.

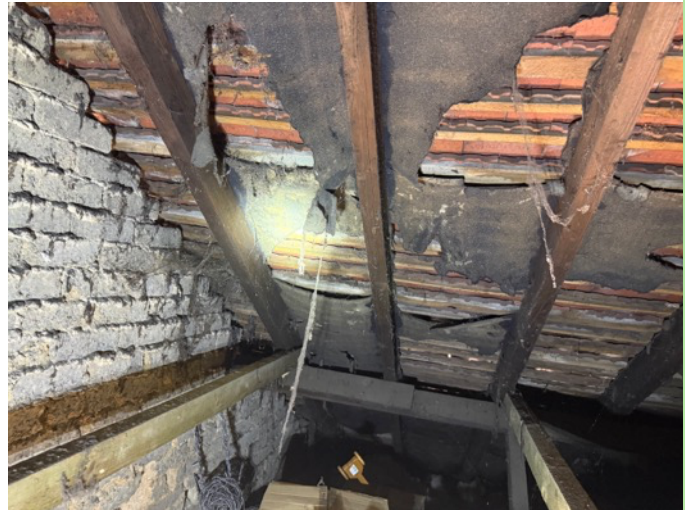
Inside loft 3

A thorough inspection of accessible areas of the loft recorded no evidence of current or historic bat use, including:

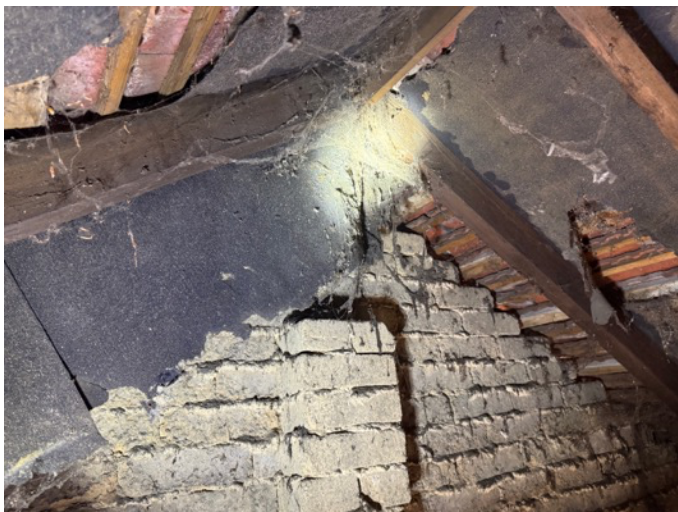
Inside loft 4

The loft space contained mineral wool insulation, with some sections found to be loose and displaced. Movement within the loft was limited due to the presence of stored personal belongings restricting access.

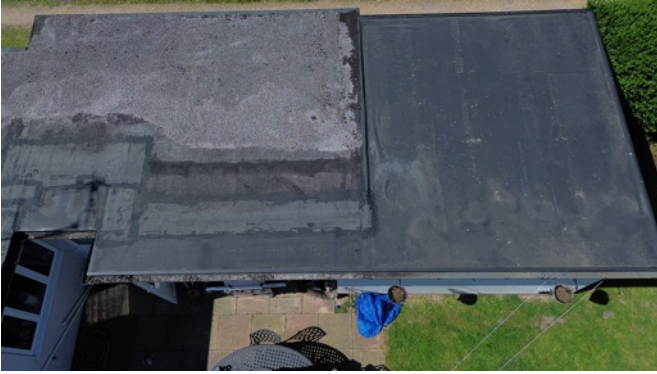
Flat roof arial view

The flat-roofed extension was in generally good condition, with only minor moss growth noted. The aerial inspection identified blue tarpaulin weighted with bricks, adjacent to the junction with the original pitched roof, indicating a localised defect; the ceiling below has been reported to be subject to leaking. This feature is not considered to provide a suitable entry point for bats, and the structure as a whole is assessed as having low potential for bat roosting.

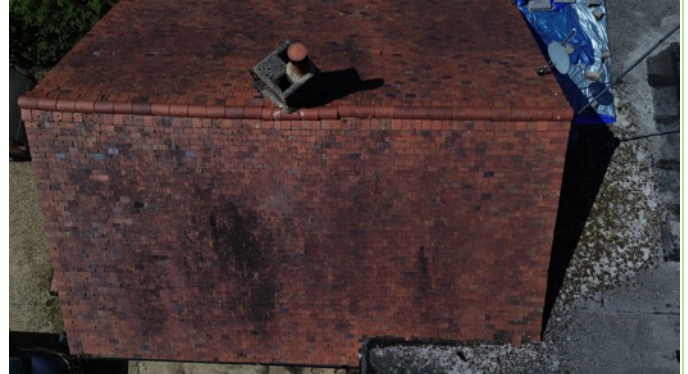
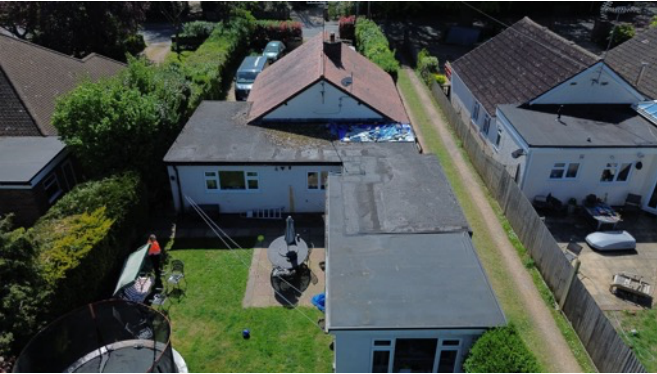
Main Dwelling roof arial view

The chimney stack was externally intact and well pointed, with no visible crevices or defects suitable for roosting identified from ground-level.
