## **PRELIMINARY ECOLOGICAL APPRAISAL (DBW) AT 8 BARHOLM CLOSE LOWER EARLEY**

**Prepared for:  
Mr C Fielding  
8 Barholm Close  
Lower Earley  
Wokingham  
RG6 3TQ**

**3 November 2024**

**Ref: SPH/NP/PEA-24/22.10**

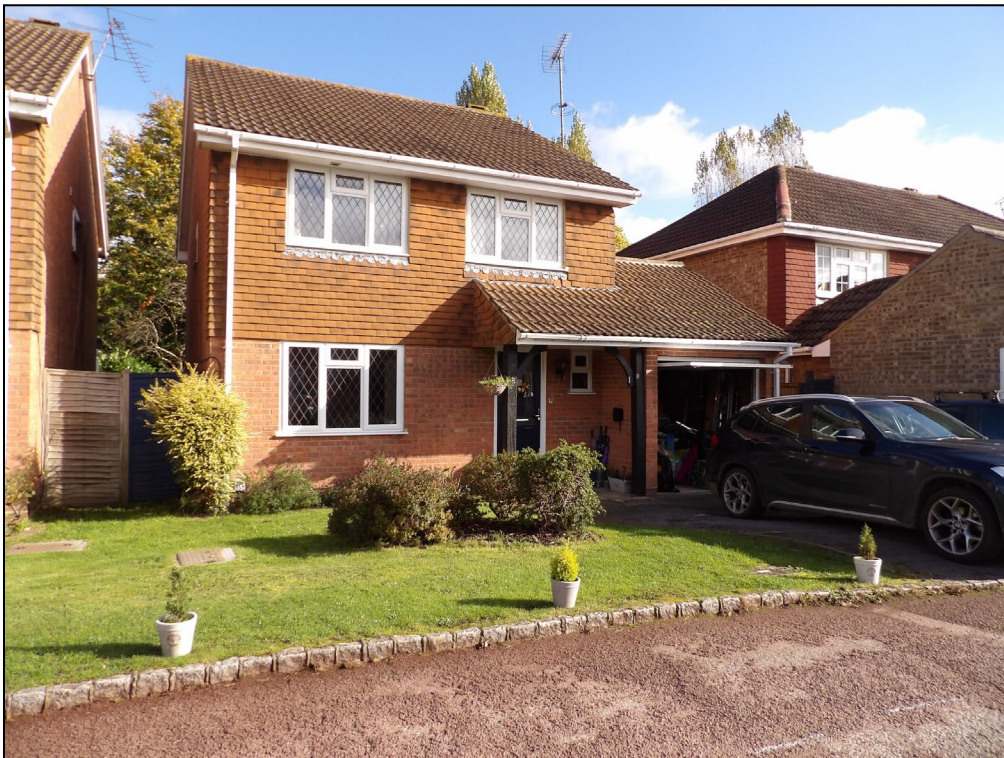
The application site comprises a detached, brick-built property with attached garage and rear home office/utility, see cover photograph. The remainder of the site comprises a driveway/parking area with lawn and shrubs, and a rear garden which is mainly laid to lawn, with patio area, some shrubs and mature trees on the rear boundary, see Figure 3 below. The site itself offers some foraging and commuting habitat for bats and there is good ecological connectivity to alternative habitat for foraging and commuting bats in the wider landscape.

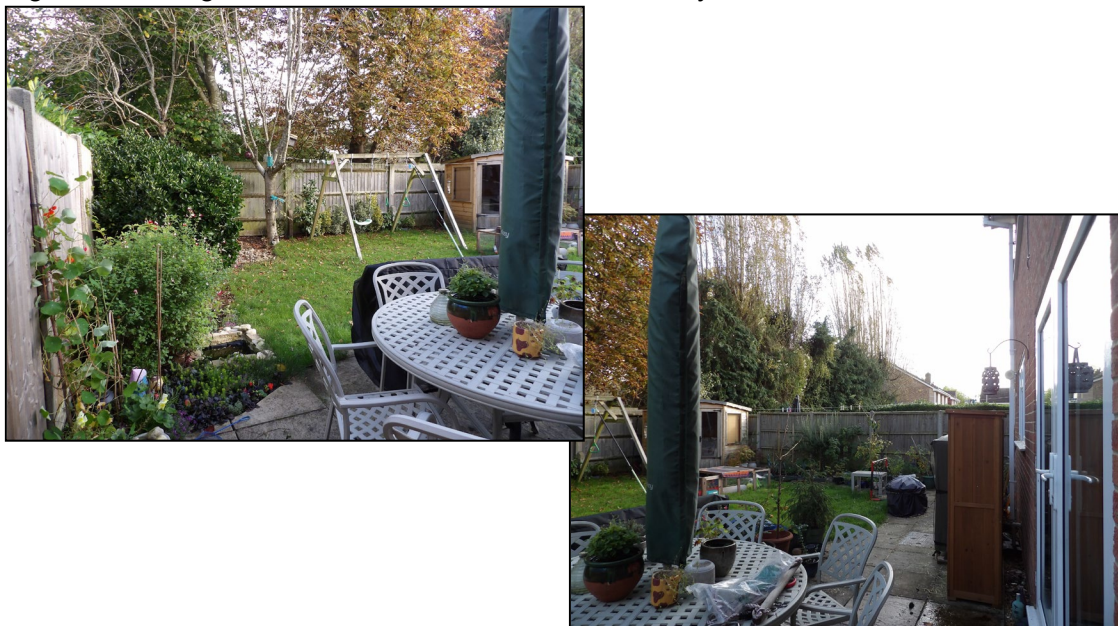
Figure 3. Rear garden. 8 Barholm Close, Lower Earley. 22.10.24

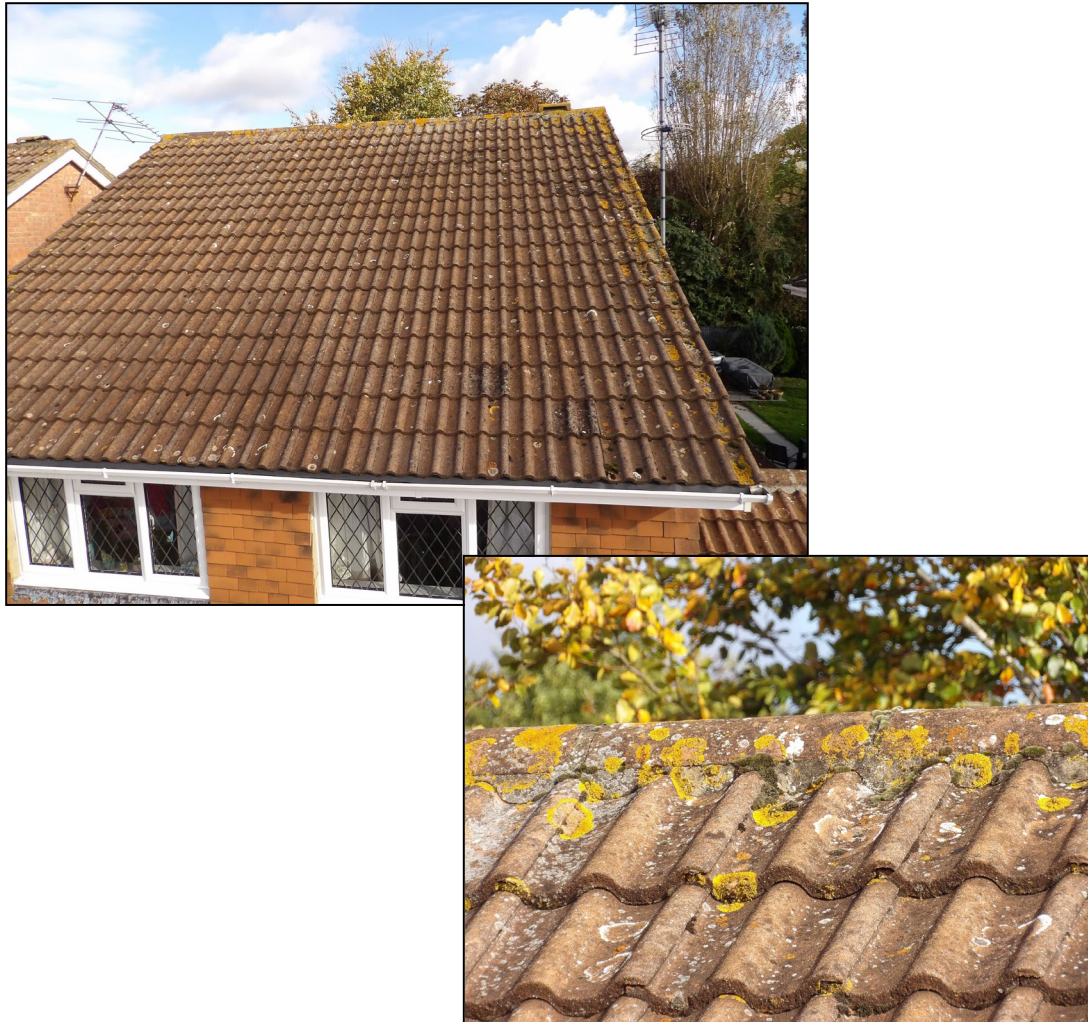
The property is a detached, brick-built 2 storey building that is in a good condition externally. The pitched roof of the property is covered in closely fitted tiles, none of which are missing or broken, see Figure 4 below. The ridge tiles are all tightly fitted and have no gaps in which roosting bats could exploit and the verges are all sealed with no missing mortar, see Figure 5 on page 9. The uPVC soffits and fascias are all tightly fitted to the walls and have no visible gaps in which bats could use for roosting, see Figure 6 on page 9. The front, first floor elevation of the property is covered in hanging tiles, the majority of which are tight with no gaps (see Figure 7 on page 10), however under the right window there are a number of slipped tiles with gaps (see Figure 8 on page 10) in which crevice dwelling bats could utilise for roosting.

Figure 4. Tightly fitted roof and ridge tiles. 8 Barholm Close, Lower Earley. 22.10.24

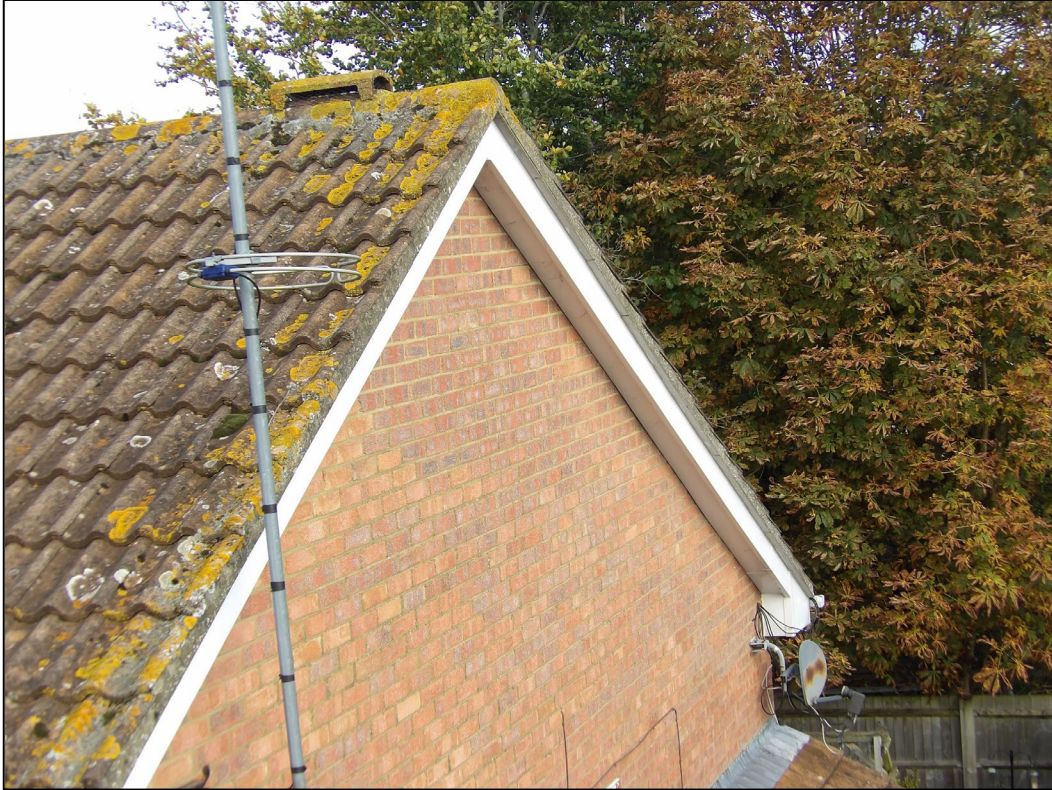
Figure 5. Example sealed verges. 8 Barholm Close, Lower Earley. 22.10.24

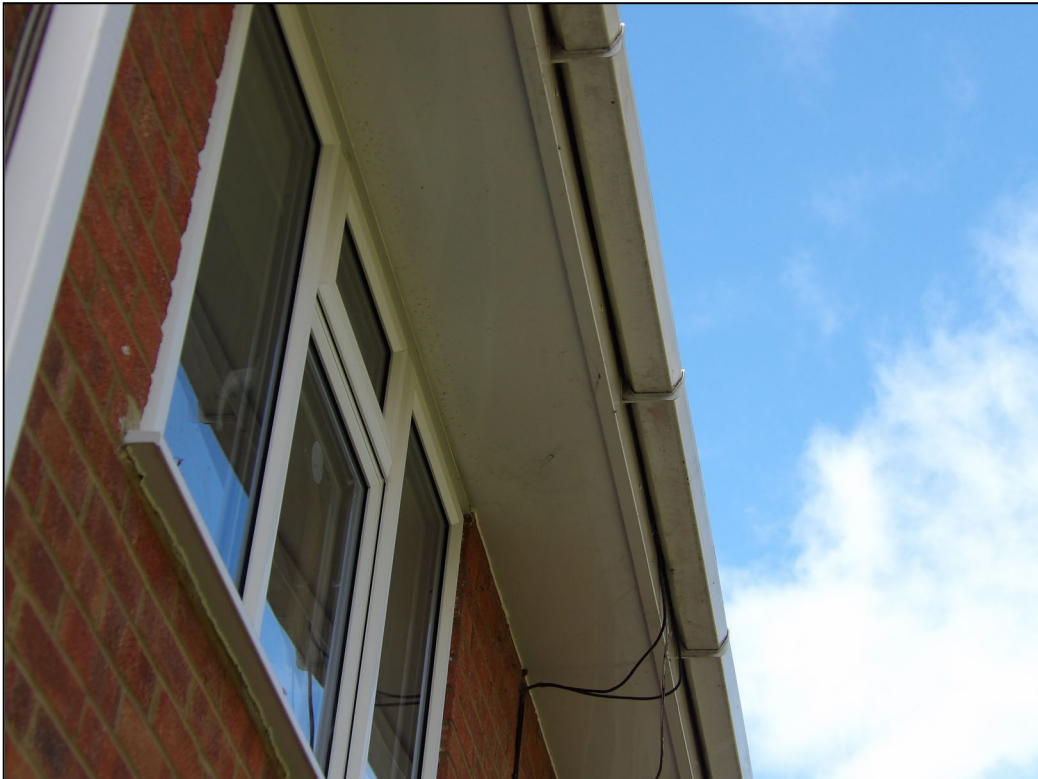
Figure 6. Example of soffits and fascias. 8 Barholm Close, Lower Earley. 22.10.24

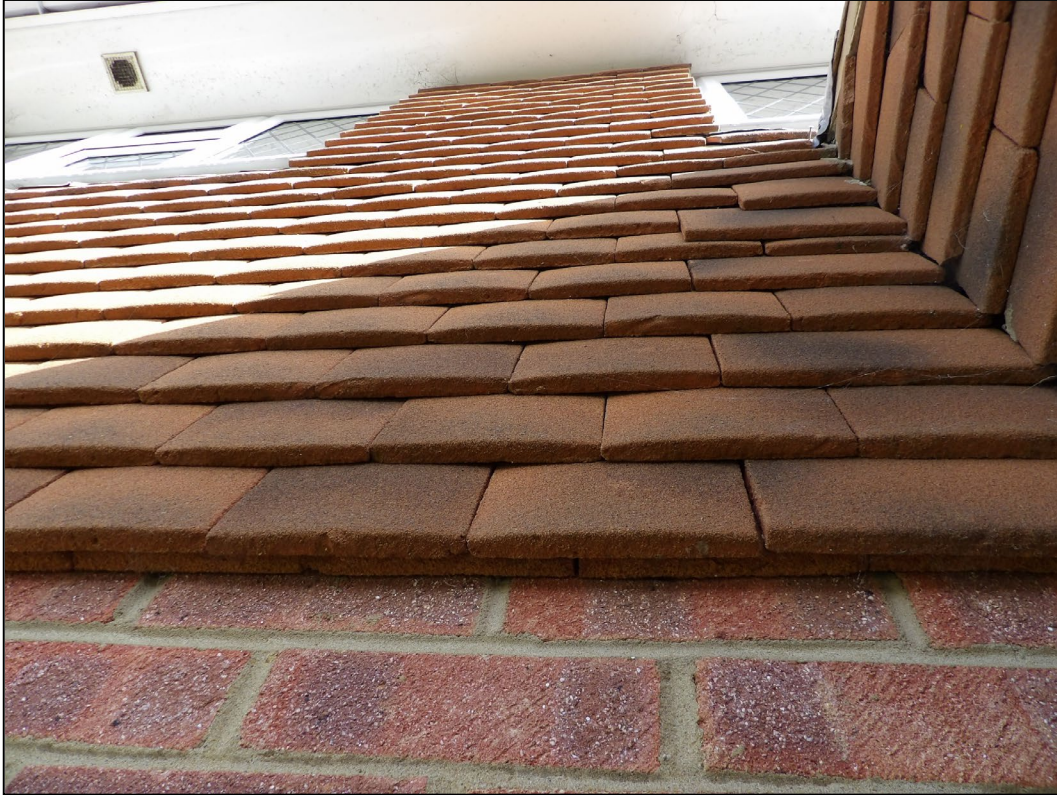
Figure 7. Example well fitted hanging tiles. 8 Barholm Close, Lower Earley. 22.10.24

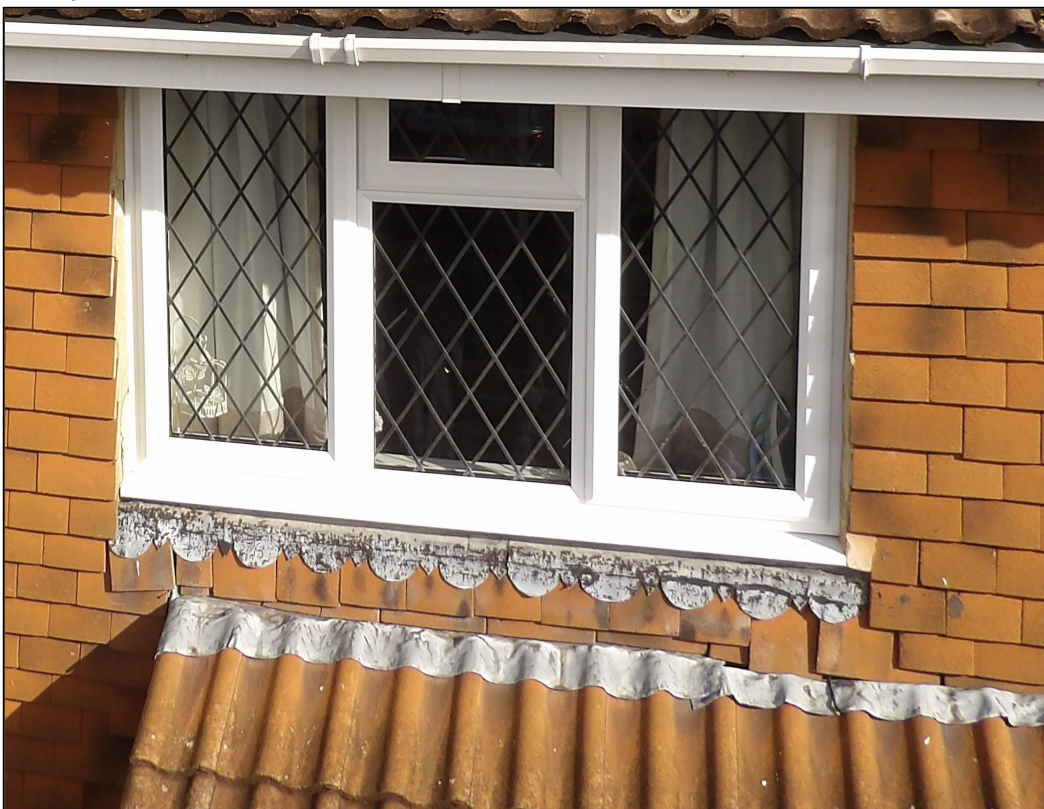
The small number of gaps in the hanging tiles on the front elevation of the property, below the front right window, could provide opportunities for crevice dwelling bats to roost however, this section of the building will not be affected by the proposals. Based on recommendations in the Bat Workers Manual and the Bat Surveys Good Practice Guidelines guidelines<sup>2</sup>, no further survey effort is required.

No bats or evidence of bats was recorded externally on the sections of the building to be affected by the proposed works. However, the gaps in the hanging tiles at the front of the property could provide potential roosting opportunities for bats externally.

Figure 8. Gaps in hanging tiles below front right window. 8 Barholm Close, Lower Earley. 22.10.24

Should the proposals change, and the area of hanging tiles below the front right window be affected by any development proposals, further survey effort will be required in order to establish the presence or absence of roosting bats.

If the proposed plans change and alterations are required to the hanging tiles below the front right window of the property further survey effort will be required.

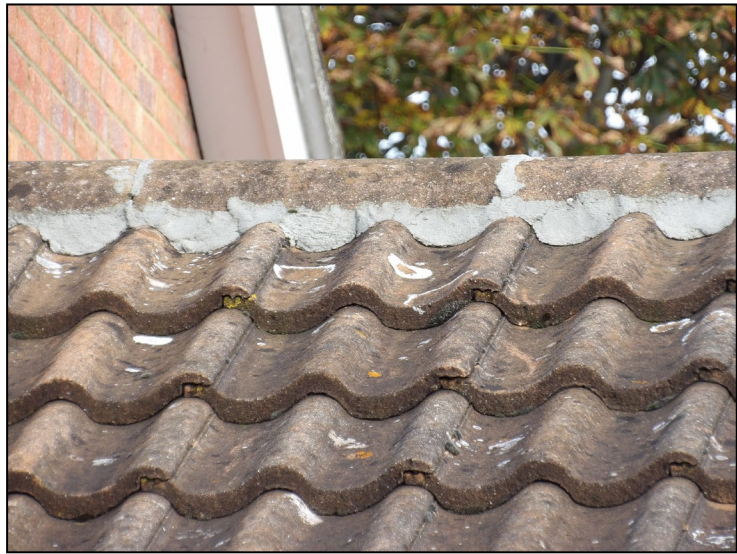
The attached garage with rear home office/utility are also brick-built and are in a good condition externally. The pitched roof above the garage and 'lean-to' style roof above the home office/utility are also covered in closely fitted tiles (see Figure 9 on page 11), and the lead flashing affixing the buildings to the main property is tight with no gaps and there is no missing mortar from the verges, see Figure 10 on page 11. The soffits and fascias around the home office/utility are tightly fitted to the walls with no gaps which could be used by bats to roost, see Figure 11 on page 11.

Figure 9. Sealed roof and ridge tiles above garage. 8 Barholm Close, Lower Earley. 22.10.24

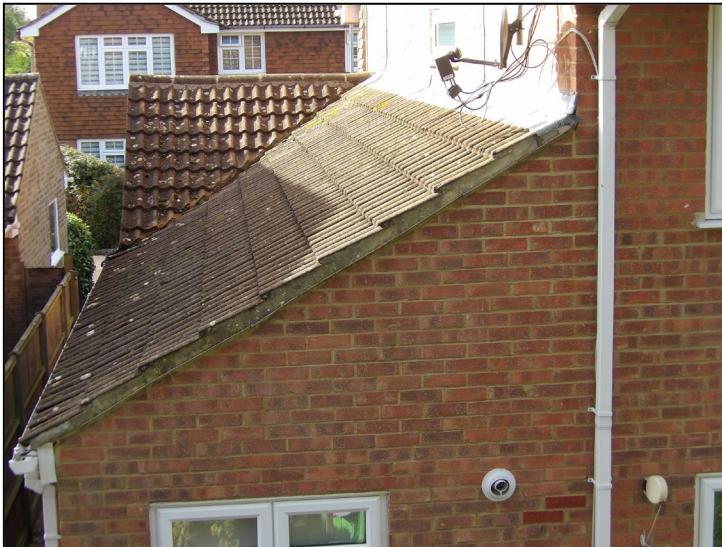
Figure 10. Roof tiles/verges and sealed lead flashing of rear home office/utility. 8 Barholm Close, Lower Earley. 22.10.24

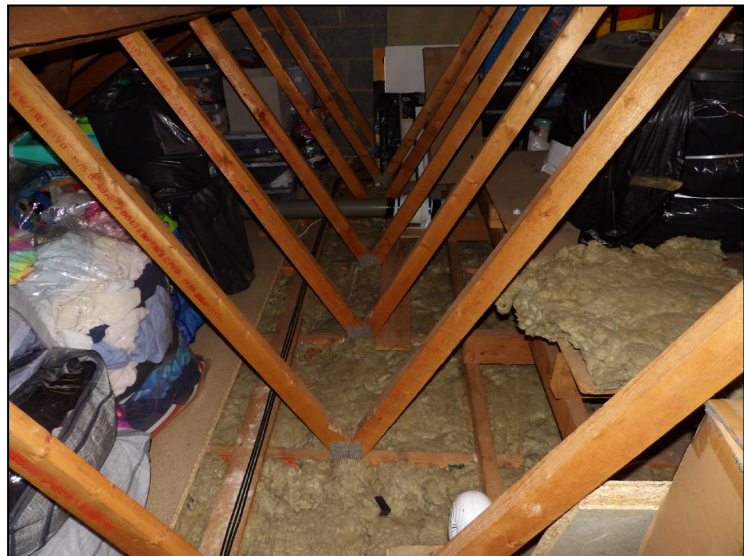
The loft was accessed through a hatch via a ladder and is in a good condition internally. The loft is used for storage, lit, partially boarded and insulated, see Figure 12 below. The roof tiles are lined with bitumen felt, none of which is ripped or torn and there are no bat roosting features internally, see Figure 13 below.

Figure 12. Example loft space. 8 Barholm Close, Lower Earley. 22.10.24

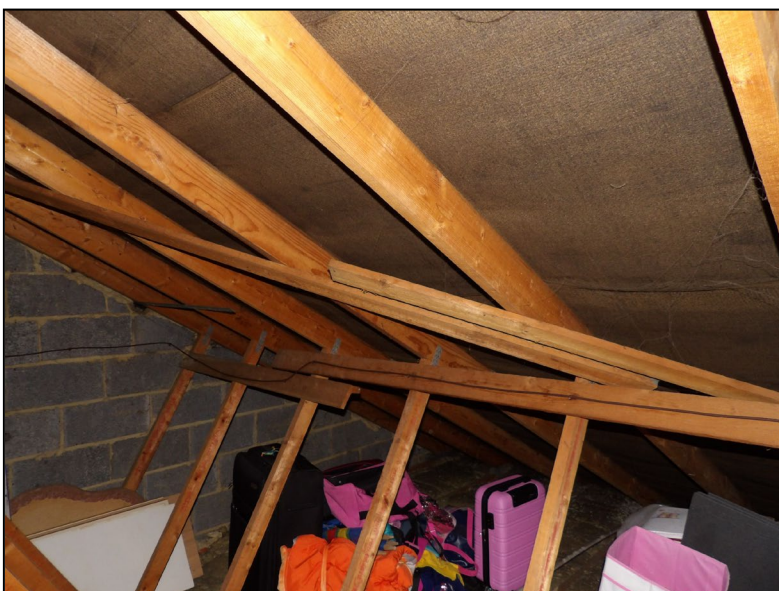
Figure 13. Example bitumen lining in loft. 8 Barholm Close, Lower Earley. 22.10.24

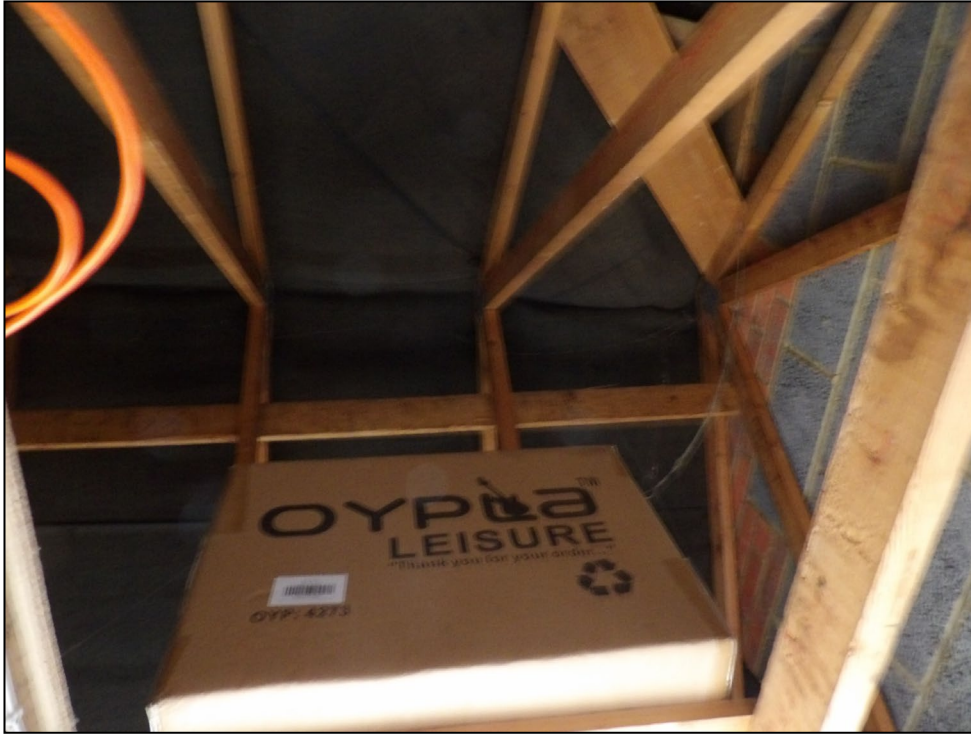
The attached garage and home office/utility were also inspected internally. The garage is used for storage, is cluttered but in a good condition. The ceiling is open to the rafters and the tiles are lined with bitumen felt, all of which is in a good condition, see Figure 14 on page 13. The ceiling above the home office/utility is boarded and had no cracks or splits in which roosting bats could exploit, see Figure 15 on page 13

Figure 14. Example of bitumen lining in pitched roof over garage. 8 Barholm Close, Lower Earley. 22.10.24

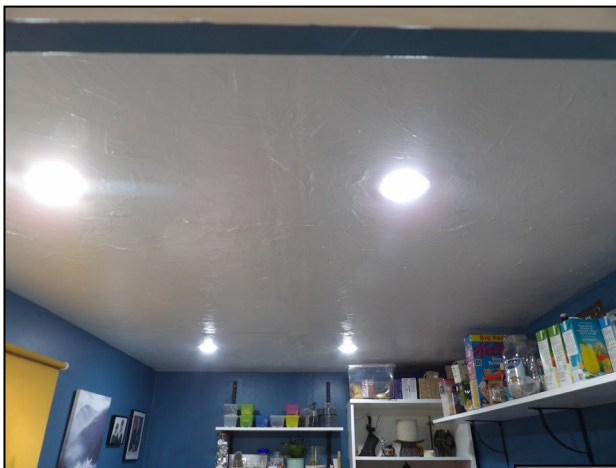
Figure 15. Boarded ceiling of home office/utility. 8 Barholm Close, Lower Earley. 22.10.24
