# Preliminary Ecological Appraisal & Roost Assessment

Little Ashridge, Forest Road, Wokingham, Berkshire, RG405RB

This report is prepared to inform a planning application with Wokingham Borough Council. Single storey and first floor extensions, revisions to fenestration including new Juliet balcony and associated driveway.

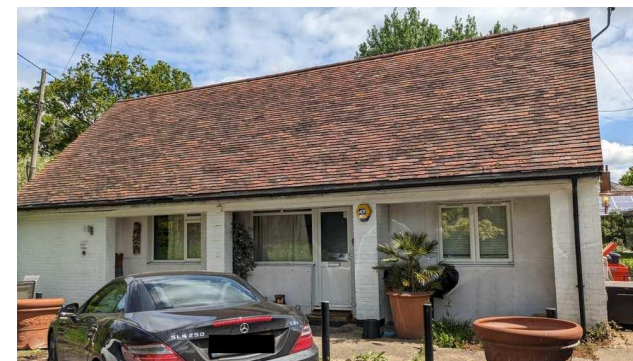
Building B1

The building is a residential dwelling with a clay tile roof and wooden soffits. The clay tiles, despite being in good condition, present numerous gaps suitable for crevice roosting bats, and damaged soffit box on the western elevation offers potential access points into the eaves and possibly further into the structure. While the internal void, recently re-roofed and insulated, showed no visible evidence of bats from the loft entrance, this does not preclude their presence, as access opportunities may exist and evidence can be subtle. Due to the presence of suitable foraging and commuting habitats in the local environment along with the multiple roosting opportunities with the building, the building is considered to have ***moderate habitat value***.

Two bat emergence/re-entry surveys are required on B1 and one bat emergence/re-entry survey is required on B2 during the active bat season (May – September) to confirm presence/likely-absence of bats roosting in or on the buildings.

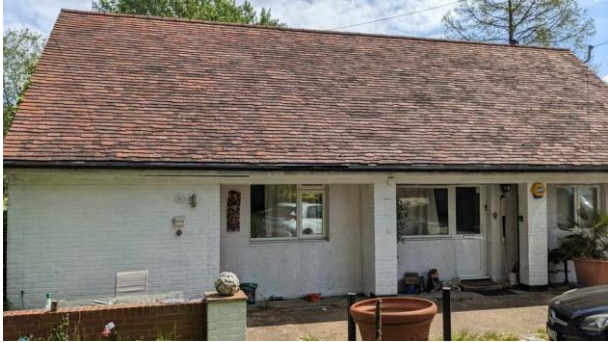
| Roof | Clay tiles | <p><b>Condition/description</b><br/>The roof is in good condition with no missing tiles or visible damage.</p> <p><b>Suitability/access/evidence of bats</b><br/>Due to the shape of the clay tiles, there are numerous gaps providing potential access for bats. This is suitable for crevice roosting bats which may roost between the external tiles and internal lining.</p> | <p><i>View of the western roof elevation.</i></p> |

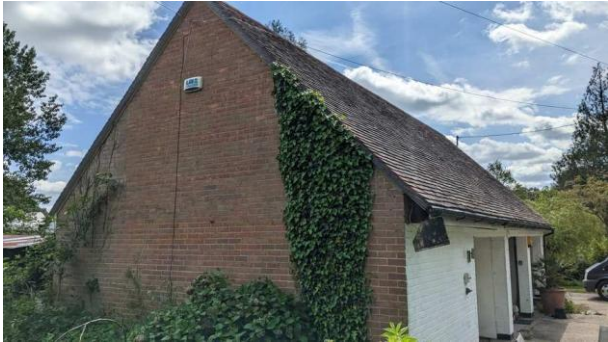
| Eaves | Timber board | <p><b>Condition/description</b><br/>The soffit boxes show damage with a lifted board on the underside of the western elevation and a missing end on the northwestern corner.</p> <p><b>Suitability/access/evidence of bats</b><br/>The gaps in the soffit may provide access for bats which may roost within the soffit of this may provide access into other internal structures which may be used by roosting bats within the eaves.</p> | <p><i>View of missing end of soffit on the northwestern corner of B1.</i></p> |

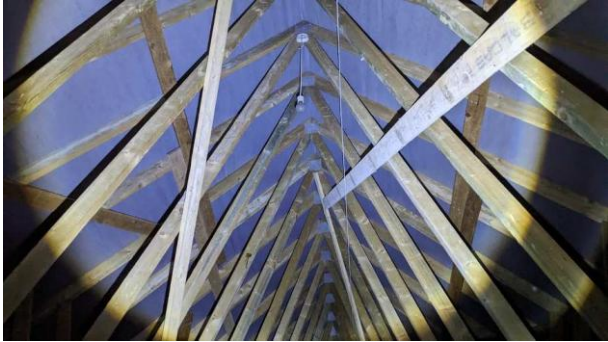
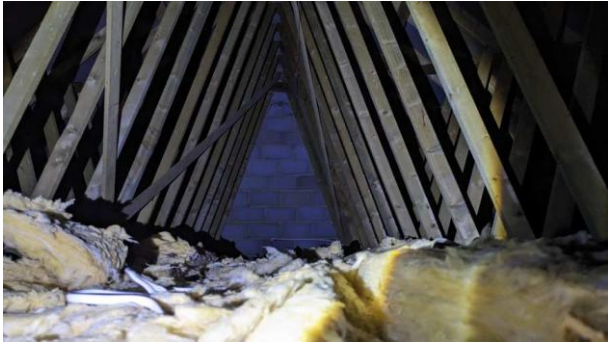
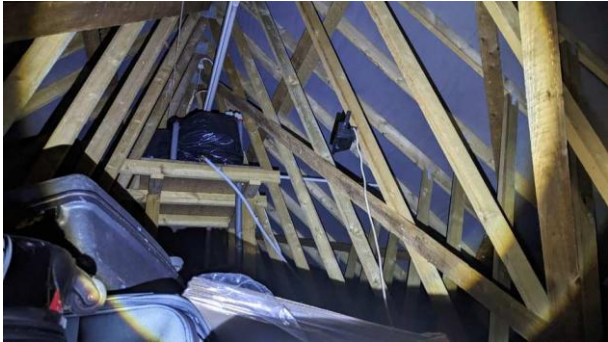
| <p>Internal void 1</p> | <p>Timber rafters.<br/>Fiberglass insulation</p> | <p><b>Condition/description</b></p> <p>The client advised that the building has recently been re-roofed approximately 8 months prior. The internal insulation was retained and showed no visible evidence of bats from the loft entrance. As a result, the internal roof lining is in immaculate condition with no signs of tears or damage. Dimensions (approx): 13m long, 7m wide, 2.5m tall</p> <p><b>Suitability/access/evidence of bats</b></p> <p>There were no visible access opportunities or evidence of bats visible from the entrance to the loft. However, the loft was not fully inspected due to the requirement for a taller ladder and evidence may have been missed. This is not considered to be a significant limitation due to the requirement for further surveys and the fact that evidence of bats is often not visible even where bats are present.</p> | <p><i>View of the internal ridge.</i></p> <p><i>View of the internal gable wall.</i></p> <p><i>View of timber rafters and internal lining.</i></p> |

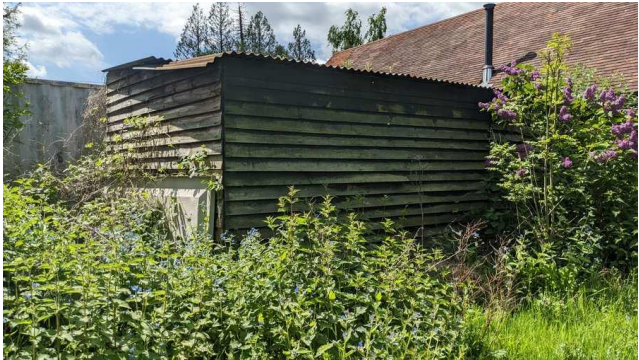
North and eastern elevations of B2.

The building is a timber-clad shed with a single-skinned corrugated metal roof. While the timber walls offer minimal overlap and the metal roof is single-skinned, some limited roosting opportunities for crevice-roosting bats may exist within small gaps beneath the external cladding and at the junctions where the walls meet the roof, as well as where the corrugated sheets overlap. The building therefore is considered to have **low habitat value**.

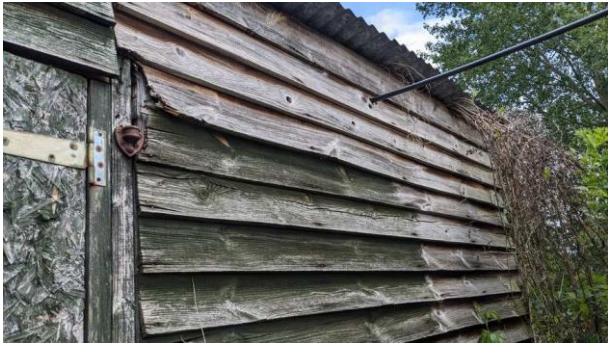
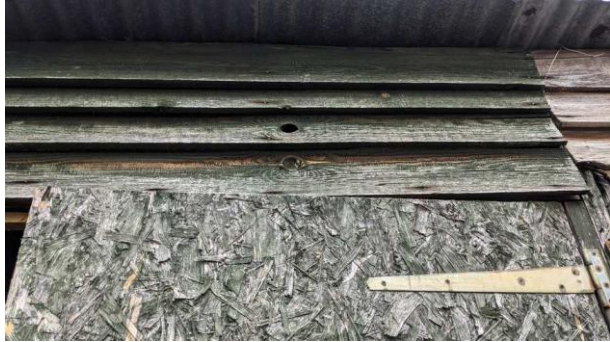
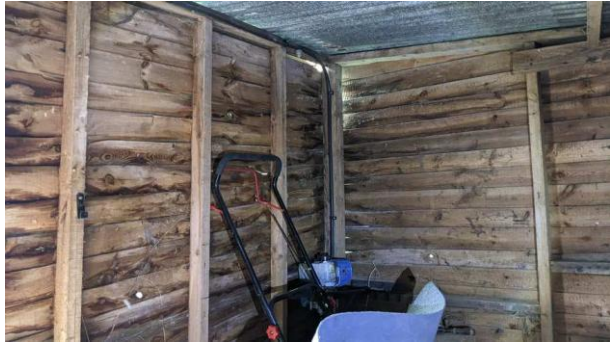
| Feature | Materials/Details | Condition / description / suitability | Photograph |
|---|---|---|---|
| Walls | Timber clad | <p><b>Condition/description</b></p> <p>The wooden clad walls are single skinned with minimal overlap and therefore provide no opportunities for roosting bats.</p> <p><b>Suitability/access/evidence of bats</b></p> <p>There are limited roosting opportunities for bats with the only potential roosting features being small gaps beneath the external cladding and internal joists which may provide minimal opportunities for crevice roosting bats.</p> | <p>B2 walls</p> |

| | | | <p><i>B2 walls</i></p> <p><i>B2 walls</i></p> |

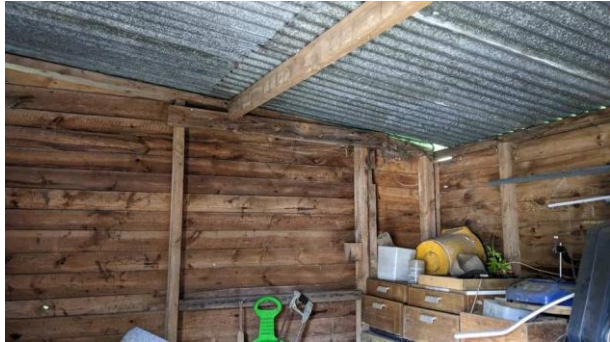
| Roof | Metal sheeting | <p><b>Condition/description</b><br/>B2 is a shed/workshop which shows evidence of weathering and as a result is in a state of disrepair. The roof is corrugated metal which is also single skinned and of suboptimal value for bats due to the absence of thermoregulation.</p> <p><b>Suitability/access/evidence of bats</b><br/>There are limited roosting opportunities for</p> | <p><i>B2 roof</i></p> |

| | | bats with the only potential roosting features being where the walls meet the roof and where the corrugated metal sheets overlap. | |

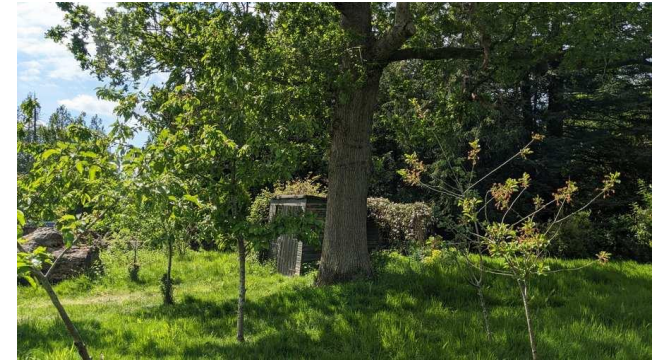
*Scattered trees; T1*

T1 is a common oak located at SU 81454 67345. The tree has a DBH of >60cm.

If any trees are to be removed during the proposed development, a ground level tree assessment (GLTA) will be required prior to removal.

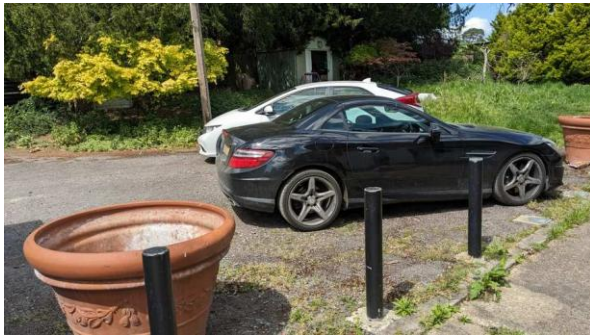
There is a gravel access track to the property along with a parking area to the west of the dwelling large enough for two cars.

*Artificial unvegetated, unsealed surface parking area.*

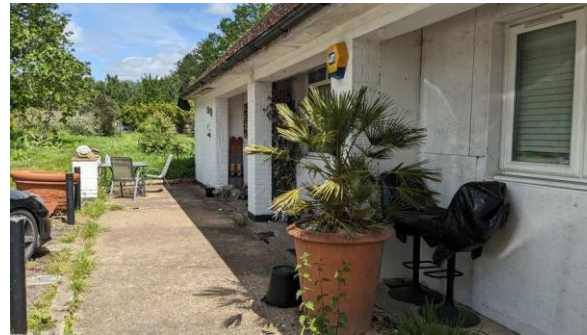
There is a concrete access path around the west, south and east of the dwelling providing connectivity to the storage buildings to the east.

*Developed land; sealed surface to the front of the dwelling.*

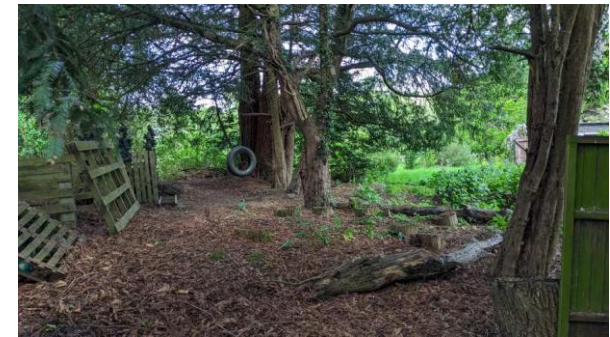
*Scattered trees; group 1*

| Tree / Group | Common Name | Condition Score |
|---|---|---|
| Group 1 | Common Yew x9 | Good |

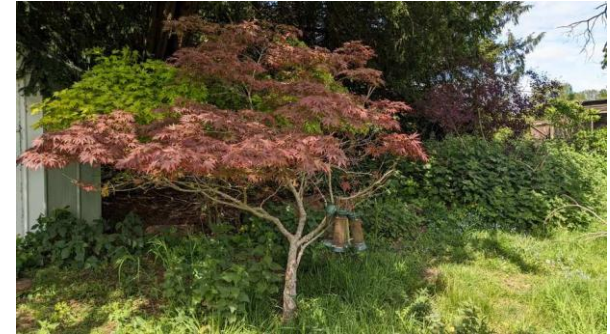
*Scattered trees; group 2*

| Tree / Group | Common Name | Condition Score |
|---|---|---|
| Group 2 | Japanese Maple x2 | Moderate |

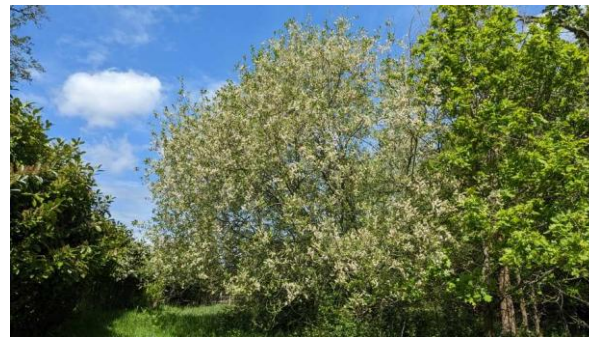
*Scattered trees; group 4*

| Tree / Group | Common Name | Condition Score |
|---|---|---|
| Group 4 | Pussy Willow x3 | Moderate |

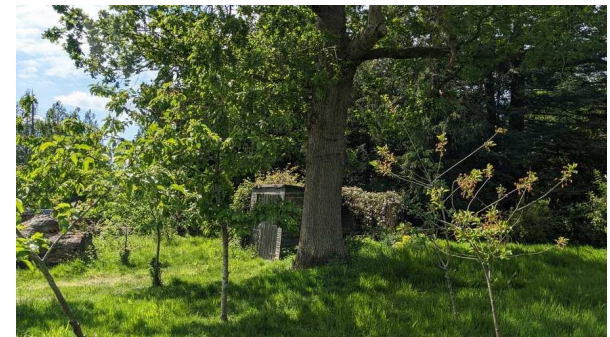
*Scattered trees; T1*

| Tree / Group | Common Name | Condition Score |
|---|---|---|
| T1 | Common Oak | Good |
