Loddon Garden Village - South

DESIGN RESPONSE

Prepared by:	Chris Shaw
Authorised by:	Leigh Abley
Date:	08 July 2025
Document Reference:	A392 – R066 LGV South RSA 2 Designers Response

Road Safety Audit – Loddon Garden Village South

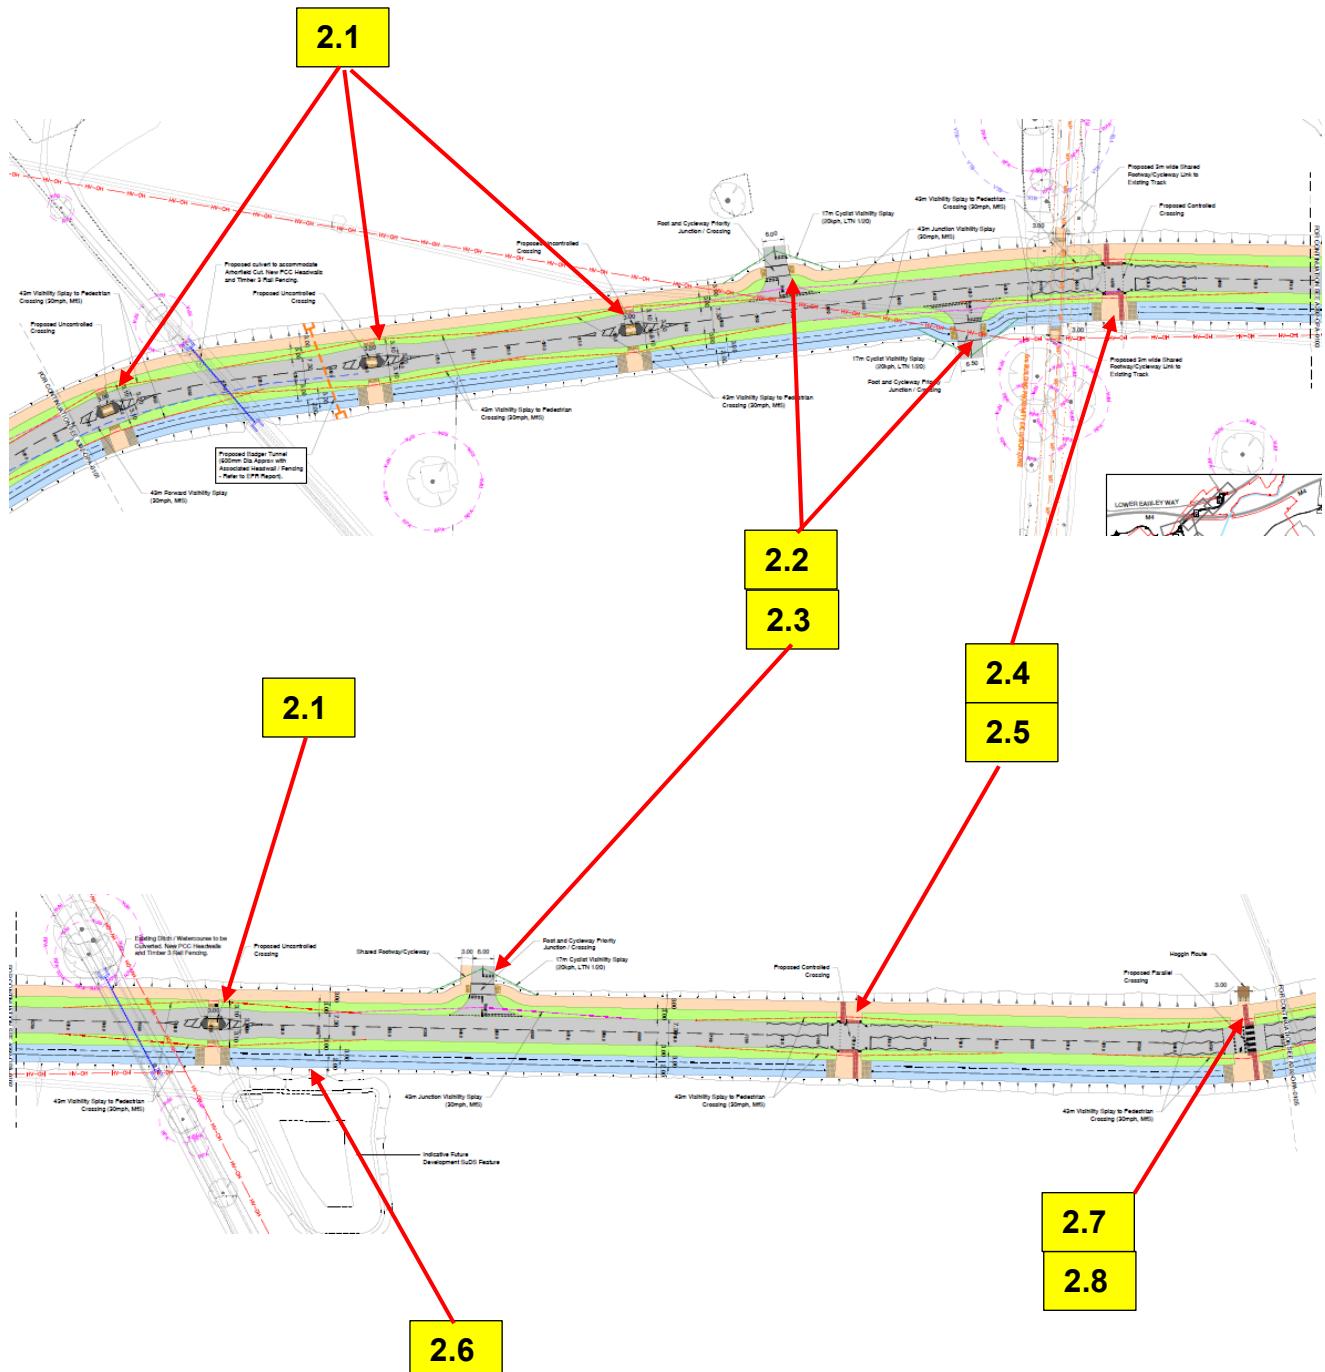
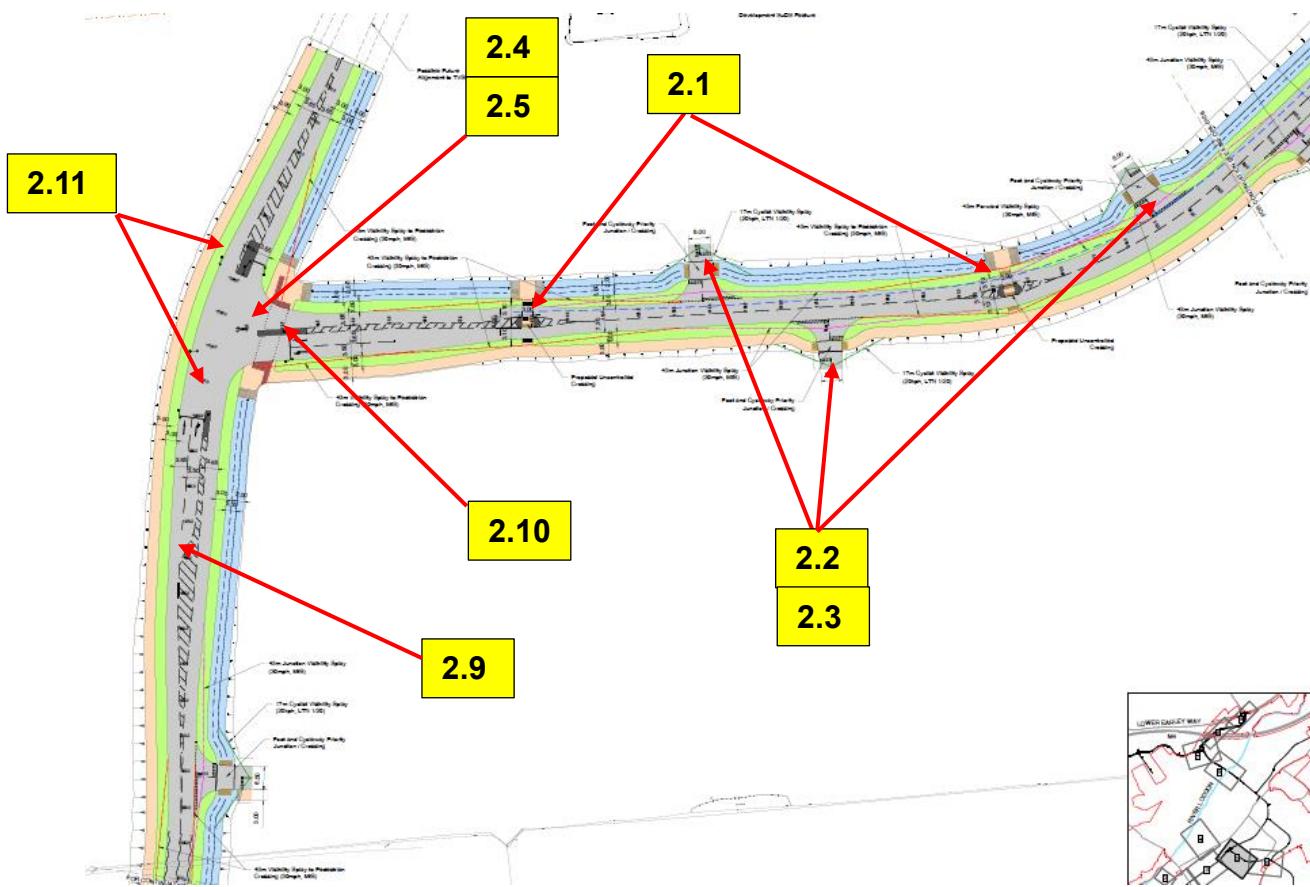
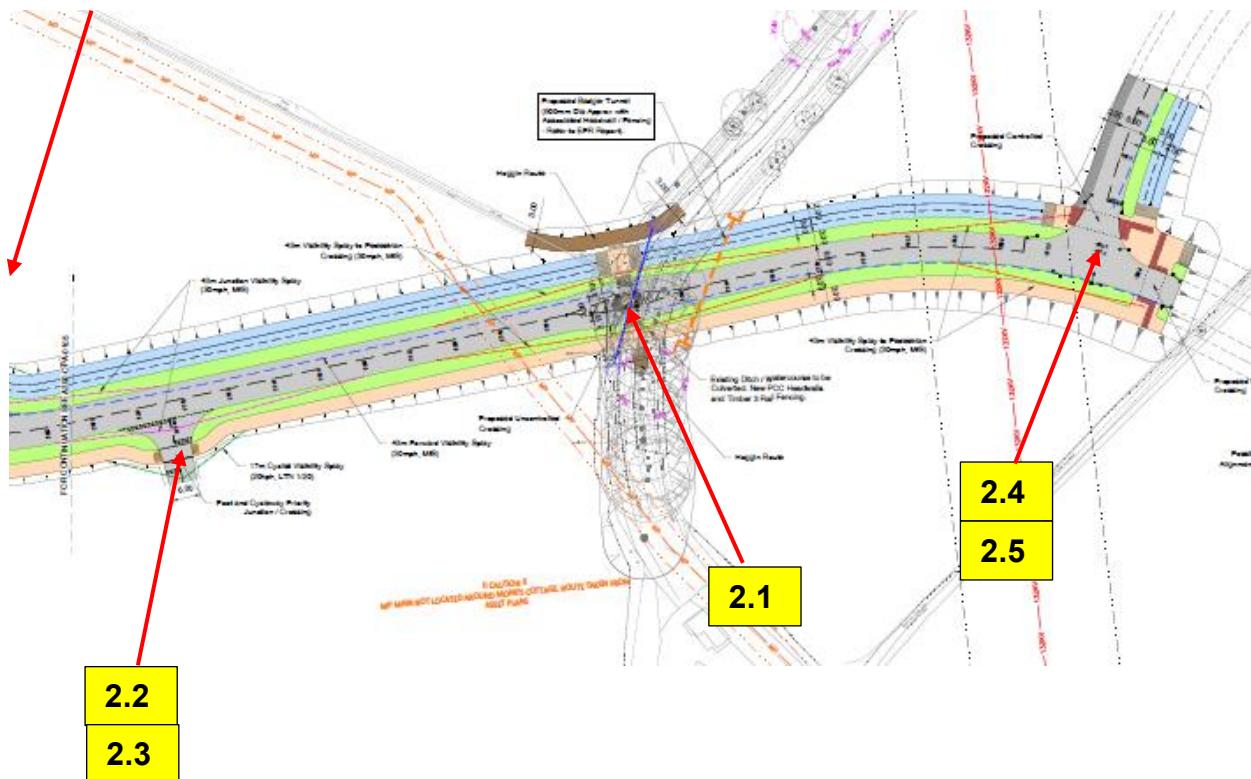
Appendix B: Key Plans showing Audit Problems

2. Safety Issues Raised in this Stage 2 Road Safety Audit. (see Appendix B for locations)
