# OCC0147 Henley Bridge – North East Parapet Wall

## Heritage Statement Addendum

Doc. Ref. 1270070-MGT-SBR-147-RP-CB-001

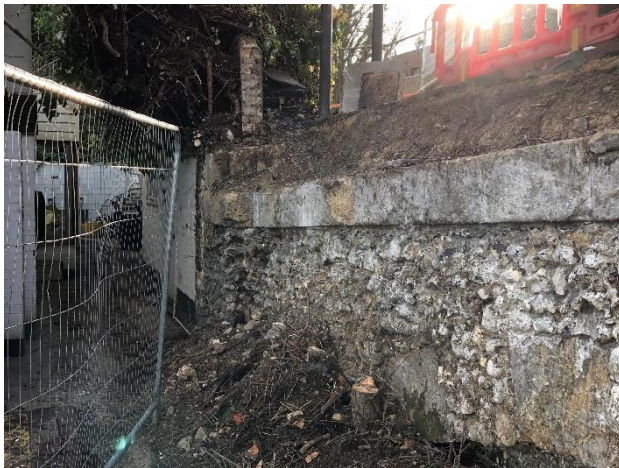
**Photo 1: View looking South-East - Exposed flint face retaining wall**

The vegetation removal revealed the full extents of the retaining wall formed of Flint construction below the parapet, with what is thought to be a former arch position denoted with alternating flint and ashlar faced voussoir stones. The Design, Access and Heritage Statement produced by Atkinsrealis in June 2024 suggests that the flint may date back to 12<sup>th</sup> century and be part of the original bridge structure (see photo 1 & 2 below showing the exposed retaining wall showing the position of a former arch and the flint work construction). Unfortunately, the stone parapet wall on top of the flint retaining wall was found to be in poor condition due to the significant Ivy root growth having up lifted it at its base and causing some localised structural cracking. The parapet was found to be leaning backwards towards Toll Gate House and was deemed to be causing a significant health and safety risk to the ongoing adjacent private building works. OCC / M Group communicated the situation immediately to both Wokingham Borough Development Control and South Oxfordshire Conservation Teams to advise that an urgent make safe operation was required, and that the parapet wall was to be carefully taken down, with the existing stones taken to Northampton Stone (sub-subcontractor for main Bridge repair works) mason's yard for safekeeping.

- i) Undertake the reconstruction of the North-East parapet wall and upper stringcourse using the existing retained stones (wherever possible) following preparation, and in accordance with the original recorded geometry (matching the adjacent parapet wall to the South-East).
- ii) Complete localised plastic repairs in lime mortar and with stainless steel 10mm diameter pins where required to the lower parapet stone stringcourse that remains in-situ.

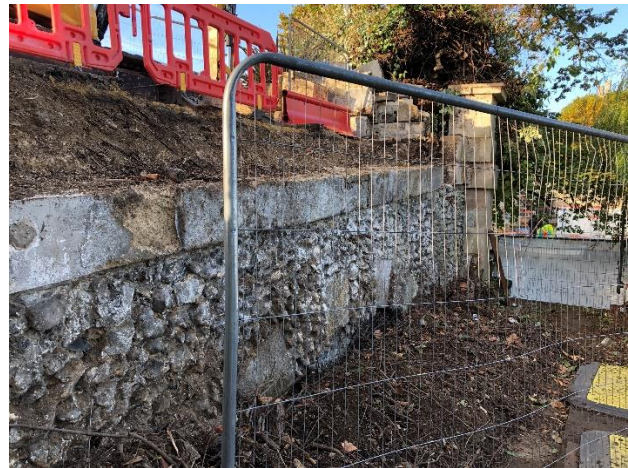
**Photo 2: View looking North-West - Exposed flint face retaining wall**
