## **Preliminary Roost Assessment**

**Ridge Corner, Jubilee Road, Finchampstead, Wokingham, RG40  
3RU**

Survey conducted 26<sup>th</sup> February 2026

**Report Title:** Preliminary Roost Assessment

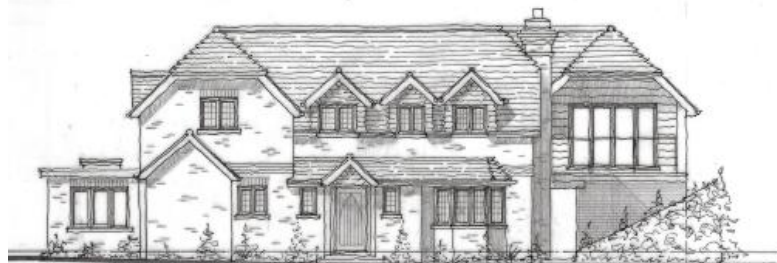
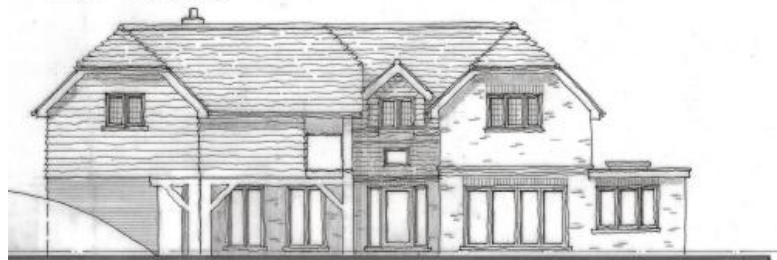
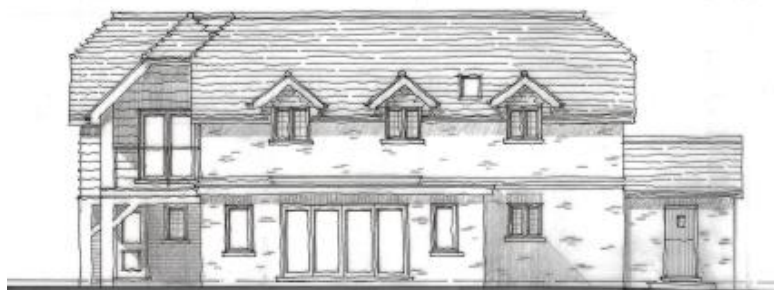
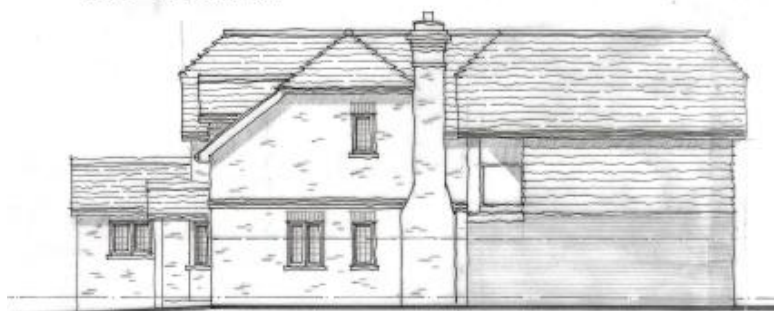
## APPENDIX 2: Proposed Elevations

The proposed works seek to add a double-storey extension onto the rear elevation.

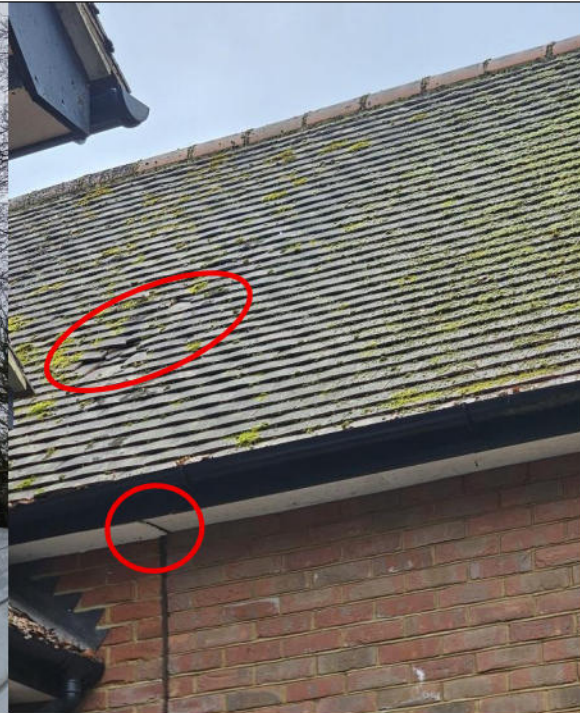
The building was carefully inspected, and the potential features were examined in the accessible spaces using an endoscope and torch with a ladder for accessing higher areas. The building has some notable features for bats such as the gaps under the roof tiles and the warped wooden soffits. In addition, approximately fifty bat droppings, which look to be consistent in shape and size to brown long eared bat droppings, were found inside the loft space. A sample of these droppings has been taken and sent for DNA testing and the results will be added to this report once they are received.

Photograph 6: Gaps under roof tiles and wooden soffits.

Two activity surveys each with three surveyors are recommended to inform if bats are using the buildings features as roosts during the active season. Surveys are recommended during optimal weather conditions and must be spaced a minimum of three weeks apart. Surveys are required to take place between May and August.

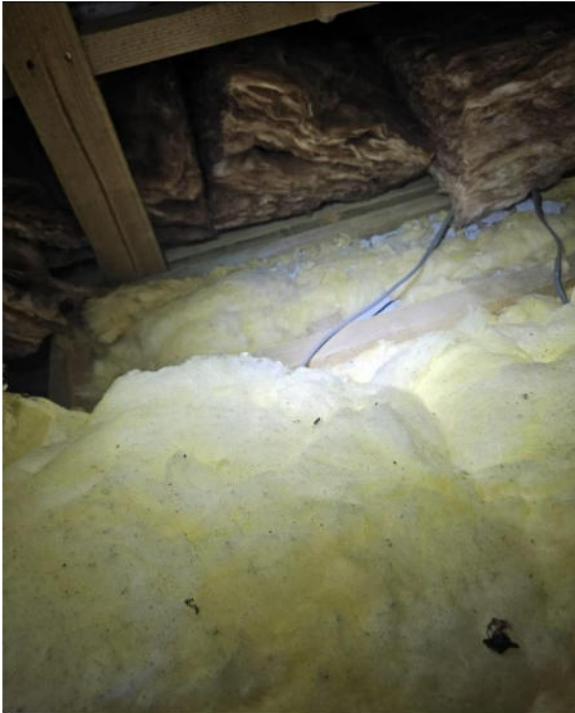
However, since considerable repair work has been undertaken on the roof prior to the current owner's occupation, and the bat droppings appear to be degraded, the building has been deemed to have moderate potential to establish if the roost is an old one that can no longer be accessed by bats due to the newer roof.

Photograph 9: approximately 50 bat droppings found in the loft space.

If any bats are found to be roosting and will be affected by the planned works, it may be necessary to apply for a European Protected Species Licence (EPS) with Natural England (NE). A bat mitigation plan would also be designed from the survey results to minimise disturbance and reinstate bat roosting areas and access points.

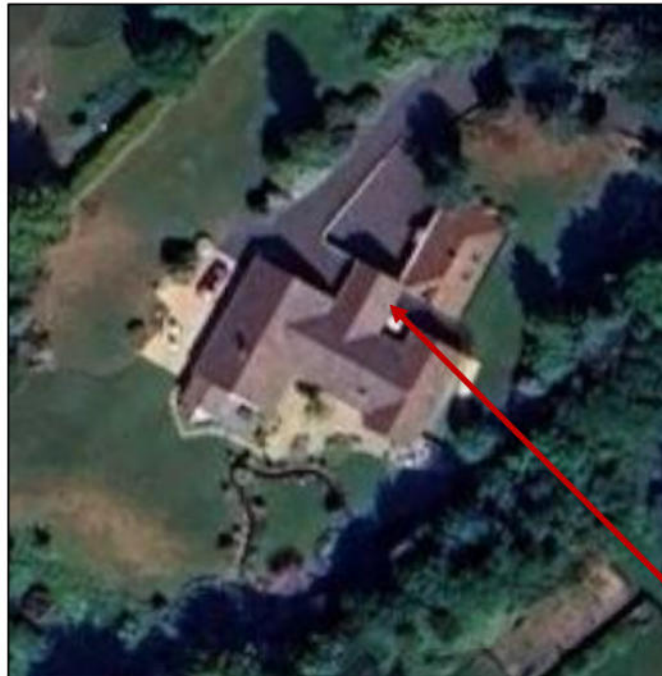
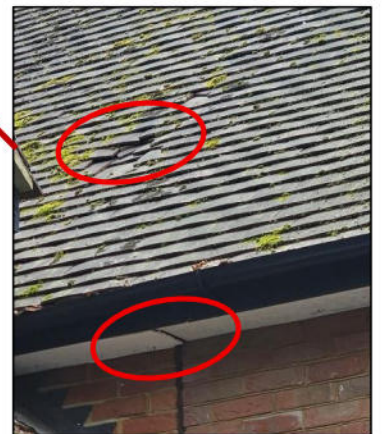
## APPENDIX 4: Map of potential features

Gaps under roof tiles  
and around soffits.

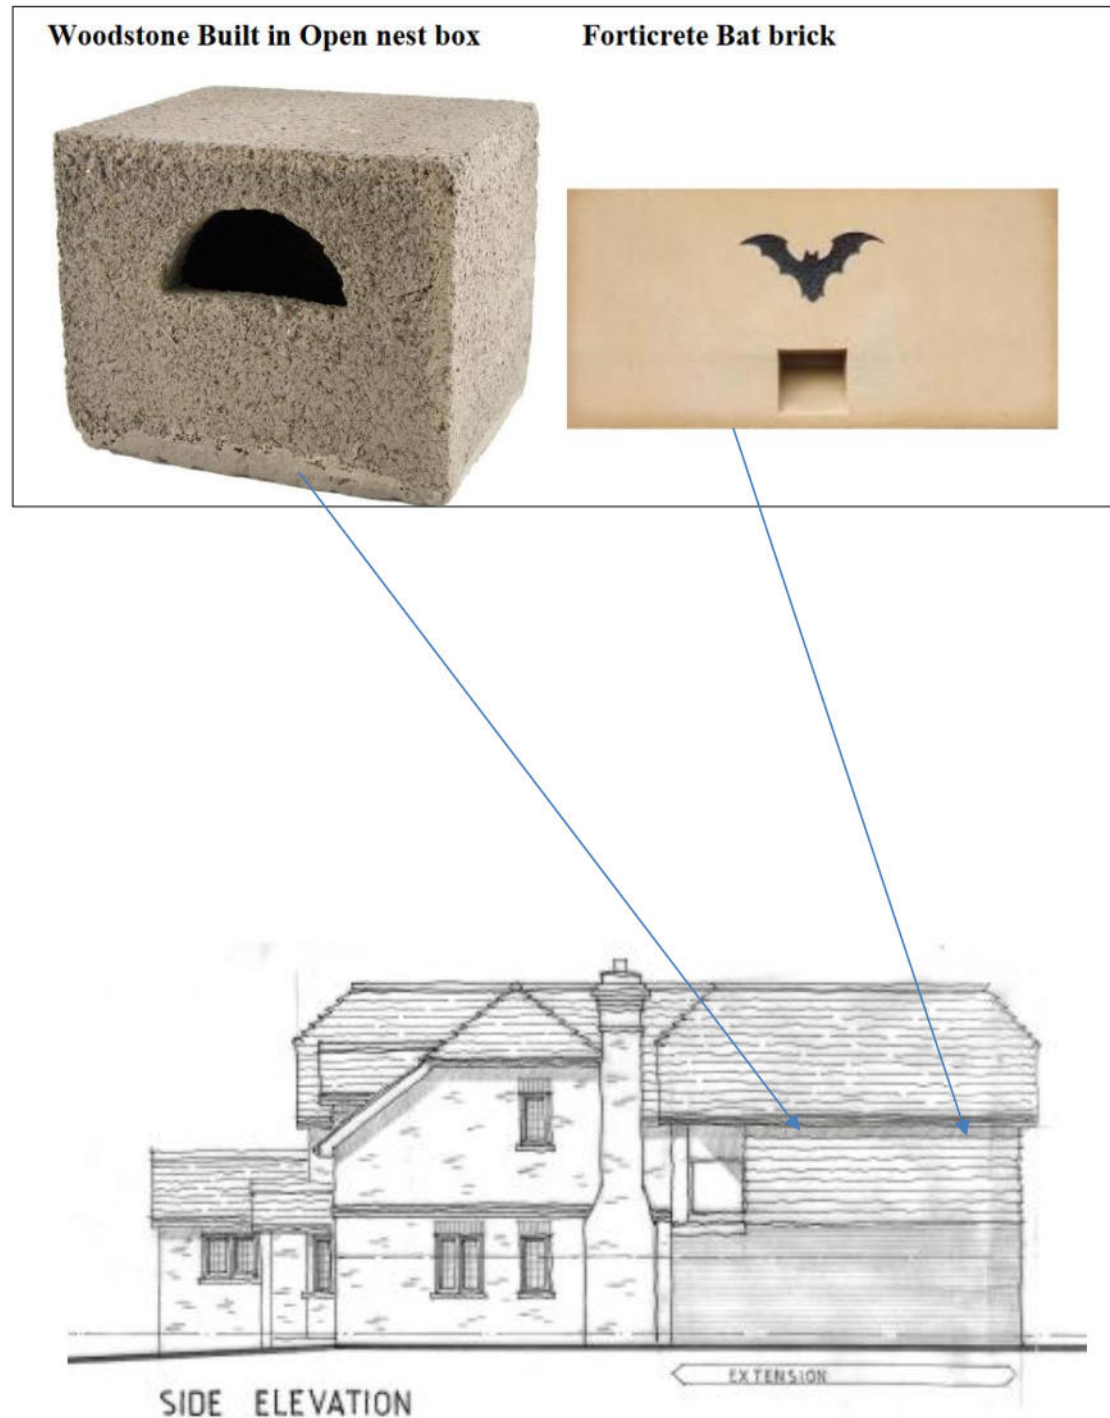
## APPENDIX 6: Biodiversity Enhancements

Under the National Planning Policy Framework<sup>7</sup> a development must provide enhancement for biodiversity. To support this, it is recommended that one bat brick and one open nest brick be installed within the brickwork of the new extension.
