## **PRI24098 Oak Apples, Oaklands Lane, Crowthorne**

### **SITE ASSESSMENT OF BIN STORE AREA**

*Document Ref: PRI24098\_technote\_binstore*

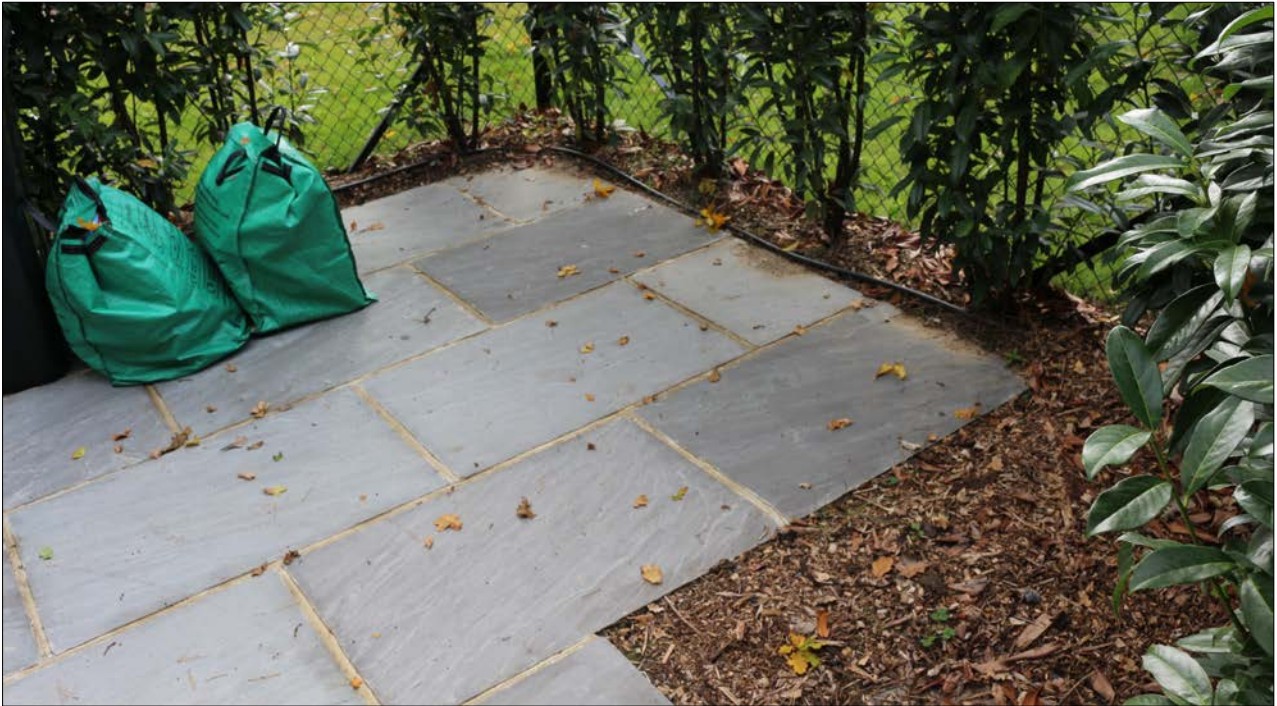
The hard standing can be seen in Figure 1 below, the profile is made up of natural stone slabs laid onto a concrete subbase. The perimeter fencing has been secured with metal posts set into concrete footings.

Figure 1 Binstore hardstanding and perimeter fencing.

The following technical Note has been revised to address Officer consultation response. The footprint of the bin store paving area is to be reduced in width by 600mm. This will be achieved by removing one linear row of paving slabs. The underlying concrete sub base will be sensitively removed, with the area returned to soft landscape. The adjacent hedgerow will be retained in situ as planted. This reduction in area will increase the available area of soft landscaping within the RPA of the adjacent tree.

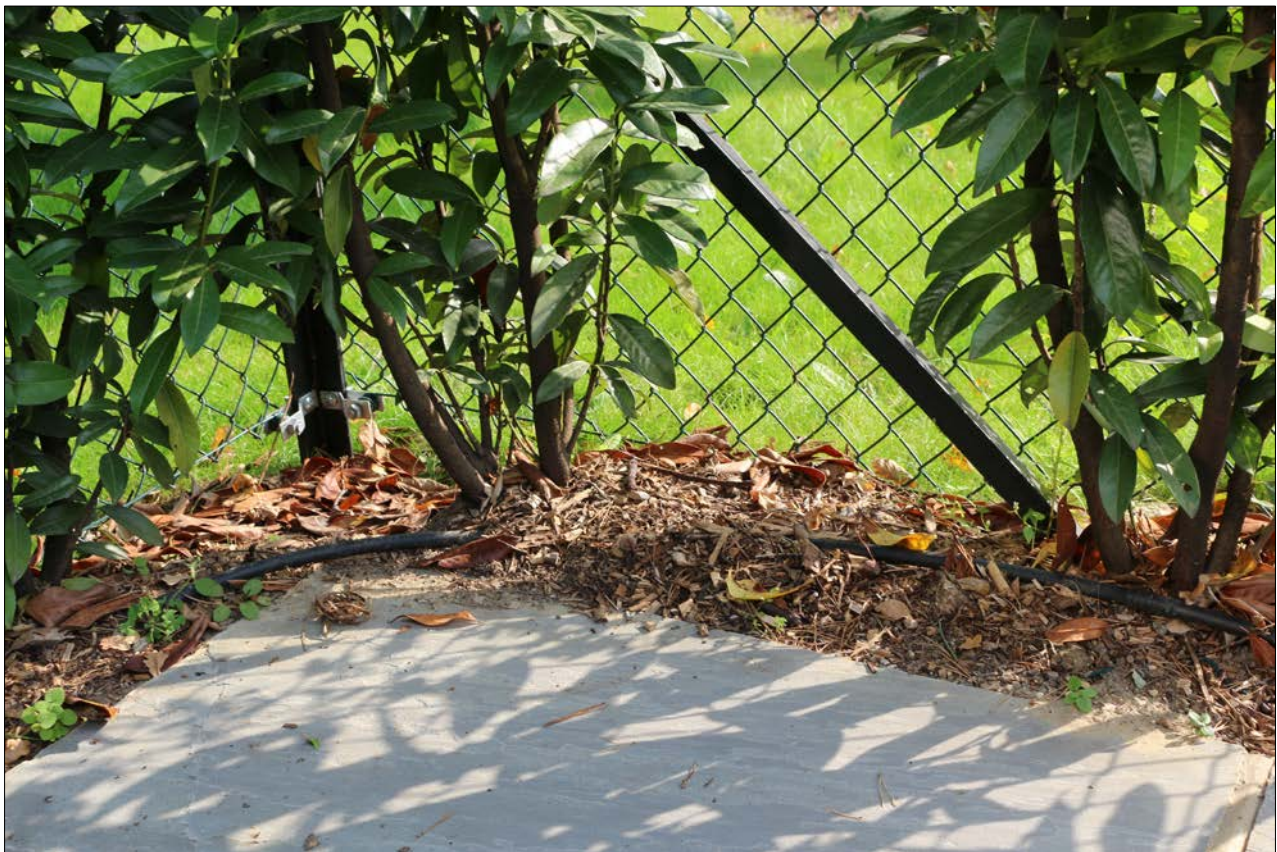
The wider area around English oak tree no. T44 has been landscaped with new grass and dressed with an area of woodchip mulch. The level of the bin store area is comparable to the finished levels around the tree which supports the conclusion it has been installed atop the existing ground levels. With the depth of turf and woodchip tying in the hard standing edging (Figure 2).

Figure 2 Finished levels tying into adjacent turfing level around Oak tree no. T44.
