## **PRELIMINARY ECOLOGICAL APPRAISAL (BATS) AT HILLSIDE HOUSE SPENCERS WOOD**

**Prepared for:  
Mr J Perkins  
Hillside House  
Basingstoke Road  
Spencers Wood  
RG7 1AP**

**25 November 2025**

**Ref: SPH/PEA-25/14.11**

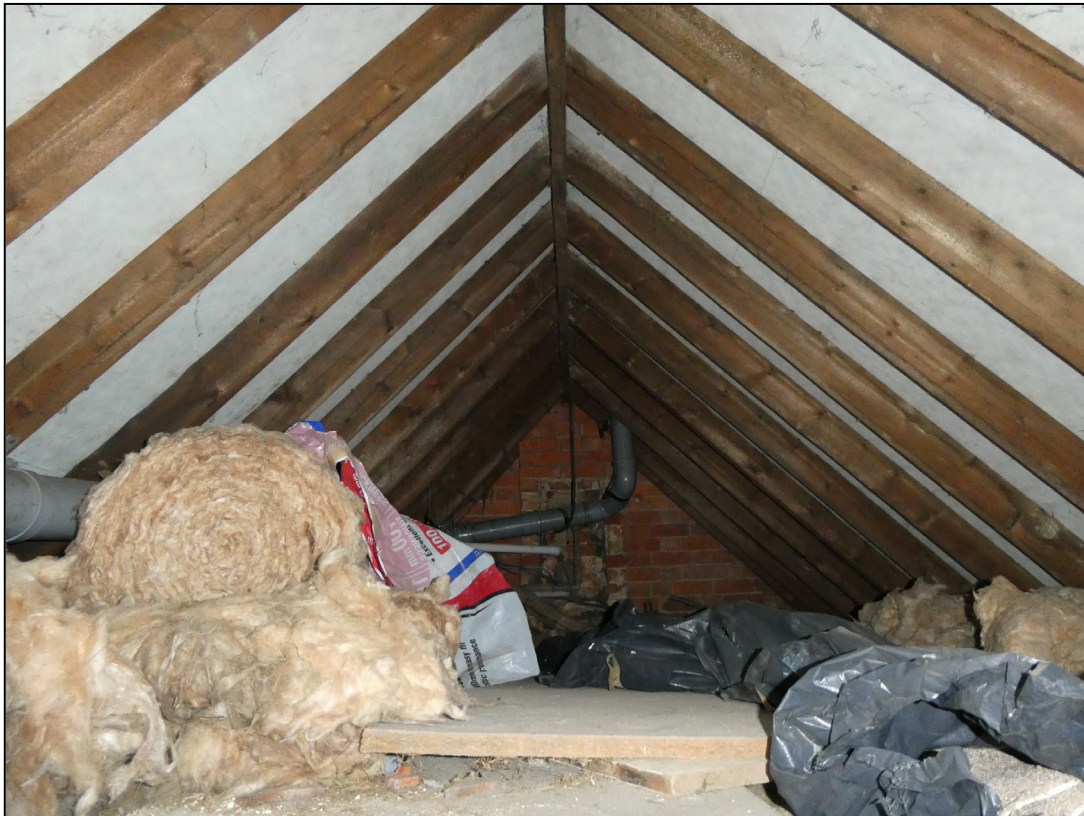
Figure 10. Example loft space of rear, single storey extension. Hillside House, Spencers Wood. 14.11.25

The loft of the property has been converted into habitable accommodation leaving no loft space or eaves storage areas. The loft space above the rear, single storey extension was accessed via a small door in the gable end and is in a good condition internally. The loft is not lit, partially boarded and insulated and the roof tiles are lined with membrane, all of which is tightly fitted with no rips or tears, see Figure 10 below.

No bats or evidence of bats was recorded during the internal inspection of the loft and internally there appeared to be no roosting opportunities for bats within the building.
