PART 3: ANALYSIS

# DEFINING CHARACTERISTICS OF **THE SITE**

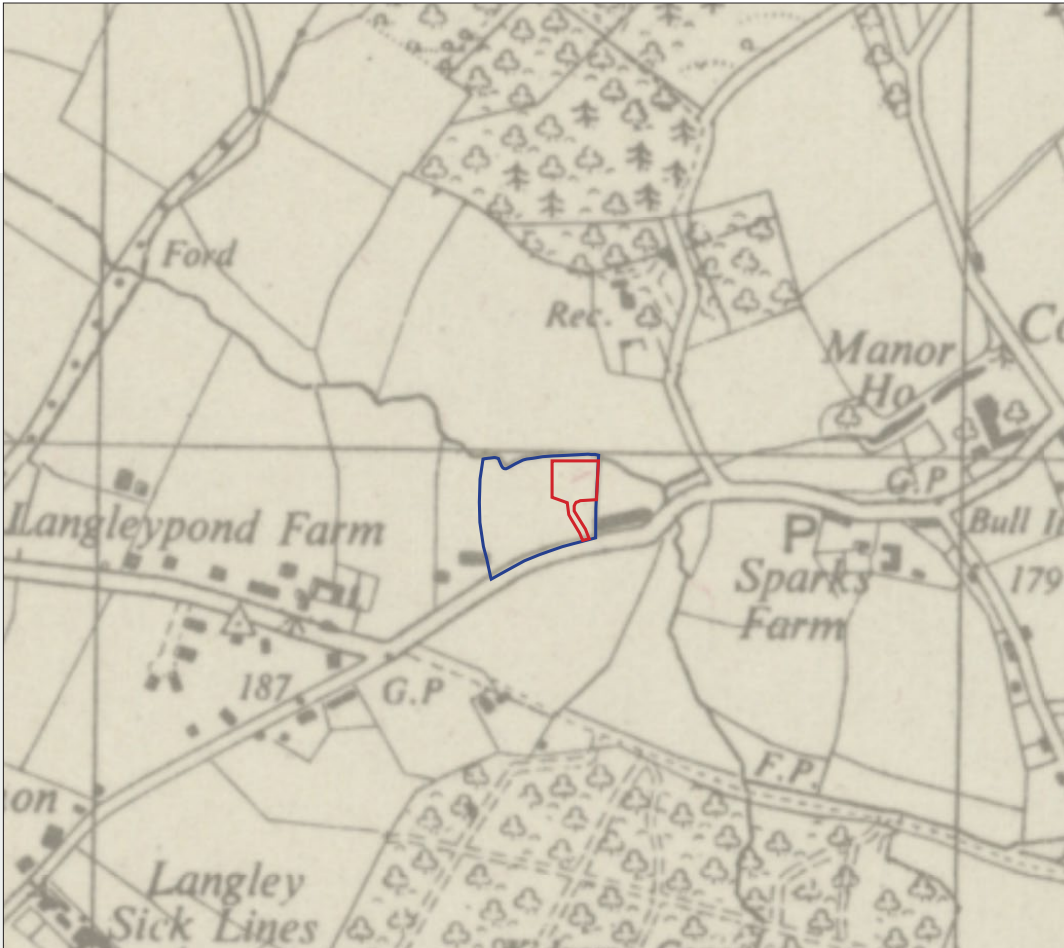
1945 to 1965 Historic OS Map  
[Image Source: National Library of Scotland - GeoMapper]

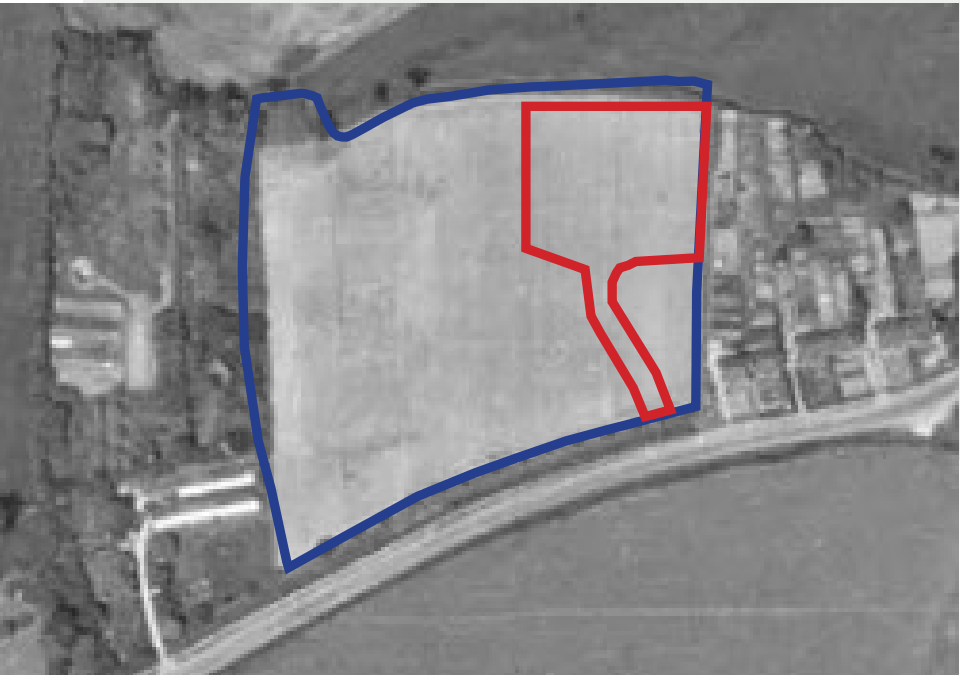
Aerial Photograph - 13th June 1967  
[Image Source: Historic England - Aerial Photo Explorer]

- RAF photography of the site from 1967 shows it to be an open field with small trees planted along the road frontage.
- Aerial images from the early to late 2000s show a clear division on the site of the area cover with self seeded trees to the west and the open grassland areas to the east.
- By summer 2022 we see that the open area to the east has become overgrown with scrub.

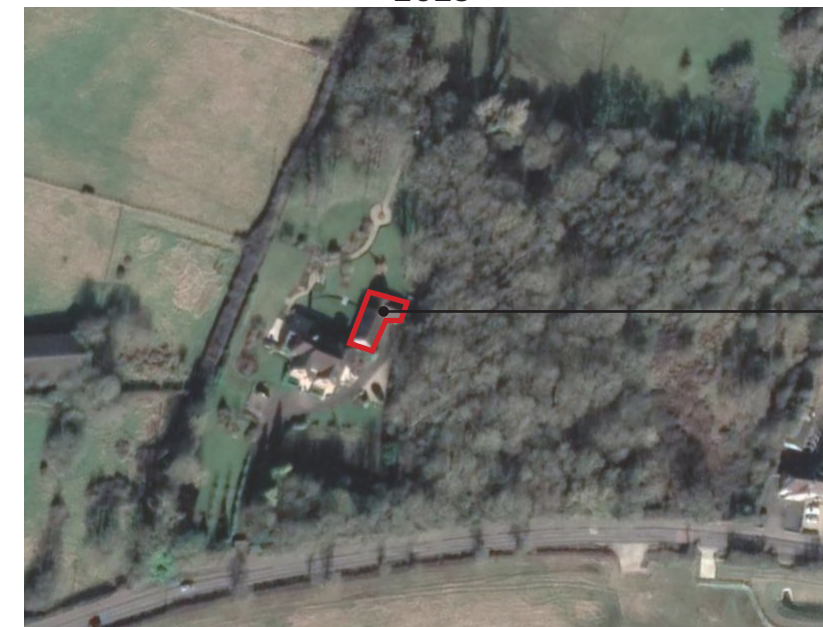
2023

Existing outbuilding that has been demolished

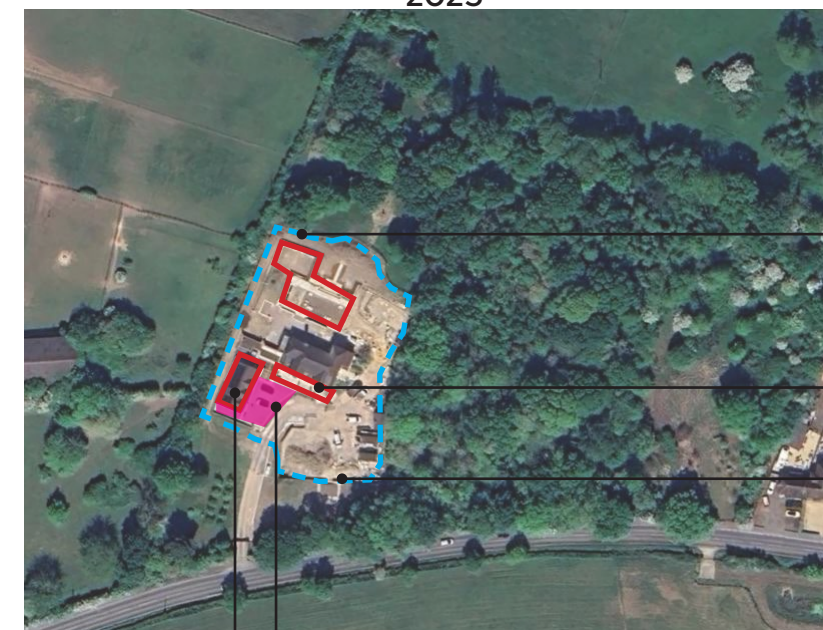
2025

Footprint of new outbuilding / annexe

New building extension

Site area reworked, with lawn removal

Resurfaced driveway

Garage development

The neighbouring property, directly next to the site boundary, is currently under a lot of construction. It is gaining an extension, has a new garage with space for 3 vehicles, and is constructing a new outbuilding/annexe.

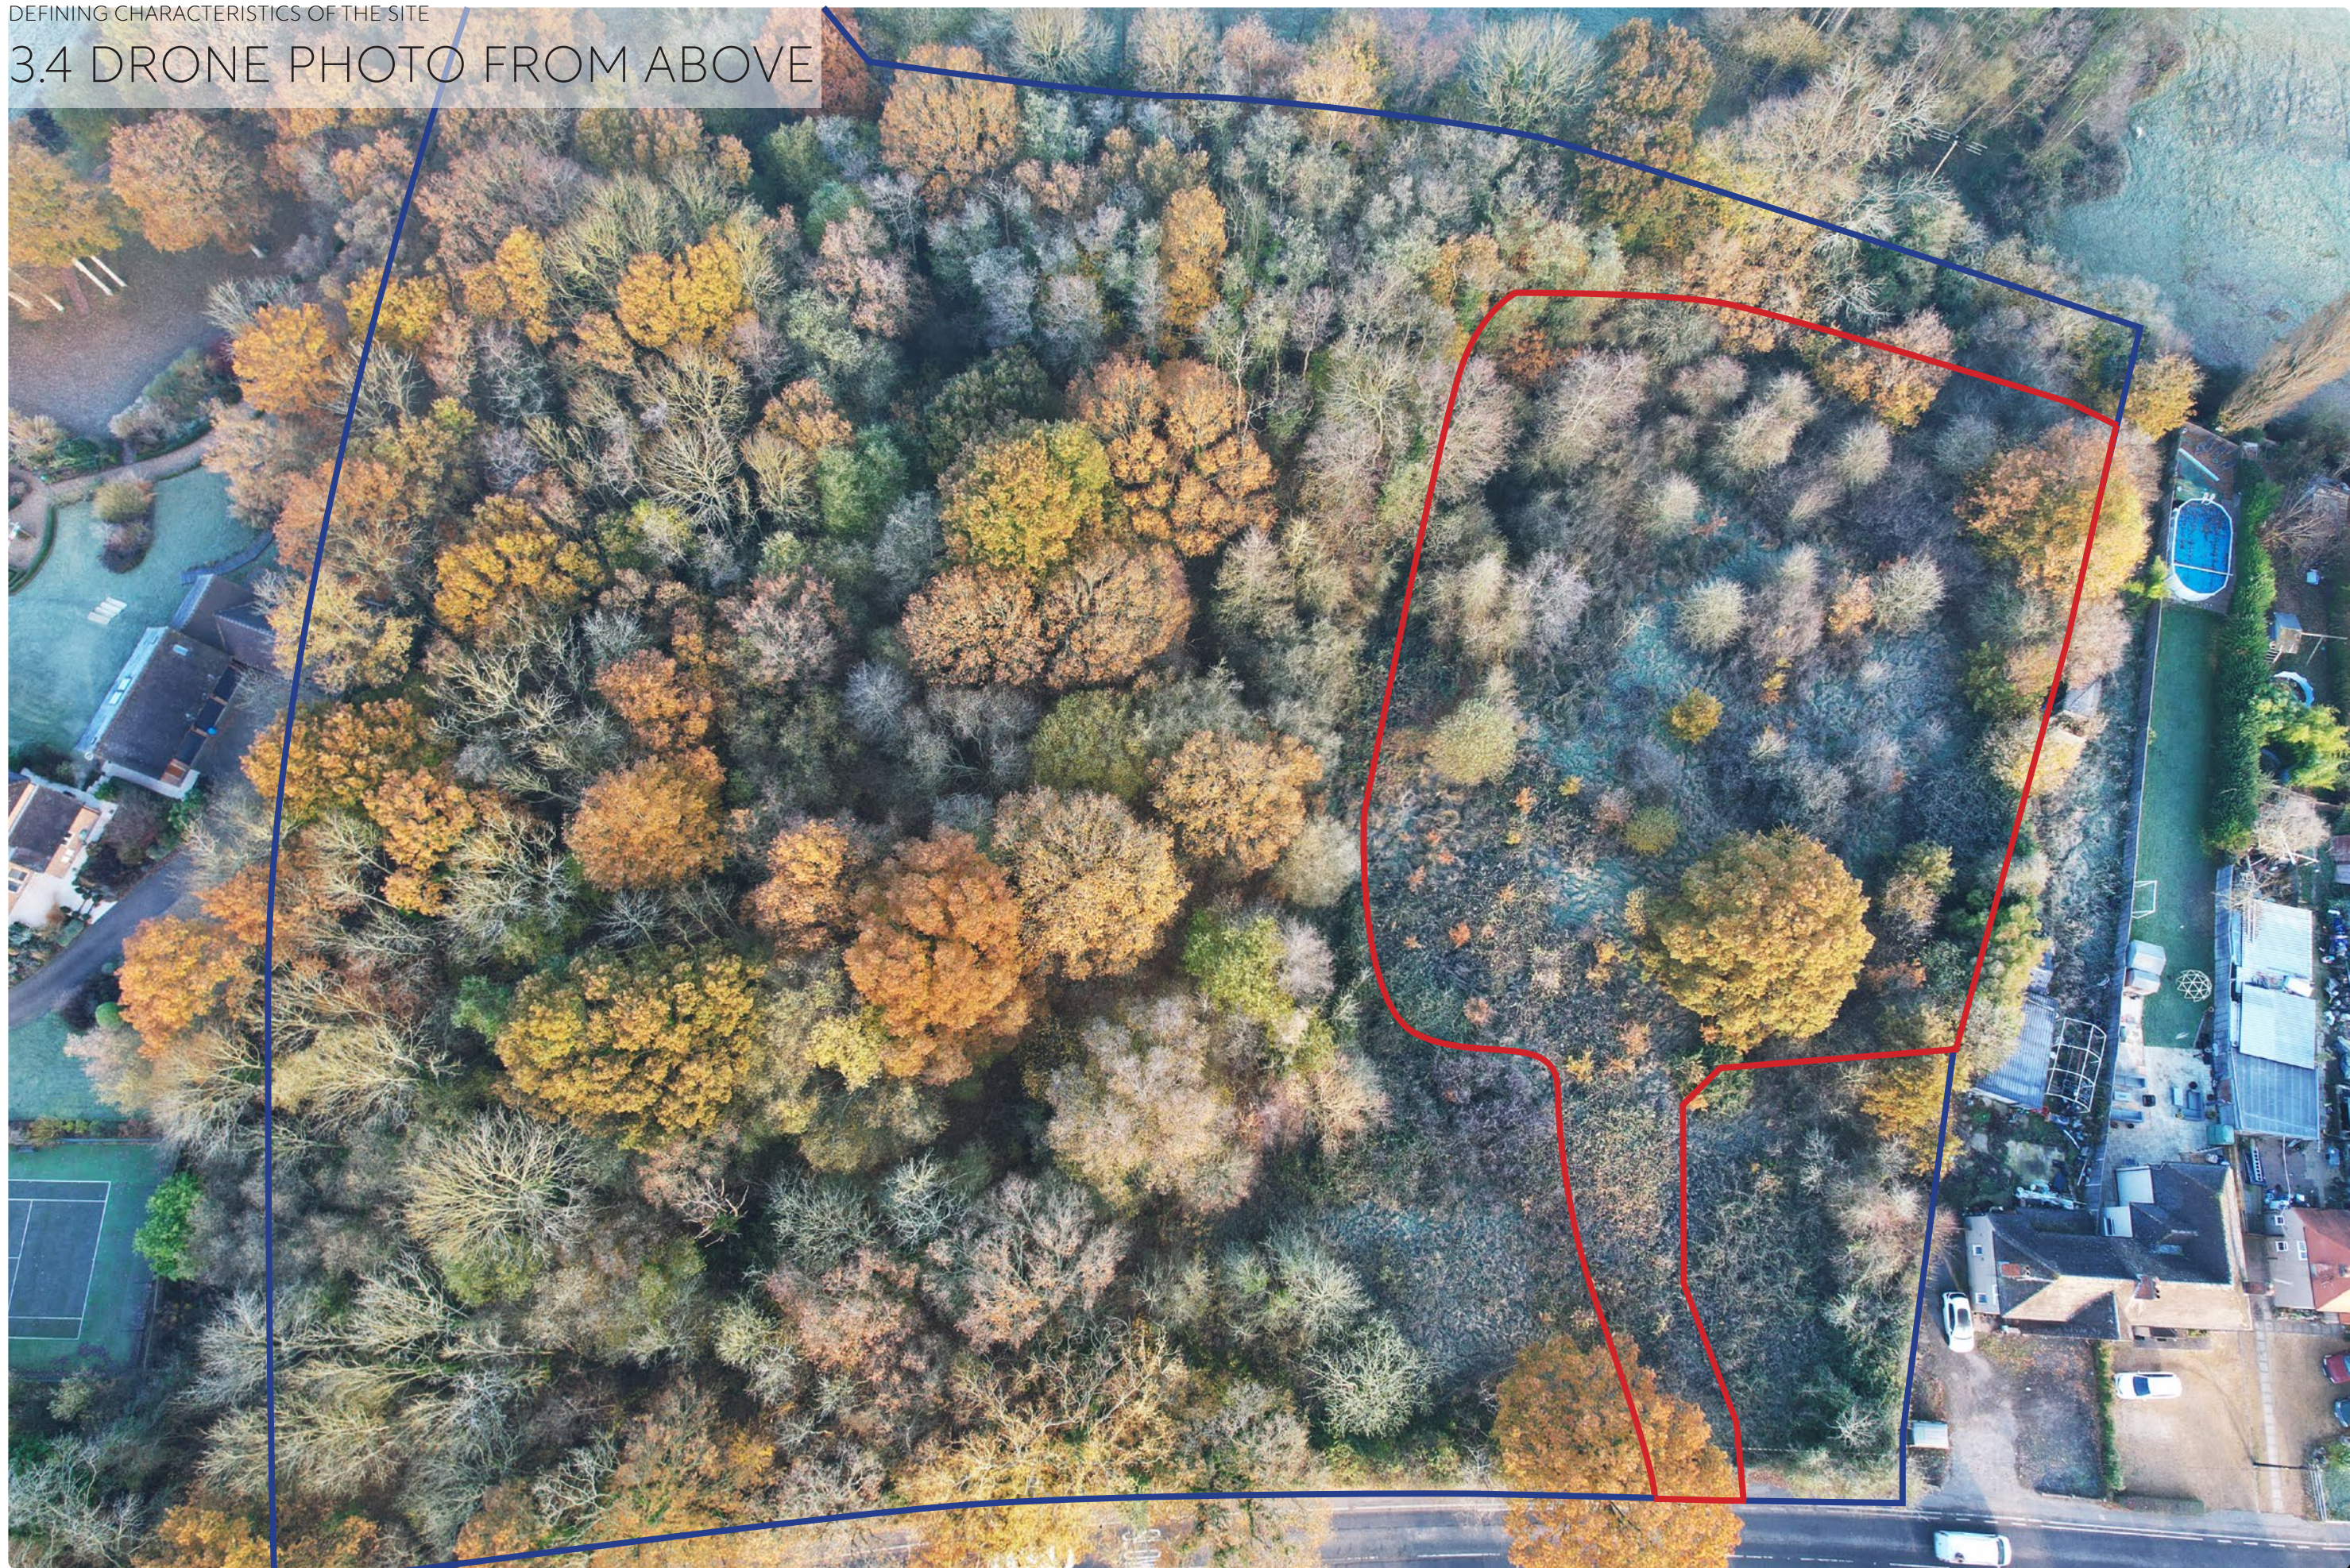
Drone Photograph courtesy of Axiom Planning – 25th November 2021
