## **PRELIMINARY ECOLOGICAL APPRAISAL (BATS) AT HILLSIDE HOUSE SPENCERS WOOD**

**Prepared for:  
Mr J Perkins  
Hillside House  
Basingstoke Road  
Spencers Wood  
RG7 1AP**

**25 November 2025**

**Ref: SPH/PEA-25/14.11**

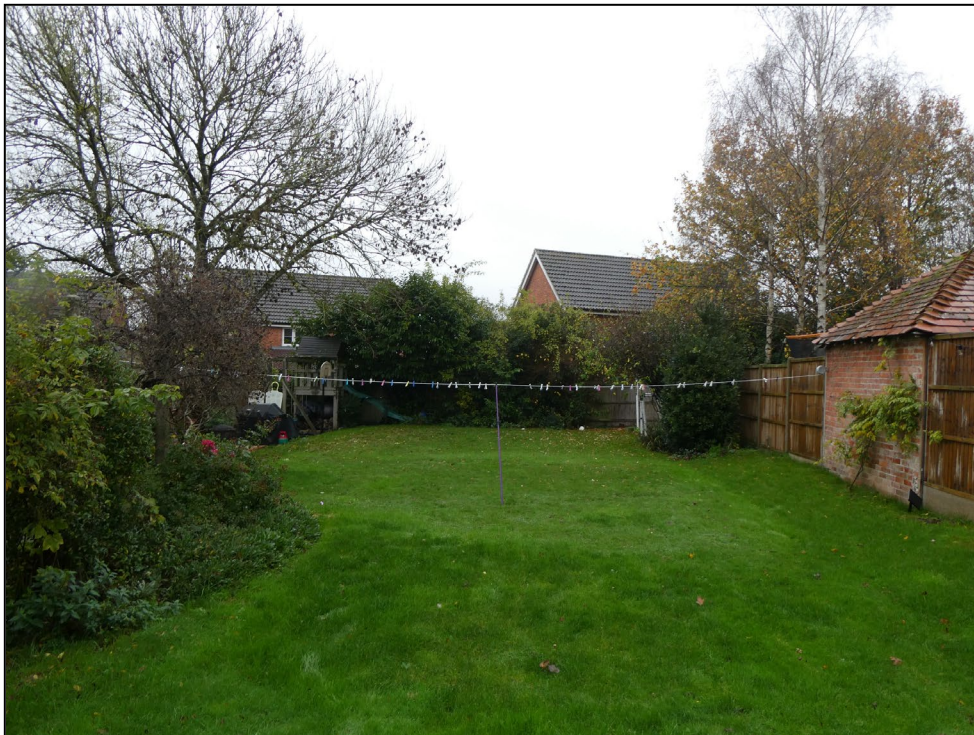
Figure 3. Rear garden. Hillside House, Spencers Wood. 14.11.25

The application site comprises a detached, brick-built two storey property with detached garage. The remainder of the site comprises, to the front, a paved driveway/parking area with various shrubs and herbaceous plants. To the rear the garden is mainly laid to lawn with various shrubs and mature trees, mainly on the boundaries, see Figure 3 below. The site itself offers some foraging and commuting habitat for bats.

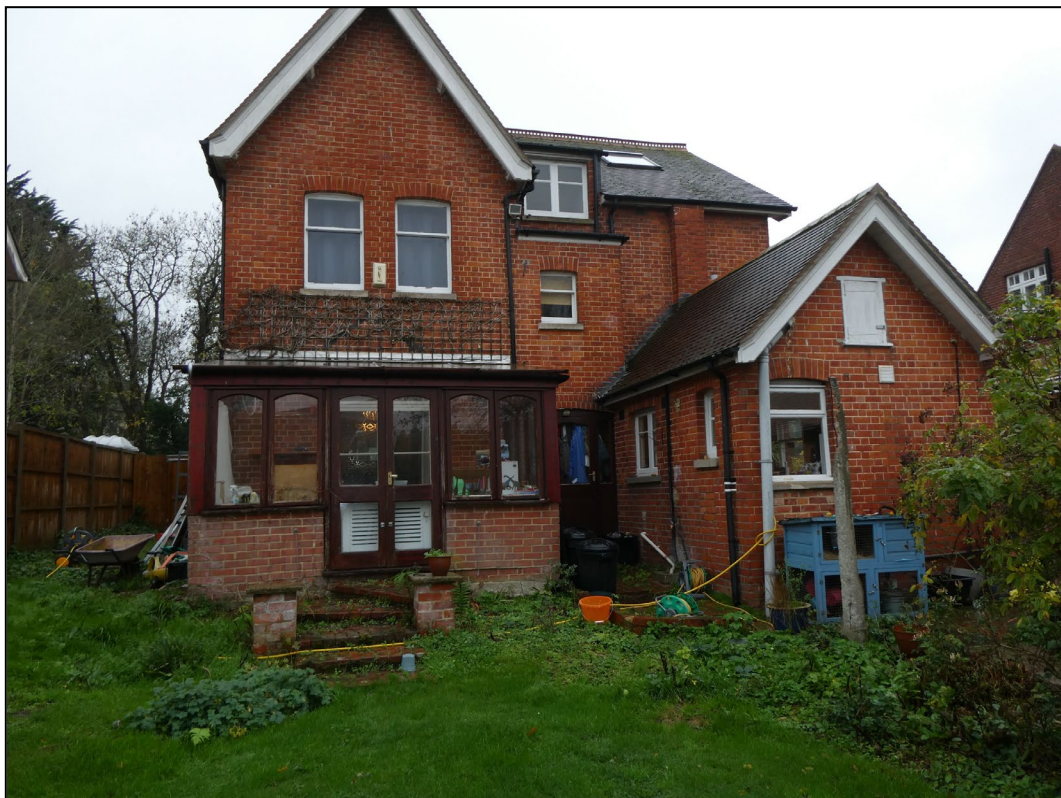
Figure 4. Rear view of property. Hillside House, Spencers Wood. 14.11.25

The property is a detached, brick-built two-story building that is in a good condition externally. The cross-pitched roof with rear, single storey pitched roof extension (see Figure 4 below) are covered in close fitting composite tiles, none of which are missing or broken, see Figure 5 on page 9. There is no missing mortar from the verges or ridge tiles, they are all tightly fitted and offer no roosting potential, see Figure 5 on page 9. The lead flashing around the chimney stack, Velux windows and affixing the single storey extension to the main dwelling is flush fitting (see Figure 6 on page 10), and the soffits and fascias on the main dwelling and single storey rear extension are all in a good condition and have no cracks or splits which could be utilised by roosting bats, see Figure 7 on page 10. On the rear elevation are two flat roof sections both of which are covered in well fitted bitumen felt with no rips or tears that crevice dwelling bat species could use for roosting (see Figure 8 on page 11) and they are firmly affixed to the main dwelling. The attached rear wood and glass conservatory on dwarf brick wall offers no roosting potential due to the construction materials, thermal properties and light ingress, see Figure 9 on page 11. On the front bay window are hanging tiles, some of which have moved/are broken, however this section of the property is not being affected by the proposed works.

No bats or evidence of bats was recorded externally on the main property and there appeared to be no visible roosting opportunities for bats or access into the building for roosting bats.

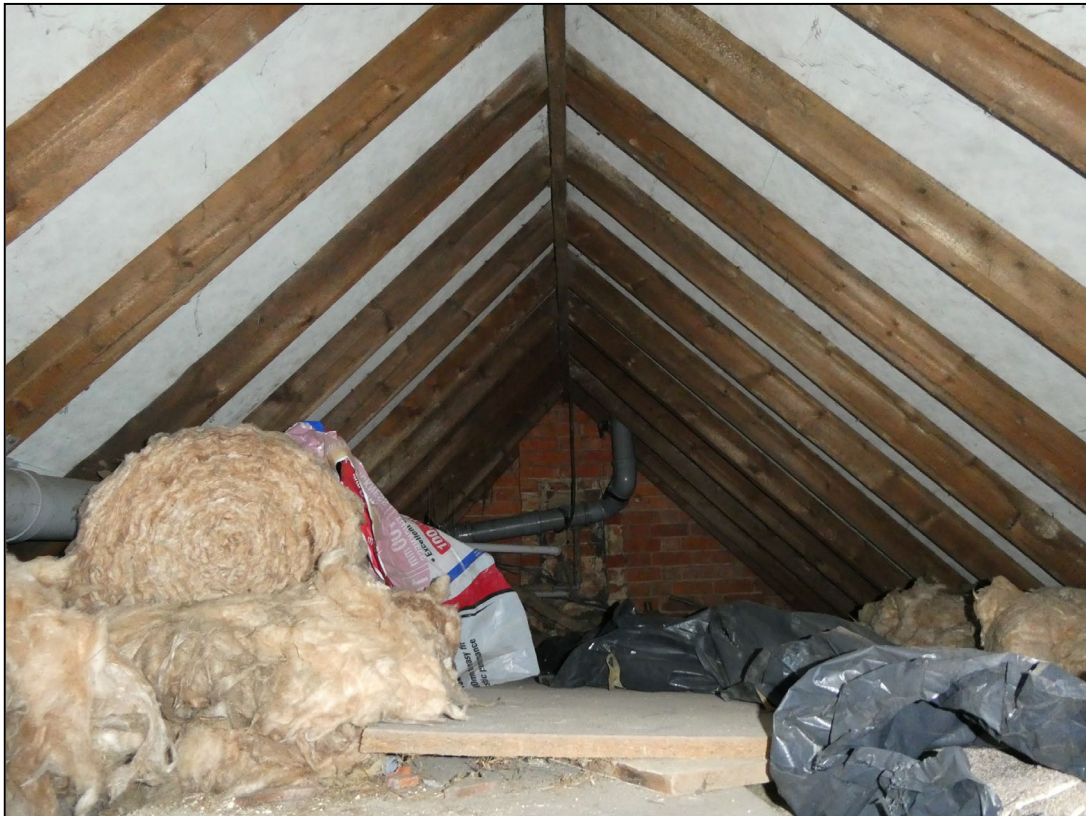
Figure 10. Example loft space of rear, single storey extension. Hillside House, Spencers Wood. 14.11.25

The loft of the property has been converted into habitable accommodation leaving no loft space or eaves storage areas. The loft space above the rear, single storey extension was accessed via a small door in the gable end and is in a good condition internally. The loft is not lit, partially boarded and insulated and the roof tiles are lined with membrane, all of which is tightly fitted with no rips or tears, see Figure 10 below.

No bats or evidence of bats was recorded during the internal inspection of the loft and internally there appeared to be no roosting opportunities for bats within the building.
