## Preliminary Roost Assessment

53 Paddock Heights, Reading, Berkshire, RG10 0AR

This report is prepared to inform a planning application with Wokingham Borough Council. This proposal can be described as proposed two storey side and single storey rear extension and loft conversion to bungalow.

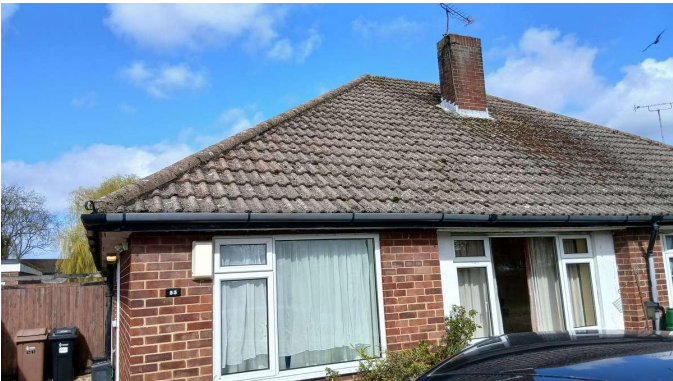
B1 - southeastern elevation

B1 is a one-storey, semi-detached, brick-built dwelling. The main roof is hipped and constructed of tiles in good condition with an intact covering and no apparent gaps. The walls, windows, and eaves are also in perfect condition with no signs of damage. Internal voids were recorded within the building. No bat evidence was found during the survey.

In line with Good Practice Guidelines (Collins, J (Ed) 2023), B1 is assessed to have negligible habitat value for roosting bats due to general good condition of the dwelling and a lack of suitable roosting features.

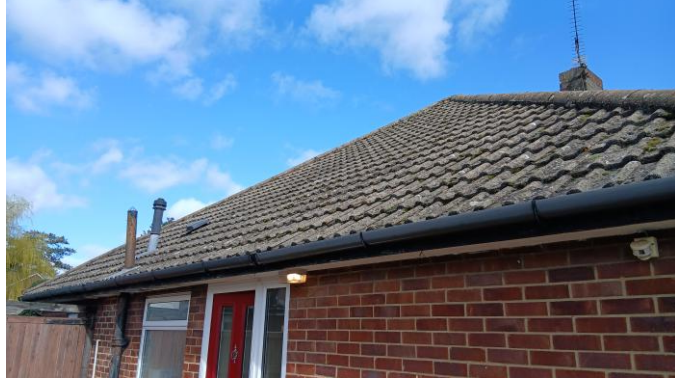
| | Roof | Tiles | The roof tiles were assessed to be of good condition with none lifted or missing. | <br><i>B1 – roof tiles</i> | |

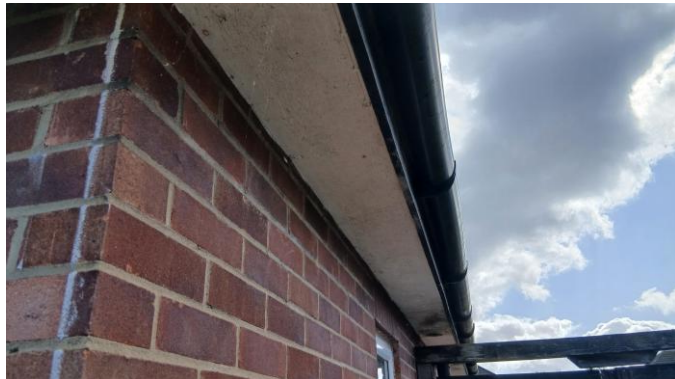
| | Walls | Brick-built | The brickwork was assessed to be of good condition with no cracks or missing mortar. | <br><i>B1 – brickwork</i> | |

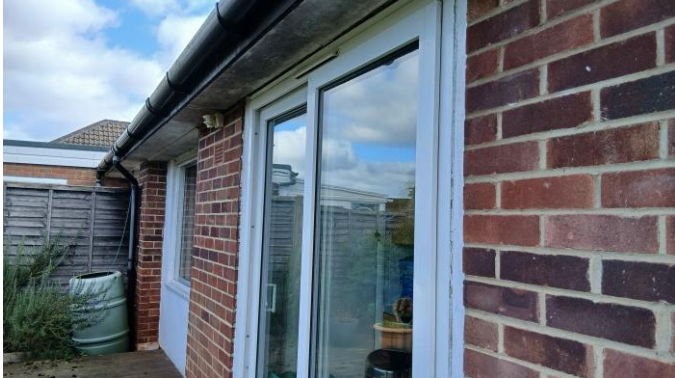
| | Windows | PVC | The windows and doors were assessed to be of good condition as they were well sealed with no gaps. | <p><i>B1 – rear door windows</i></p> | |

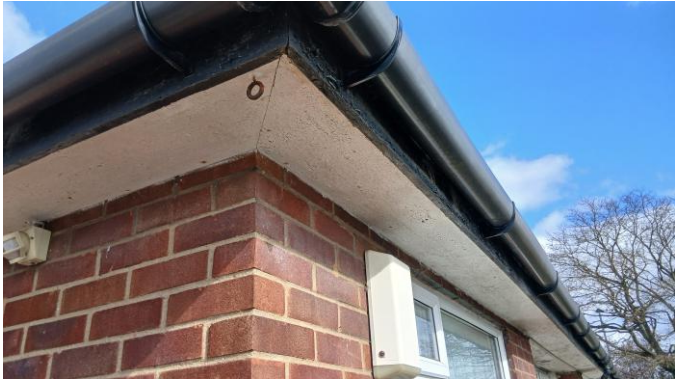
| | Eaves | Timber | The eaves and soffit boxes were assessed to be of good condition with no gaps or damage. | <p><i>B1 – eaves</i></p> | |

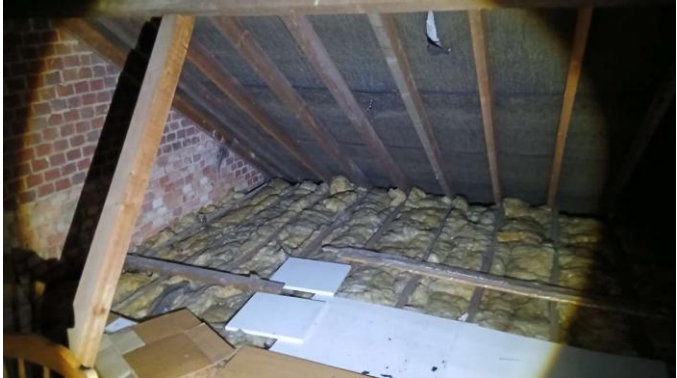
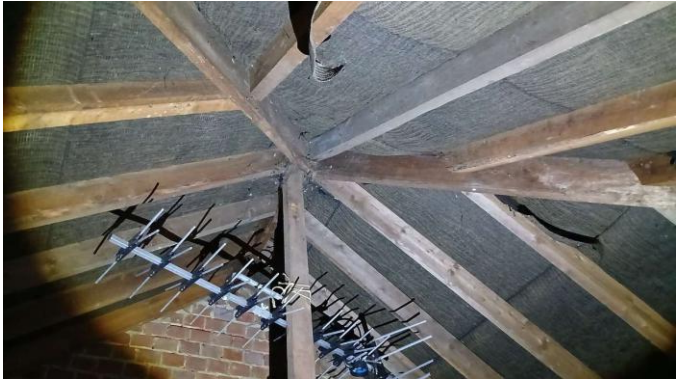
| Voids | Bitumen felt | <p>A void was recorded within B1, designated as Loft 1. This void is accessible and measures approximately 10m in length, 6m in width, and 3m in height, with an estimated area of 60m<sup>2</sup>. The void is lined with bitumen felt. The recorded temperature was 14.3°C and humidity was 62.8%. No specific roosting features or bat evidence were noted within this void.</p> | <p>Loft 1</p> <p>Loft 1</p> |
