## Preliminary Roost Assessment

**Survey site:** 66 Arbor Lane, Winnersh, Wokingham, Berkshire, RG41 5JD

This report is prepared to inform a planning application for the complete renovation including new roof of main dwelling, including the demolition and rebuilding of the garage.

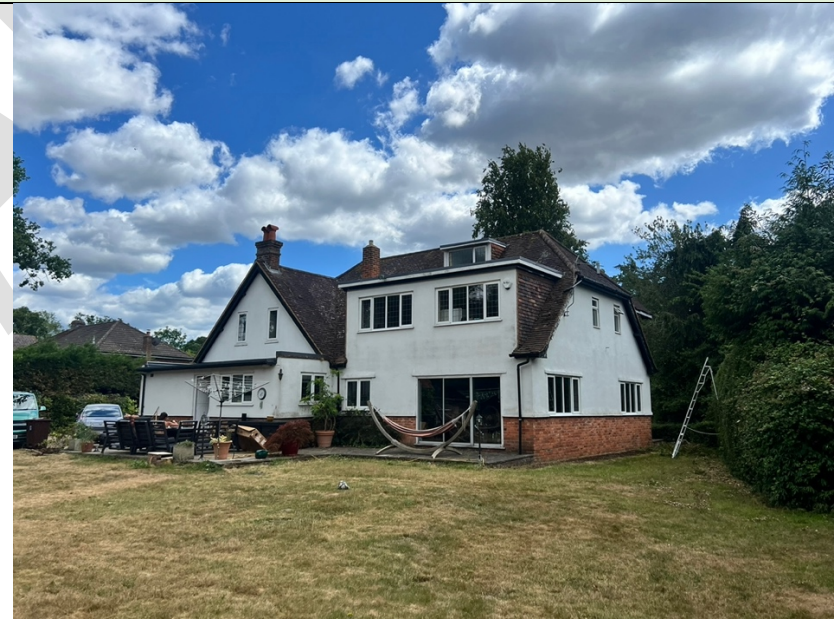
#### *B1 Summary*

B1 is a detached dwelling, with a composite roof with pitched, hipped, and gabled sections. The roof is constructed with clay tiles with brick and mortar chimneys. The walls are constructed with brick and mortar, with rendering on all elevations. The windows and doors are PVC-framed. The soffits and fascias are constructed with timber. Two loft spaces are present within B1, featuring timber framing, bitumen lining, and insulation.

B1 is assessed to have **moderate** habitat value for roosting bats due to the presence of lifted roofing tiles.

| <i>Recommendations</i> | <p><b>B1</b><br/>Buildings - Moderate</p> <p><b>Two</b> bat emergence and re-entry surveys are required during the active bat season (optimal May to August, suboptimal September) to confirm presence or likely absence of a bat roost in the building. Both of the surveys should be completed during the optimal survey period mid-May to August inclusive.</p> <p>Infra-red cameras should be used as an aid. Surveys should be a minimum of three weeks apart.</p> <p><b>Four</b> surveyors are required to provide full coverage of the building.</p> |

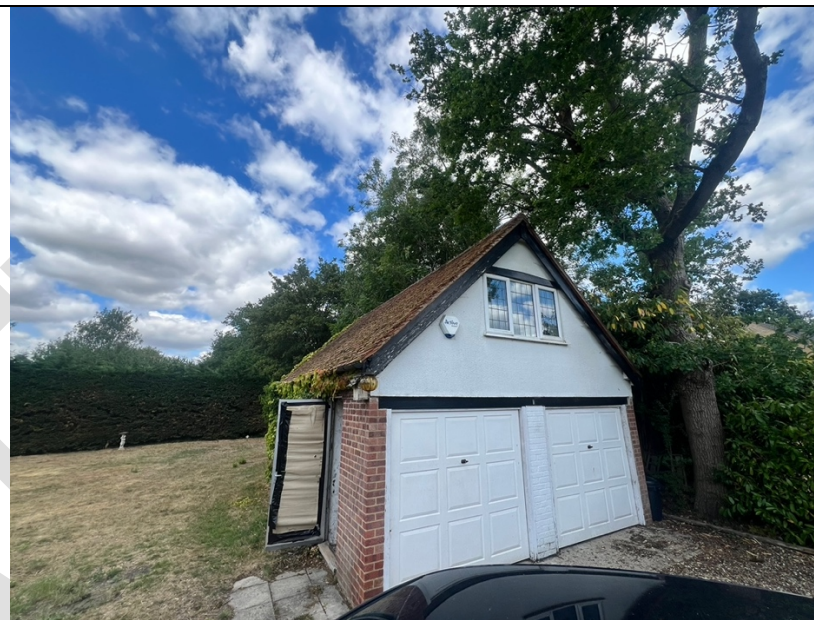
*B2 Summary*

B2 is a detached garage building, with a pitched and gabled roof constructed with clay tiles. The walls are constructed with brick and mortar, with two garage doors present on the southern elevation. The loft space has been fully converted internally.

B2 is assessed to have **low** habitat value for roosting bats due to the presence of a handful of lifted tiles.

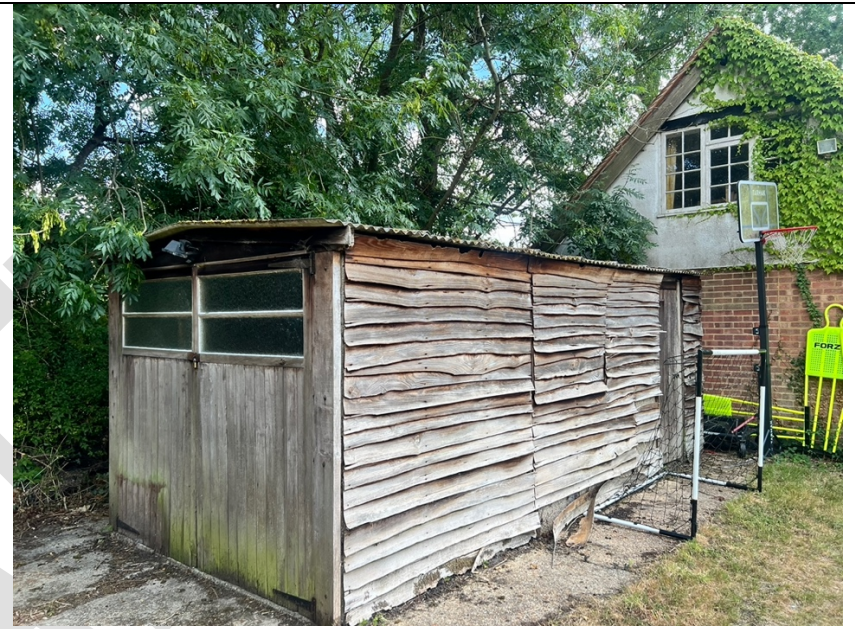
*B3 Summary*

B3 is a detached single-skinned storage shed. The roof is constructed with corrugated plastic and asbestos roofing panels. The walls are comprised of timber-board cladding.

B3 is assessed to have **negligible** habitat value for roosting bats due to the single-skinned nature of the building, leaving the internal space subject to frequent fluctuations in temperature and humidity as a result.

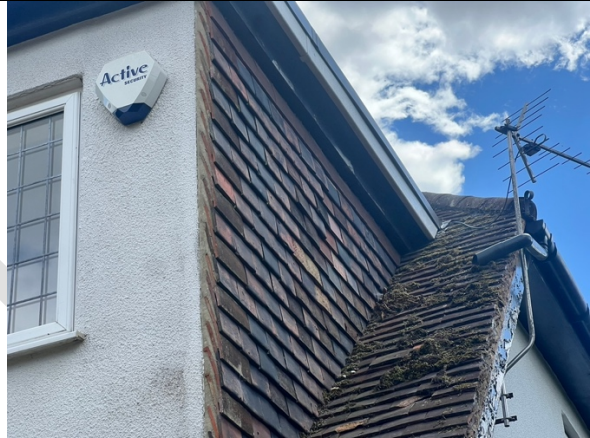
| B1 | | | | |
|---|---|---|---|---|
| Walls | Brick and mortar, render, hanging clay tiles | <p>The brickwork, mortar pointing, and rendering were in uniformly good condition.</p> <p>Hanging clay tiles were present on adjoining walls of dormer windows. These hanging tiles were in a weathered condition but were tightly interlocking, with no gaps or raised tiles observed.</p> | <p>No roosting habitat observed.</p> <p>No evidence of bat use found.</p> | |

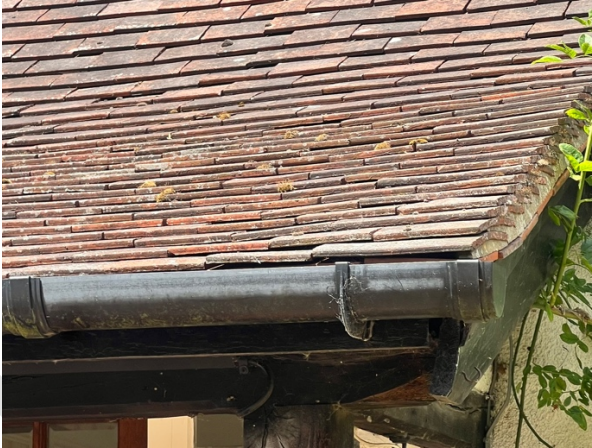
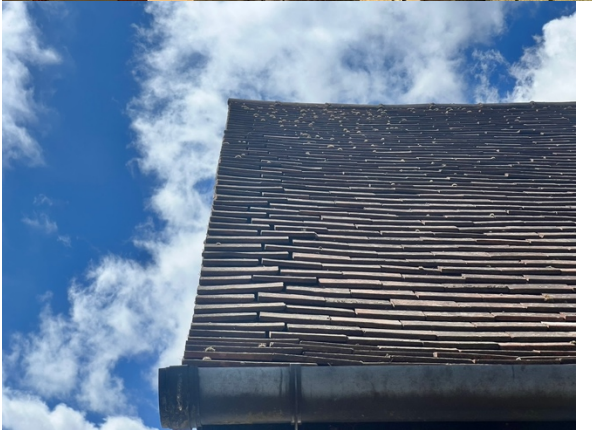
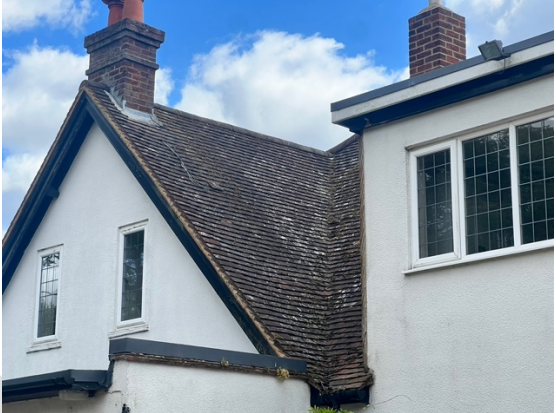
| Roof | Clay tiles | <p>The clay roofing tiles were in a weathered condition.</p> <p>Multiple raised tiles were observed, exposing gaps underneath.</p> | <p>There is opportunity for crevice-dwelling bats to roost under the raised roofing tiles.</p> <p>No evidence of bat use found.</p> | |

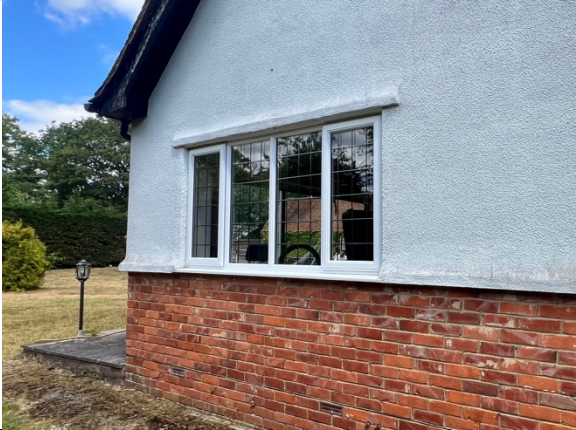
| Windows and doors | PVC-framed | The windows and doors were in uniformly good condition, fitting tightly to the adjoining walls. | No roosting habitat observed.<br><br>No evidence of bat use found. | |

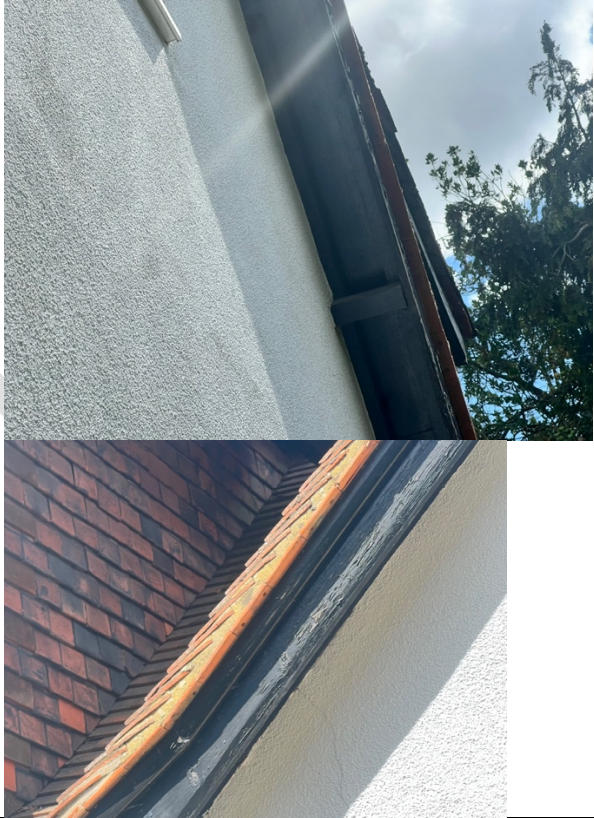
| Soffits and fascias | Timber | <p>The soffits and fascias were in a weathered but good condition.</p> <p>No gaps or holes were observed.</p> | <p>No roosting habitat observed.</p> <p>No evidence of bat use found.</p> | |

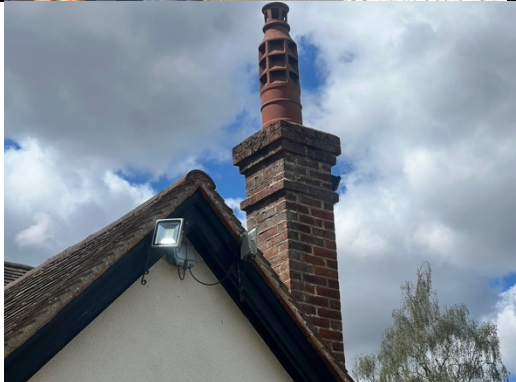
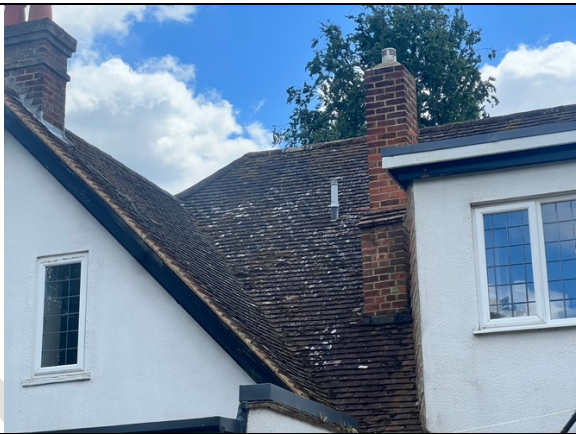
| Chimneys | Brick and mortar | <p>The brickwork and mortar pointing of the chimneys was in uniformly good condition.</p> <p>No gaps or holes were observed.</p> | <p>No roosting habitat observed.</p> <p>No evidence of bat use found.</p> | |

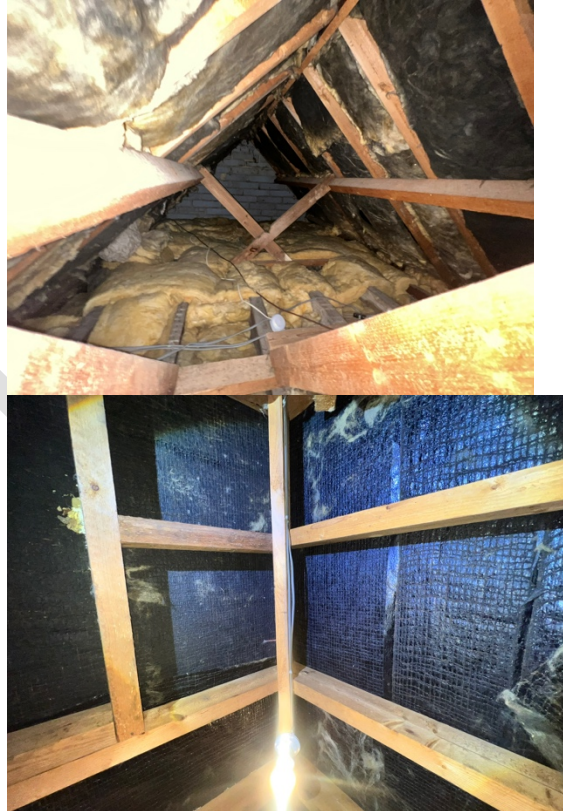
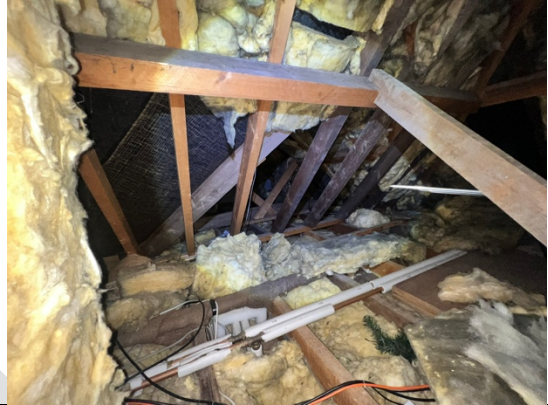
| Internal voids | Timber frame, bitumen lining, insulation | <p>The loft spaces were constructed with timber beams, with bitumen lining.</p> <p>The bitumen lining and timber beams were in good condition.</p> <p>No access points observed or areas of light ingress.</p> <p>Temperature: 29.8°C<br/>Relative humidity: 46.5%</p> | <p>Suboptimal for void dwelling bats due to the small size.</p> <p>No bat evidence or access points noted.</p> | |

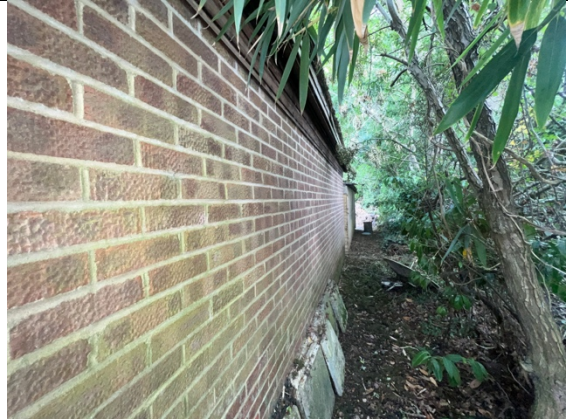
| Walls | Brick and mortar | <p>The brickwork and mortar pointing were in uniformly good condition.</p> <p>No holes or gaps were observed.</p> | <p>No roosting habitat observed.</p> <p>No evidence of bat use found.</p> | |

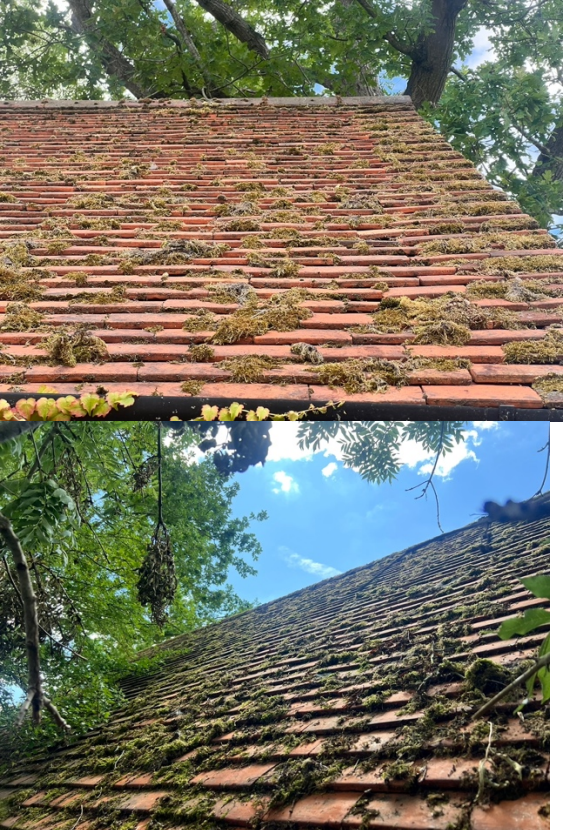
| Roof | Clay tiles | <p>Some clay roofing tiles were slightly lifted on the western elevation of the roof.</p> <p>The tiles on the eastern elevation of the roof were uniformly tight.</p> | <p>No roosting habitat observed.</p> <p>No evidence of bat use found.</p> | |

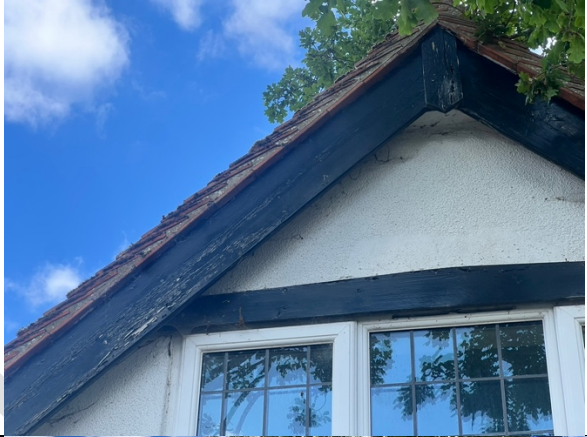
| Bargeboards | Timber | The bargeboards were in a weathered state but were in good condition with no cracks or holes observed. | No roosting habitat observed.<br><br>No evidence of bat use found. | |

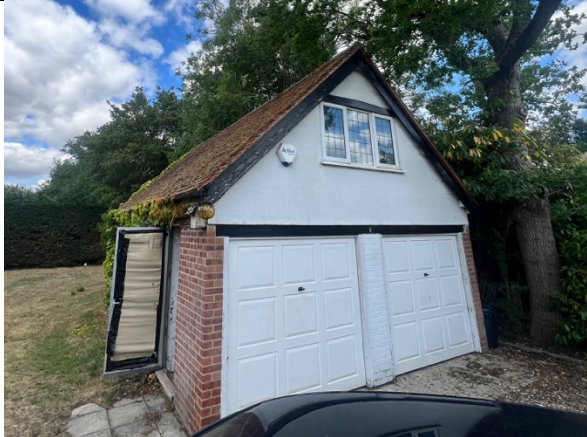
| Windows and doors | PVC | The windows and doors were in uniformly good condition, fitting tightly to the adjoining walls. | No roosting habitat observed.<br><br>No evidence of bat use found. | |

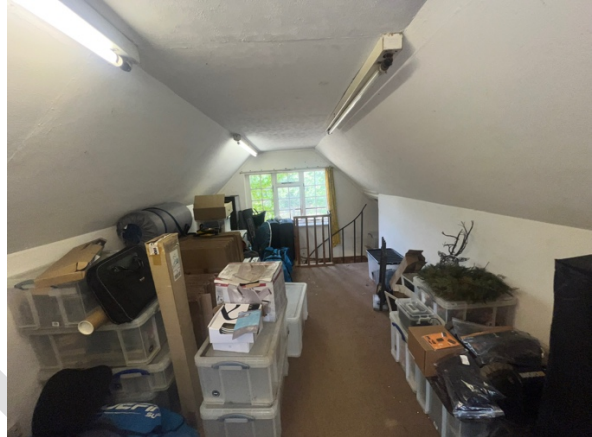
| Internal void | Plaster | <p>The internal loft space had been fully converted.</p> <p>No access points were observed.</p> | <p>Negligible habitat value for void-dwelling bats.</p> <p>No bat evidence or access points noted.</p> | |

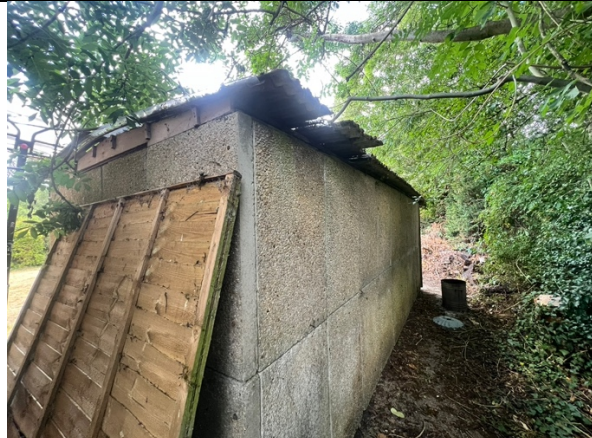
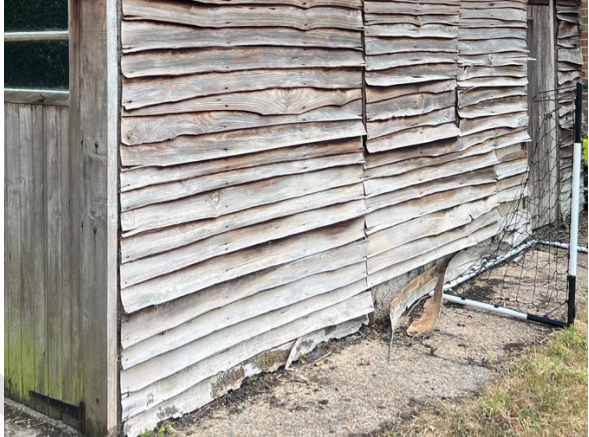
| Walls | Concrete panels, timber cladding | <p>The concrete panels were tightly fitting to adjoining panels.</p> <p>The thin timber cladding on the western elevation was heavily weathered and damaged.</p> | <p>No roosting habitat observed.</p> <p>No evidence of bat use found.</p> | |

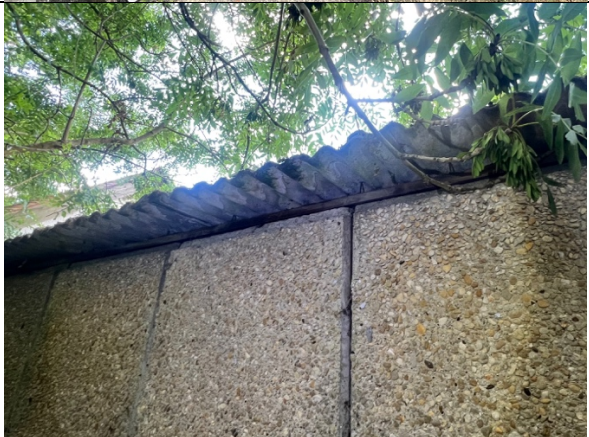
| Roof | Asbestos, PVC | Corrugated asbestos panels were heavily weathered, with small gaps between overlapping sheets. | <p>The gaps between overlapping corrugated asbestos and PVC panels do not provide habitat value for crevice-dwelling bats due to poor temperature regulation associated with asbestos and PVC panels.</p> <p>No evidence of bat use found.</p> | |

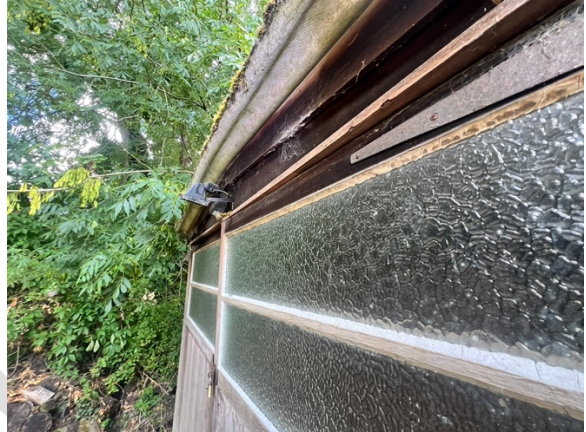
| Windows | Timber-framed | <p>The windows and doors were in uniformly good condition.</p> <p>Framing fitted tightly to adjoining panels.</p> | <p>No roosting habitat observed.</p> <p>No evidence of bat use found.</p> | |
