15 Gorrick Square  
Wokingham  
Berkshire  
RG41 2PB

# Preliminary Roost Assessment

Report ref.: R2850\_PRA\_a

**January 2025**

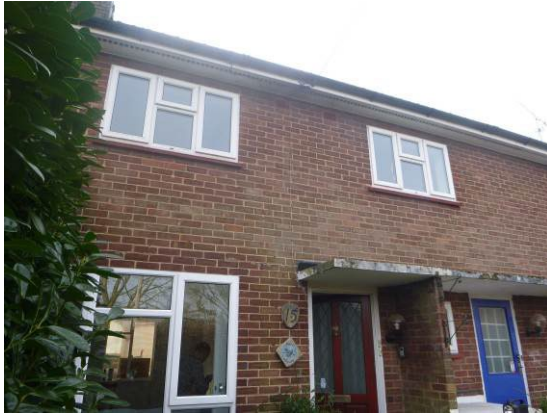
**5.2.2** The property was mid-terraced of modern brick cavity walls with a pitched roof and a corrugated plastic roofed conservatory on the rear elevation (**Photographs 1 & 2**).

*Photograph 1. Front of house, viewed from the north.*

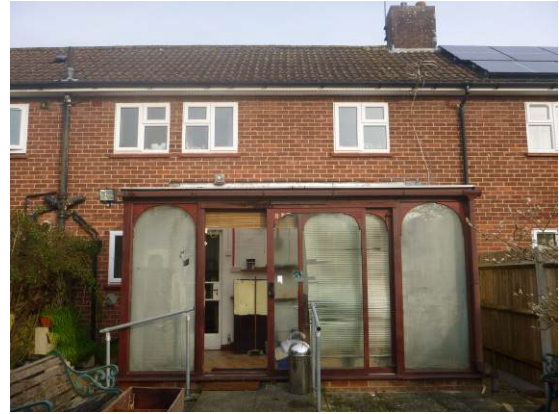
*Photograph 2. Rear of the property, viewed from the south.*

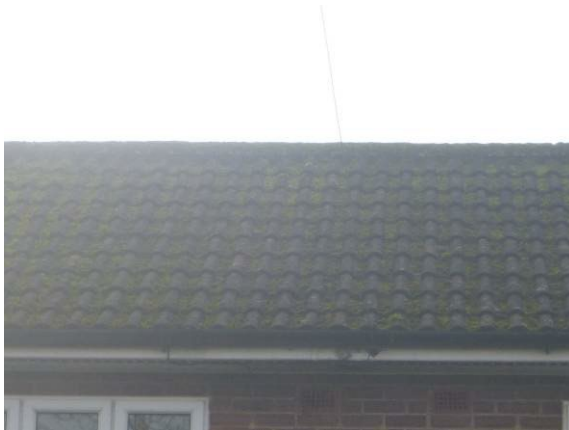
- 5.2.3** The interlocking roof tiles were tight across both elevation, and the tiles were mossy on the northern elevation (**Photograph 3**). The ridge tiles were tight across the roof, with occasionally crumbling mortar below the ridge tiles on the rear elevation, which looked superficial in extent when investigated with a high powered torch, but could offer a low suitability feature for opportunistic use by individual bats (**Photograph 4; Target note 1**).

*Photograph 3. Mossy roof tiles (front elevation).*

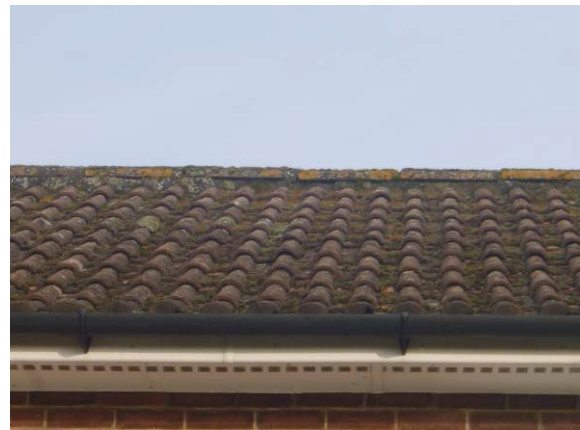
*Photograph 4. Crumbling and missing section of mortar below ridge tile (rear elevation).*

**6.1.3** The potential bat roost feature of missing mortar below the ridge tiles on the rear elevation (**Photograph 4; Target note 1**) may lead to a potential roost site (under the ridge tile) suitable for use by crevice-dwelling bats, such as the locally recorded common pipistrelle (*P. pipistrellus*). The scale of this potential roost site is considered likely to be able to support opportunistic use by individual or small numbers of non-breeding crevice-dwelling bats. Furthermore, a section of lifted lead flashing on the western end of the conservatory (**Photograph 7; Target note 2**) provides a low suitability potential roost site for these crevice-dwelling species, but a close inspection with a high powered torch found the gap to be cobwebbed and of limited extent.

**6.1.4** Taking into account the scale of the potential roost site, in conjunction with the good quality habitats nearby, the property has been assigned low potential suitability for crevice-dwelling bats (see **Appendix 2** for potential suitability categories). Based on the current survey data, the presence of a maternity colony is considered highly unlikely.

- 7.1.2** The proposed part single-storey and part two-storey rear extension are taking place a significant distance away from the only potential roost site (where bat absence has not been confirmed) located within missing mortar below the ridge (**Photograph 3; Target note 1**). The potential roost site will not be impacted during the construction works and will be retained unchanged in the long-term. Therefore, the nature and scale of the proposed construction is considered highly unlikely to result in the damage/destruction of a bat roost or lead to the disturbance, injury and/or death of bats (if present at the time of the works).

- 7.1.3** The development proposals do not impact the low potential roost site, which will remain available to bats throughout the construction and post development. As such, it is considered highly unlikely that the proposals will result in the permanent damage or loss of a bat roost.

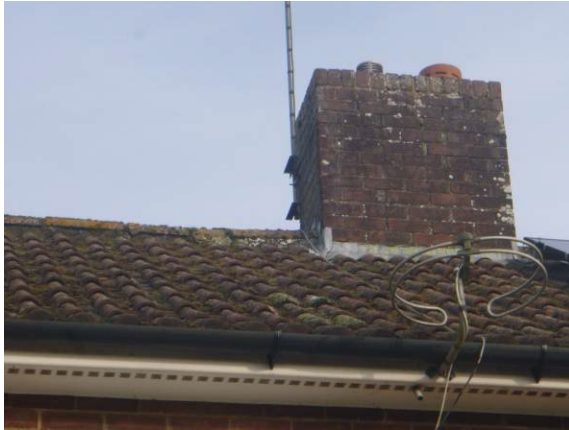
- 5.2.4** A chimney was present on the eastern end of the roof, which had flat lead flashing around the base (**Photograph 5**). The vented uPVC soffits were tight to the brickwork along the front and rear elevations, with intact sealant present and therefore offering no ingress opportunities (**Photograph 6**).

*Photograph 5. Tight lead flashing around chimney on the party end of the roof (rear elevation).*

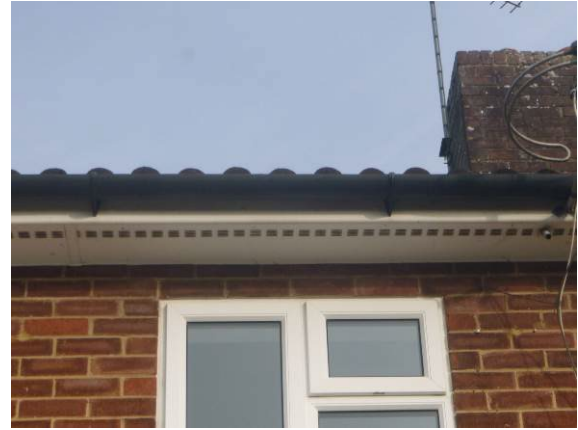
*Photograph 6. Intact sealant present along uPVC soffit (rear elevation).*

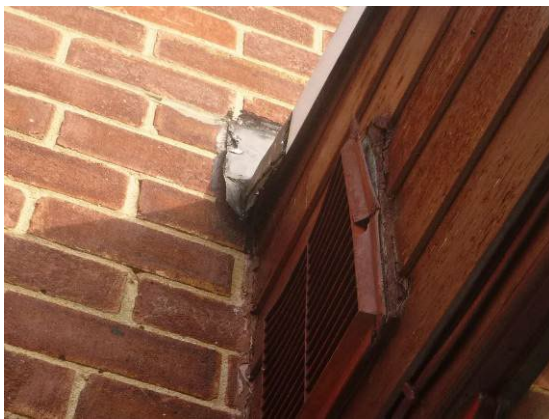
- 5.2.5** There was lead flashing along the roof of the conservatory where it joined the brickwork on the rear elevation, which was tight on the eastern end and was slightly lifted on the western end, but the gap was of limited extent and cobwebbed, so offered negligible opportunities for bats (**Photograph 7**).

*Photograph 7. Slight cobwebbed gap beneath lifted lead flashing on conservatory; negligible roosting potential (rear elevation).*

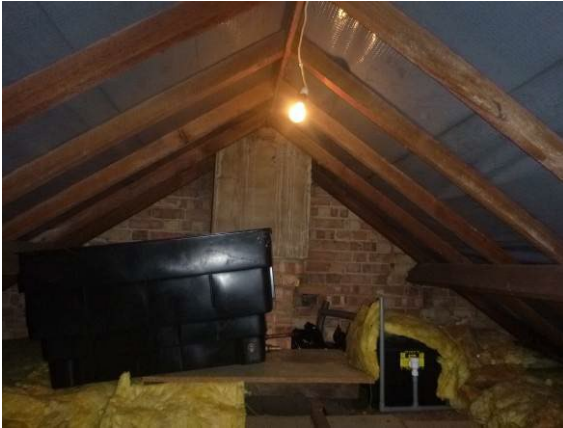
- 5.2.6** There was one roof void that covered the two storey footprint of the house and was accessible through a loft hatch. The roof void had a floor to ridge height of 1.5m, was of cut and pitch construction and the ridge was cobwebbed throughout (**Photograph 8**). The roof was lined with plastic-backed hessian felt that was intact throughout, with cardboard present on top of the rafters on a section of the roof on the rear elevation (**Photograph 9**).

*Photograph 8. Cobwebbed ridge (roof void).*

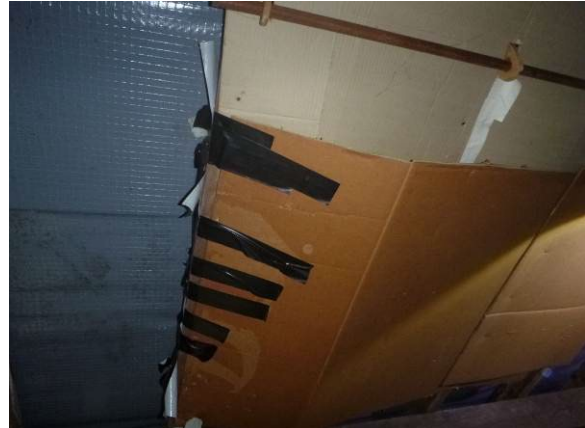
*Photograph 9. Intact plastic backed hessian roofing felt (roof void).*

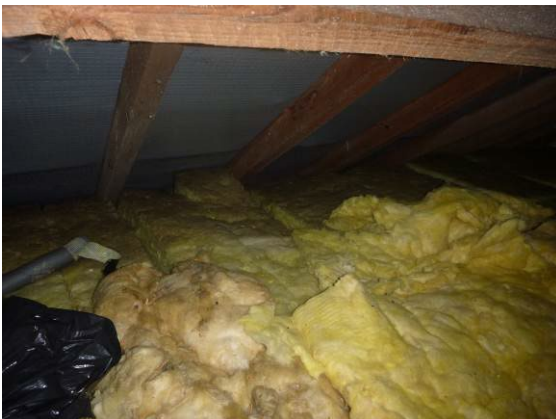
**5.2.7** The floor was centrally boarded, with a disconnected water tank present at the eastern end of the void. There was fibreglass insulation present along the edge of the void, which went up to and blocked the eaves in places, with daylight visible through open eaves in places (**Photograph 10; Target note 3**). There was a rendered chimney present at the eastern party wall which was cobwebbed and tight to the rafters (**Photograph 11**).

*Photograph 10. Fibreglass insulation present up to the eaves, blocking the eaves in places (roof void).*

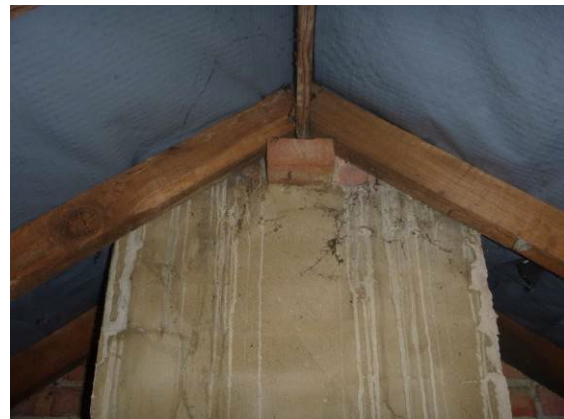
*Photograph 11. Cobwebbed rendered chimney at the eastern party wall (roof void).*

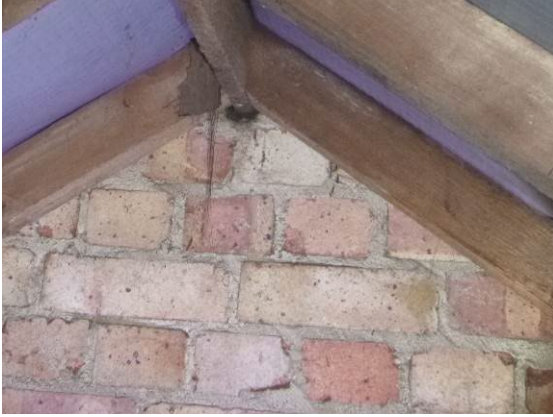
**5.2.8** The party walls at both ends of the void were cobwebbed and tight to the rafters, with no gaps present over the brickwork or around the rafters (**Photographs 12 & 13**).

*Photograph 12. Cobwebbed brickwork party wall (roof void).*

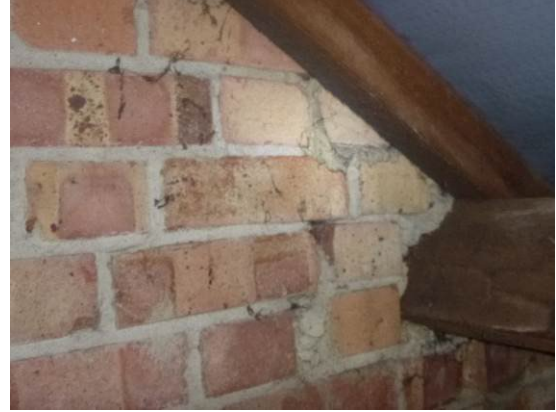
*Photograph 13. Brickwork party wall tight to rafters (roof void).*
