## HERITAGE STATEMENT

**Document No: 1312-HR-A-HS-XX-02**  
**Rev 01**

- 1.1 This Heritage Statement is submitted as part of the Listed Building application for a proposed log burner to 'Peacocks', School Road, Hurst. The document is written to assist greater understanding of the impact of the proposals upon the historic significance of the listed building. This document should be read in conjunction with the associated GA drawing.

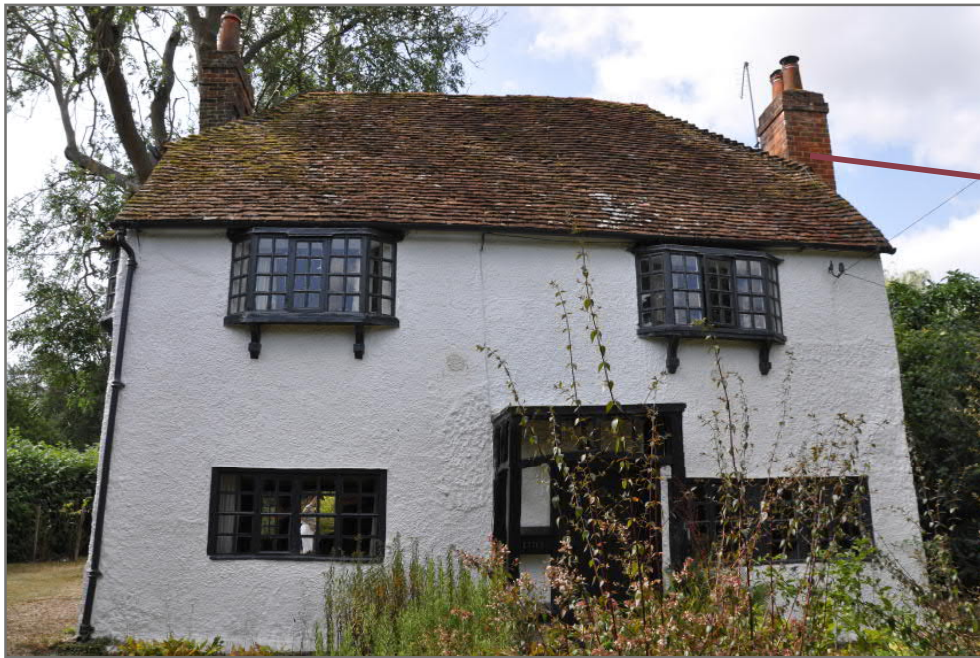
Image 2: East elevation (Phase 1 construction)

Flue/chimney  
serving the  
Dining Room

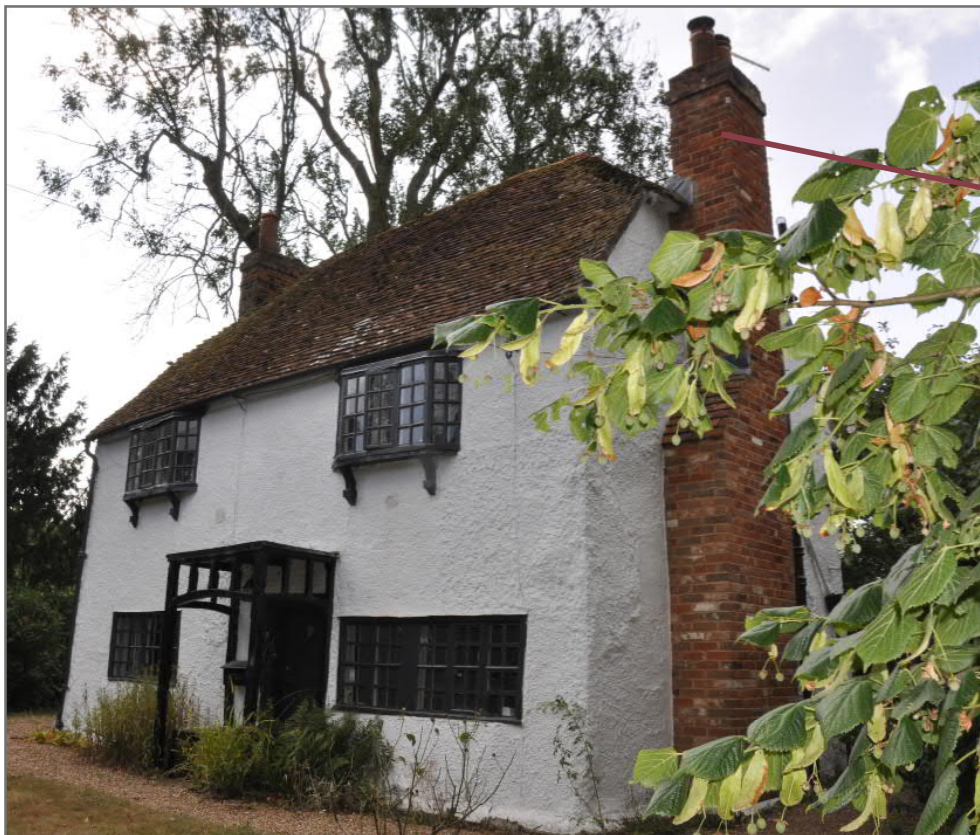
Image 3: North elevation (Phase 1 construction)

Flue/chimney  
serving the  
Dining Room

When constructed it appears the property was constructed as two cottages. The chimney to the current day Dining Room is modern and appears to have been re-built at some stage. Access to the first floor may have been via a ladder, however, evidence was not found from cursory inspection for an opening to the first floor.

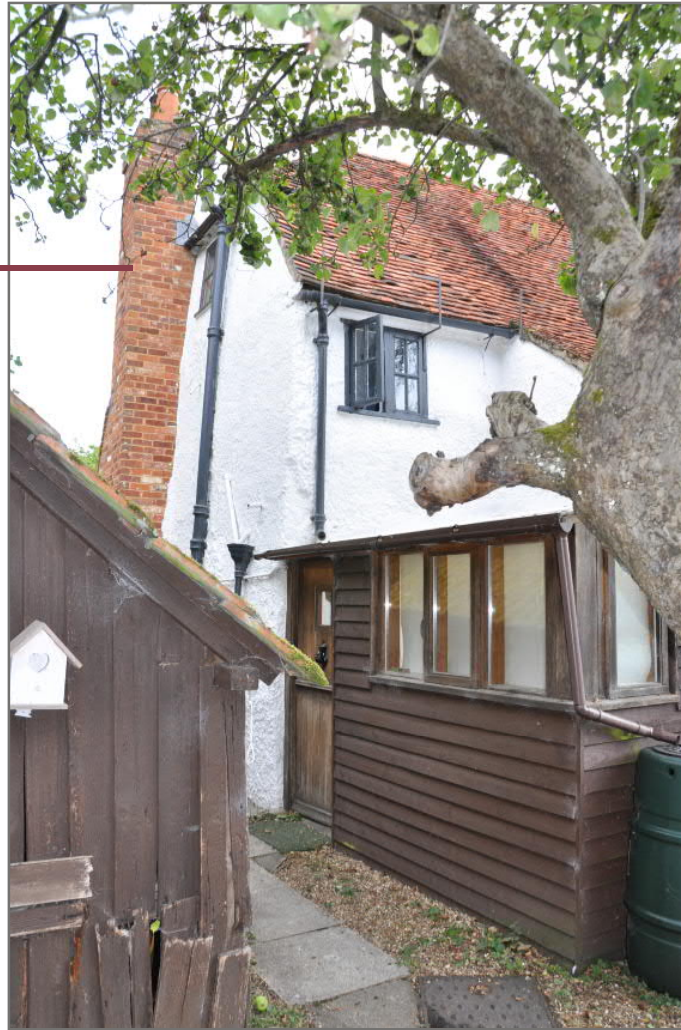
Image 6: View of north west corner - modern extension

Chimney serving  
the Dining Room

Addition of modern light weight timber framed extension to form Utility/WC function. Central stairs possibly added in early C20 as OS map indicates property as two cottages in 1898 (refer to Image 1).
