Moat House

Arborfield

LEVEL 2 BUILDING RECORDING | JUNE 2024

On behalf of Hicks Development

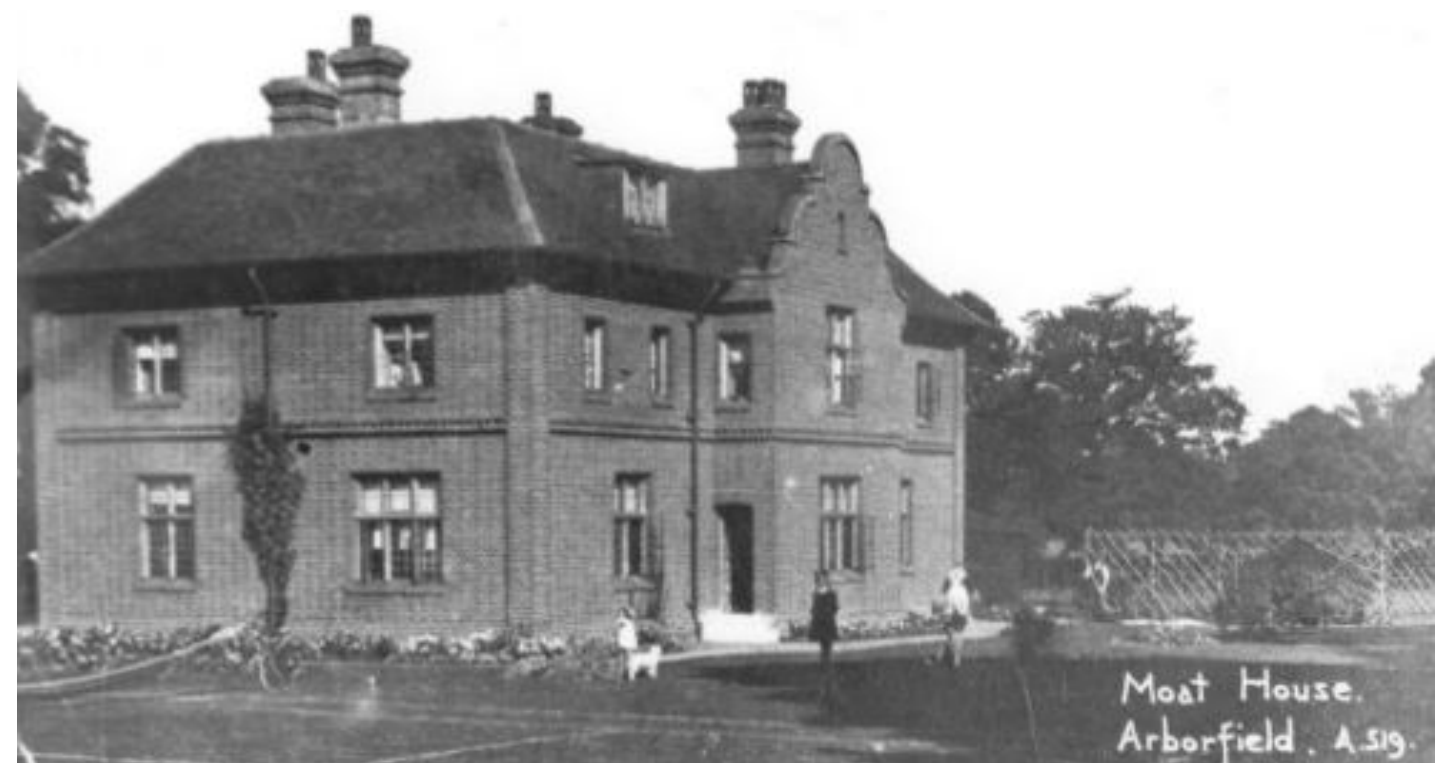
Figure 3.2 Historic Photograph of Moat House during the military use of the building

- 2.6 However, within two years of the Depot's establishment, the army set out to construct a purpose-built Officer's residence within the vicinity. The result was Moat House which was completed in 1906 and shortly after occupied by the Captain Quatermaster, J. Barry. The remaining elements of Old Bigg's Farm were then shortly demolished.

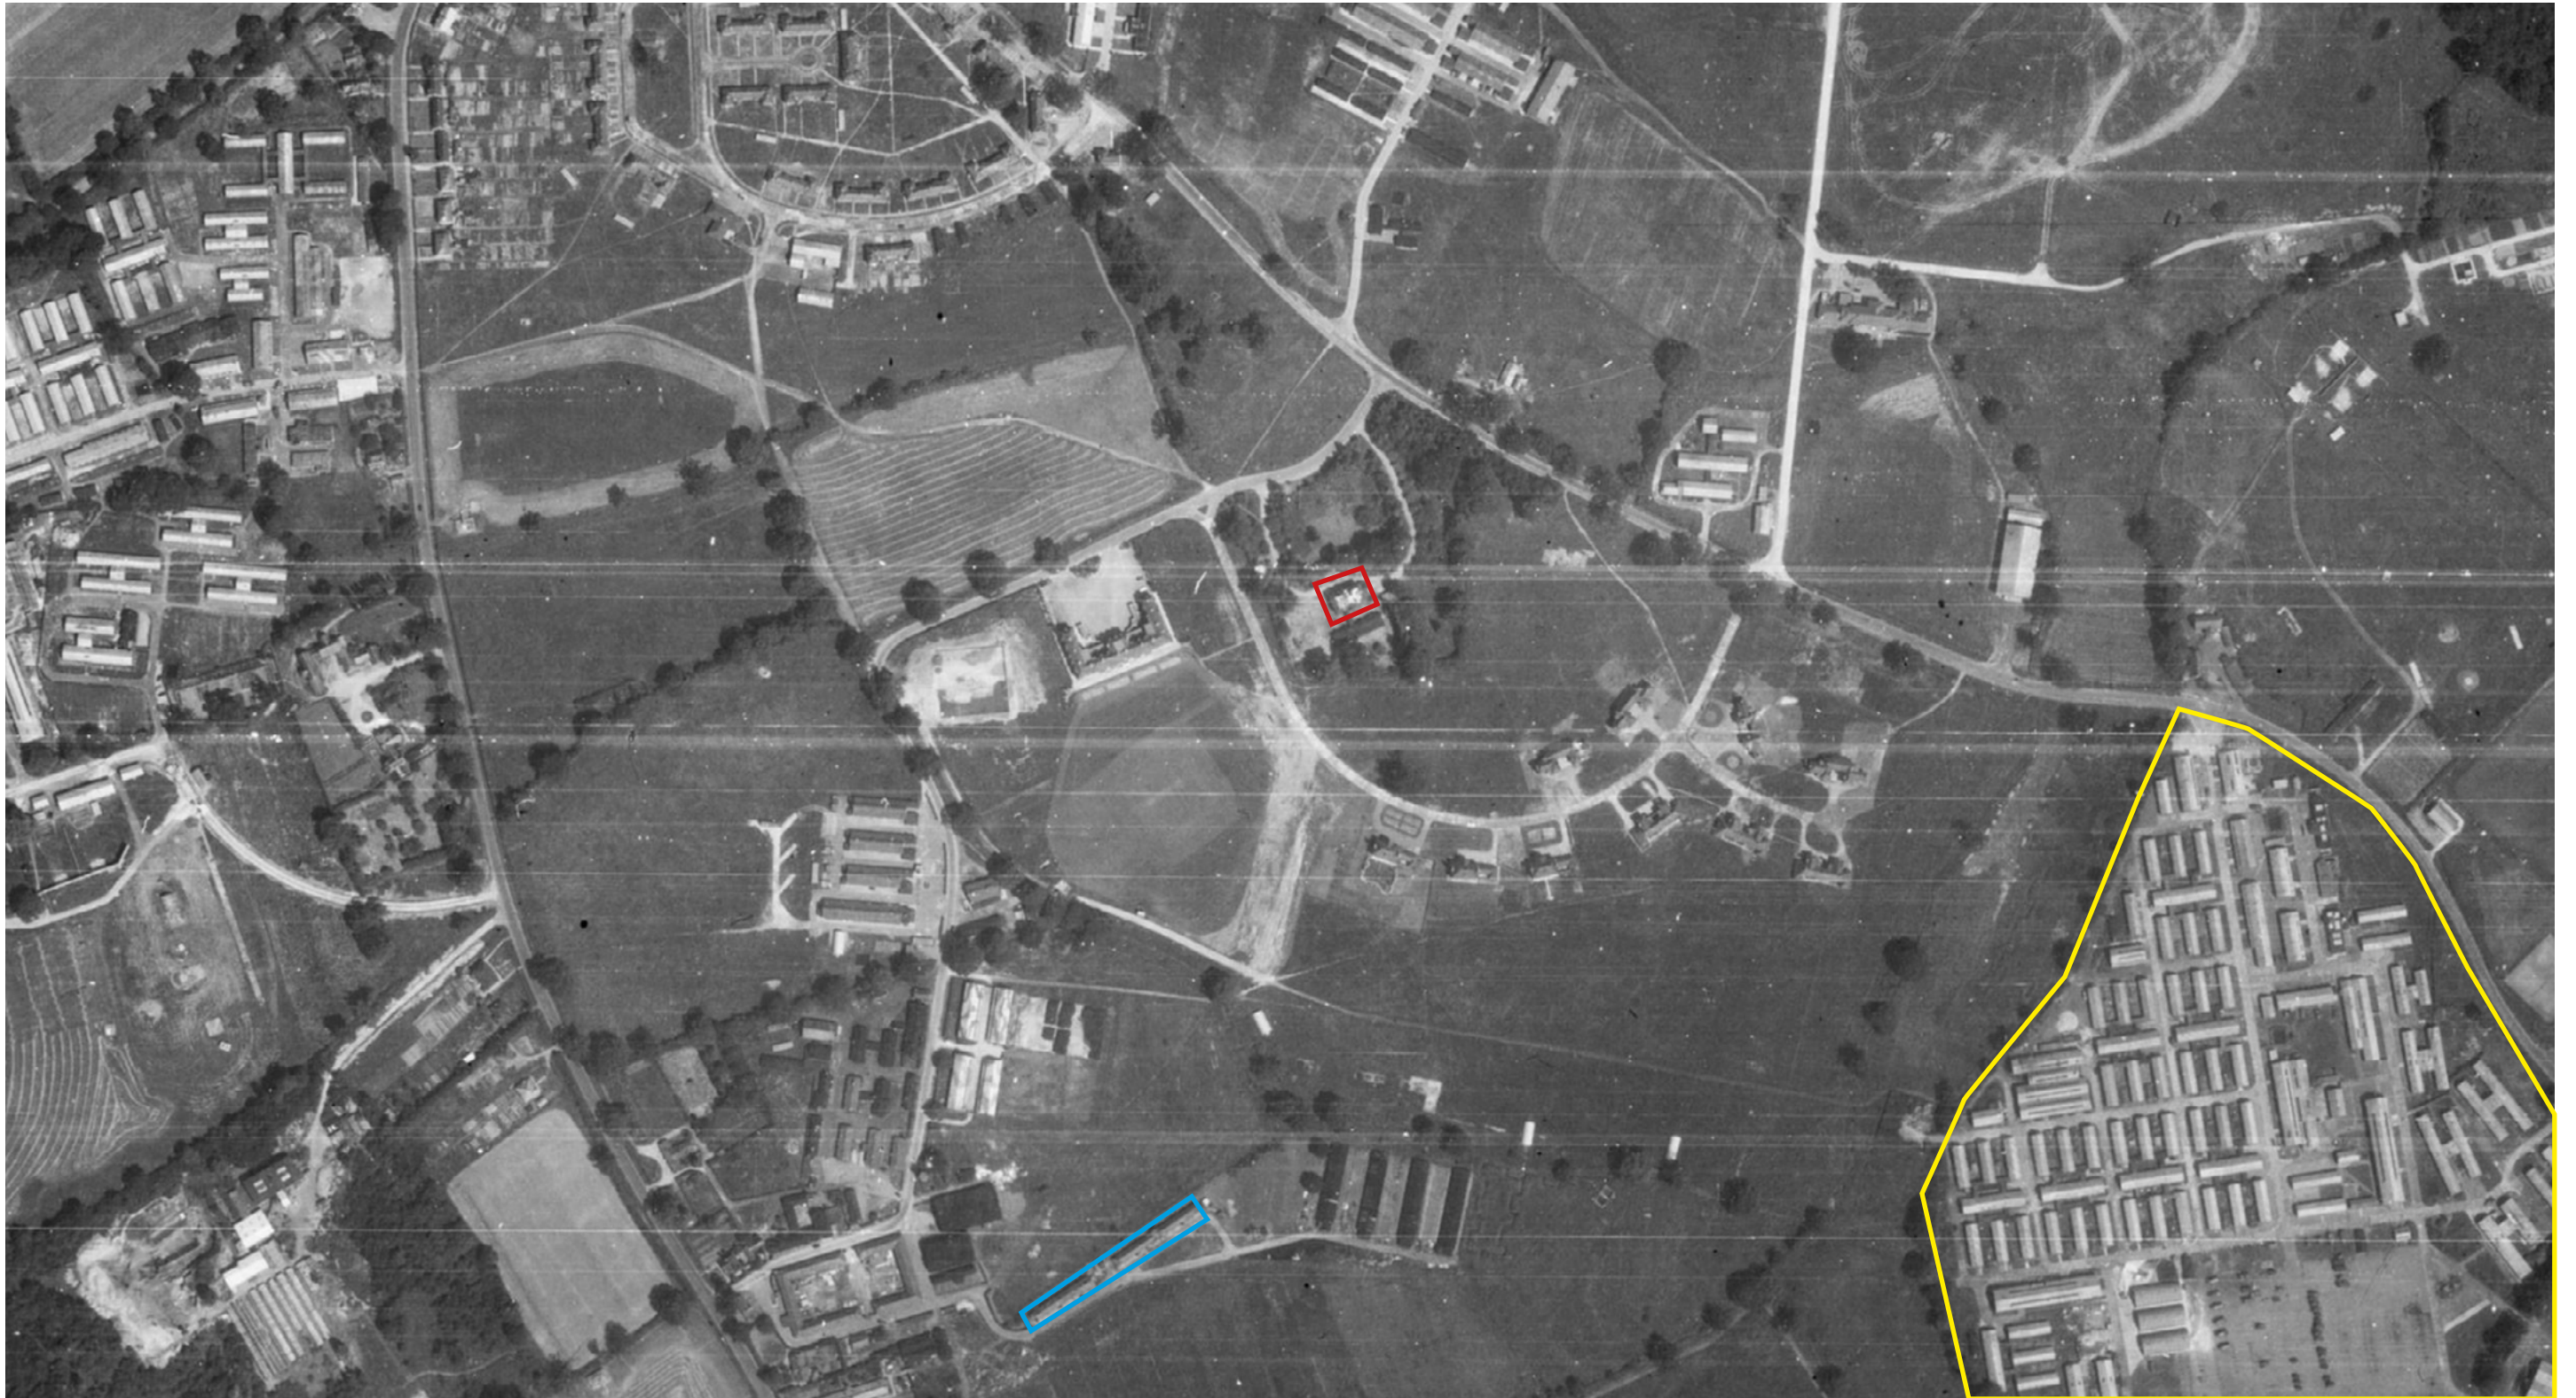
Figure 2.1 1946 Aerial Image of the Site (red outline) in context to the changing setting with the surviving Depot stables (blue outline) and early stages of Army Technical School with Bailleul Barracks shown (yellow outline).
