## **PRELIMINARY ECOLOGICAL APPRAISAL (DBW) AT 8 BRAYBROOKE GARDENS WARGRAVE**

**Prepared for:  
Mr T McMahon  
8 Braybrooke Gardens  
Wargrave  
Wokingham  
RG10 8DW**

**2 October 2025**

**Ref: SPH/NP/PEA-25/16.09**

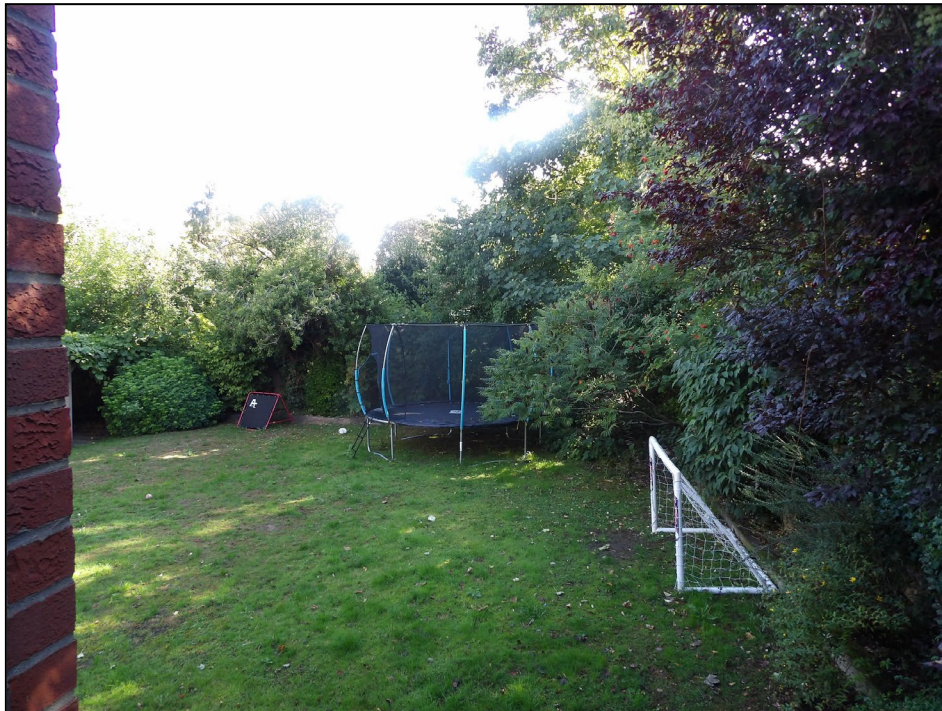
Figure 3. Rear garden. 8 Braybrooke Gardens, Wargrave. 16.09.25

The application site comprises a detached, brick-built 2 storey property. The remainder of the site comprises a shared driveway/parking area with lawn and mature trees, see cover photograph. The rear garden is mainly laid to lawn with mature trees/shrubs on the boundaries, see Figure 3 below. The site itself offers some foraging and commuting habitat for bats and there is direct ecological connectivity to the wider landscape.

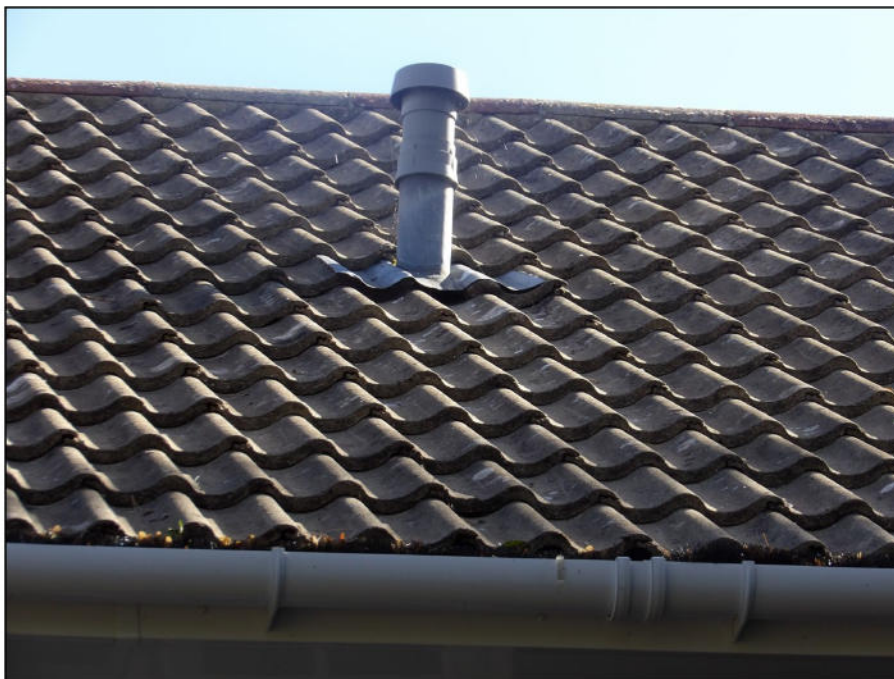
Figure 4.  
Example roof  
and ridge tiles.  
8 Braybrooke  
Gardens,  
Wargrave.  
16.09.25

The property is a detached, brick-built building 2 storey building that is in a good condition externally. The pitched roof is covered in interlocking tiles, all of which are well fitted with no missing or broken tiles, see Figure 4 on page 8. The ridge tiles and verges are all in good condition with no gaps which roosting bats could exploit, see Figure 5 on page 8. The lead flashing around the chimney stack and flues is flush with no gaps, see Figure 6 on page 9. There is a section of tightly fitted wooden cladding on the front and side (southern) elevation, with no gaps or warping and offers no roosting potential for crevice dwelling bat species, see Figure 7 on page 9.

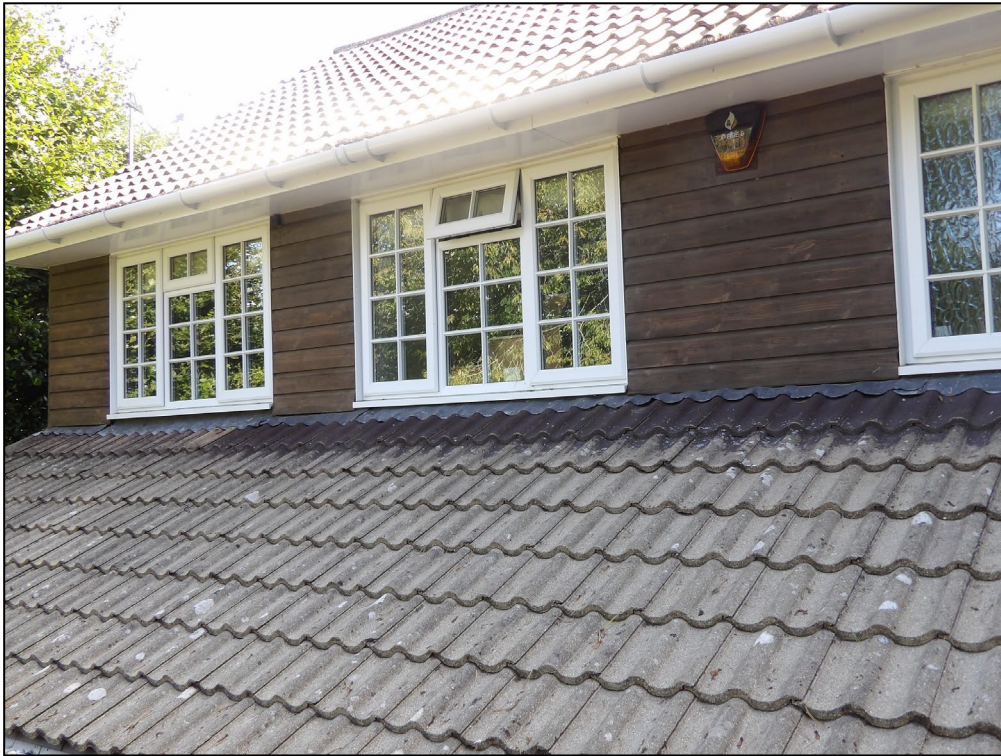
Figure 8. Example sealed front porch tiles. 8 Braybrooke Gardens, Wargrave. 16.09.25

The tiles covering the front porch are all tightly fitted with no gaps, as are the verges and lead flashing affixing it to the main dwelling, see Figure 8 on page 10. Historically a two-storey side (northern) elevation extension with attached single storey side and rear extension was added, see Figure 9 on page 10. The roof and ridge tiles on this single storey element are all tightly fitted aside from a lifted tile by a flue on the rear elevation (see Figure 10 on page 11), and this could afford roosting opportunities or access for crevice dwelling bat species however, this section of the property is not being affected by the proposed works. The soffits and fascias around the whole property are all tightly fitted to the wall plate with splits or gaps that could afford roosting potential, see Figure 11 on page 11.

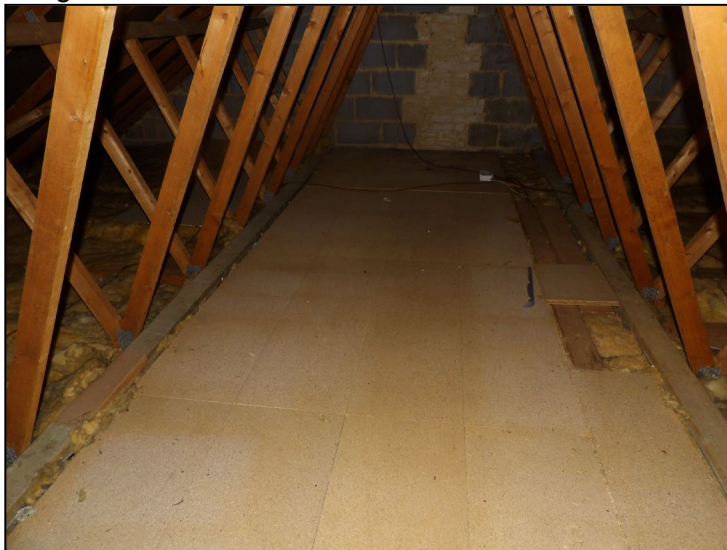
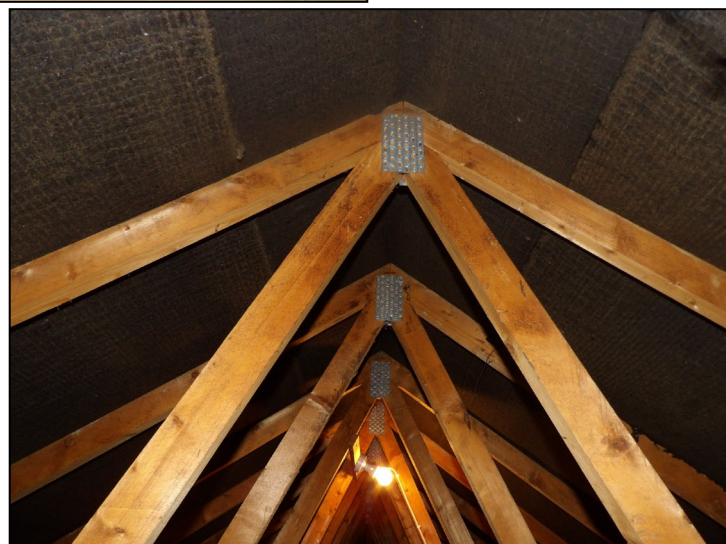
Figure 12. Example main loft space and bitumen lining to tiles. 8 Braybrooke Gardens, Wargrave. 16.09.25

There are 2 loft spaces within the property, both of which were accessed via a ladder and both are in a good condition internally. The main loft space was lit, partially boarded and insulated (see Figure 12 below) and the roof tiles are lined with bitumen felt, all of which that could be seen was in a good condition with no rips or tears. The secondary loft space was also lit, partially boarded and the roof tiles were lined with bitumen felt off of which appeared to be in a good condition with no rips or tears, see Figure 13 on page 13.
