**Outbuildings at 12 Limmer Close  
Barkham  
Wokingham  
Berkshire  
RG41 4DF**

# **Updated Preliminary Bat Roost Assessment**

Ref: R2424/a

**August 2026**

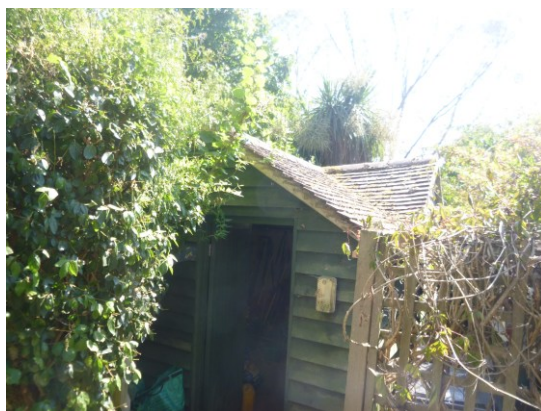
- 3.2.1 The shed (**B1**) was an 'L'-shaped building constructed of single-skin timber panels (**Photograph 1**). The pitched roof was covered with overlapping tiles that were mostly flat and tightly fitted (**Photograph 2**). There were, however, a few gaps under uneven and/or slightly raised verge tiles that, after close endoscopic inspection, showed no evidence of use by crevice-roosting bats (**Photographs 2 & 3; Target notes 2 & 3**). Mortar was missing beneath ridge tiles in places along the roof but the gaps were superficial and did not provide bats with a suitable crevice to roost inside (**Photograph 5; Target note 4**). The verge mortar on all the shed gables was complete and intact (**Photograph 6**). No evidence of bats was visible on the building.

1. Garden shed (B1) viewed from north.

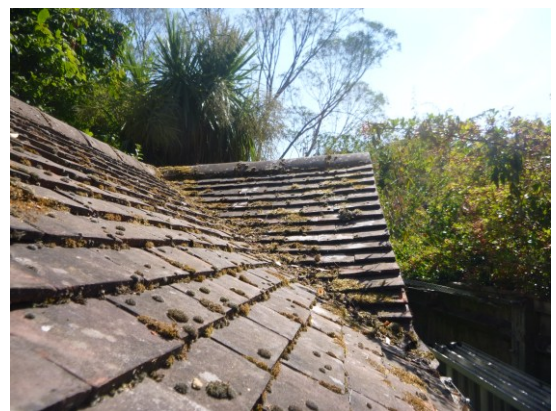
2. Mostly flat and tight overlapping roof tiles (B1).

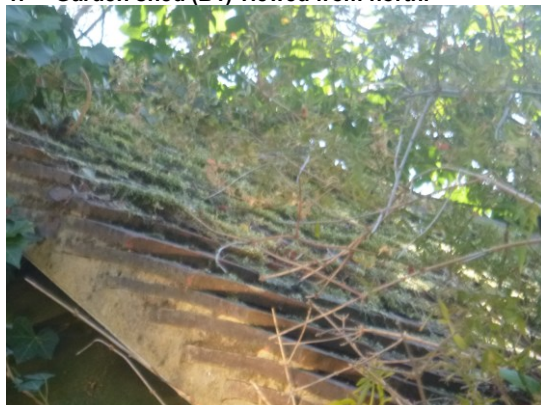
3. Inspected gaps under uneven verge tiles at western gable end (B1).

**4.1.1** The garden shed (**B1**) had a few features of low potential (refer to **Appendix 1**) for use by crevice-dwelling bat species such as the pipistrelles (*Pipistrellus* spp.) and/or small *Myotis* species. The potential bat roost features were confined to uneven and/or slightly raised verge tiles at the gable ends on the shallow pitched roof, which after close endoscopic inspection, showed no evidence of use by crevice-roosting bats. Furthermore, bat access inside the shed was blocked by breathable roofing membrane and no bat droppings were found internally, and therefore it is considered unlikely that the shed supports roosting bats, matching the findings from 2019.

**4.3.1** The demolition work will be preceded by a repeat endoscopic inspection of the features with bat roost potential, i.e. gaps under uneven and/or slightly raised verge tiles, for the presence of bats by a licensed ecologist. If bats or evidence of bats is found, the work will begin only once a licensed ecologist

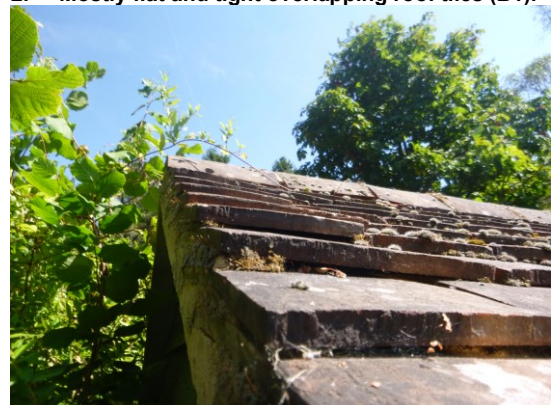
4. Inspected gaps under slightly raised verge tiles at eastern gable end (B1).

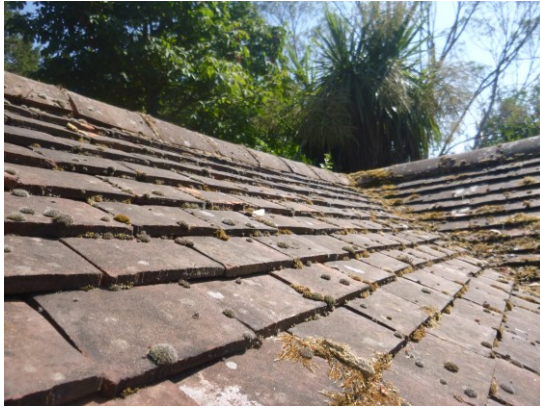
5. Superficial gaps in ridge mortar (B1).

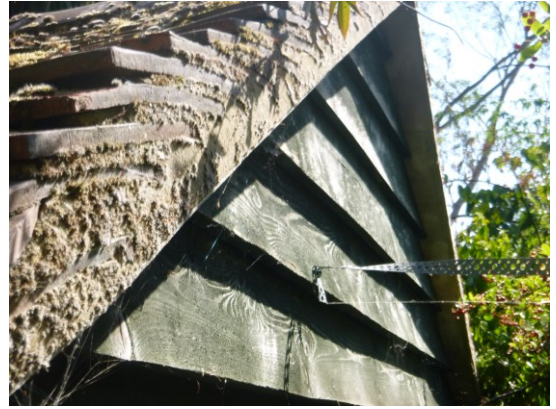
6. Intact verge mortar on northern gable (B1).

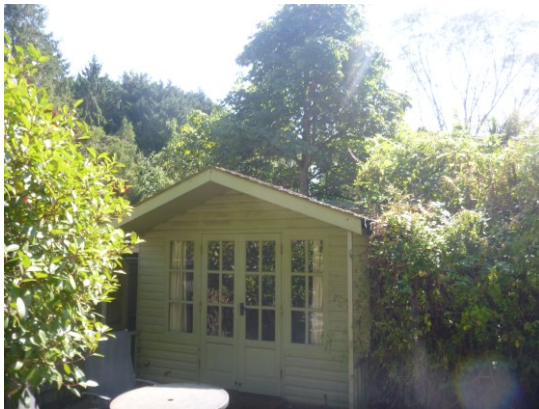
- 3.3.1 The summerhouse (B2) was a simple timber structure with a front veranda and pitched roof (**Photograph 7**). The walls were covered in timber shingles, which were warped in places creating superficial gaps beneath that were of limited extent and showed no evidence of bats during a close inspection (**Photograph 8; Target note 5**). The building was formed of painted timber panels that provided no opportunities for bats.

7. Summerhouse (B2) viewed from north.

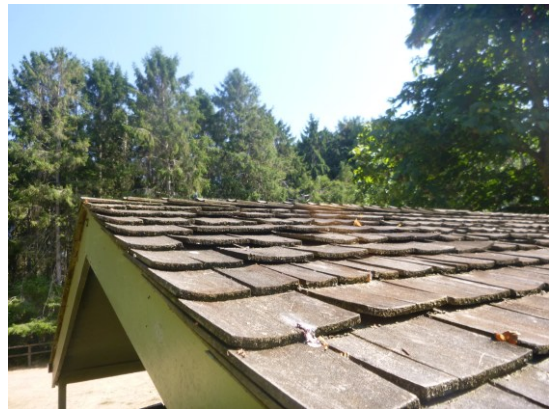
8. Timber shingle roof on summerhouse with some slightly warped shingles (B2).

**4.1.2** The summerhouse (**B2**) had superficial external features i.e. warped timber shingles, not noted in 2019, but these were unsuitable for use by crevice-dwelling bat species and there was no evidence of bats, and internally comprised living space, is therefore of negligible bat roost potential (refer to **Appendix 1**).

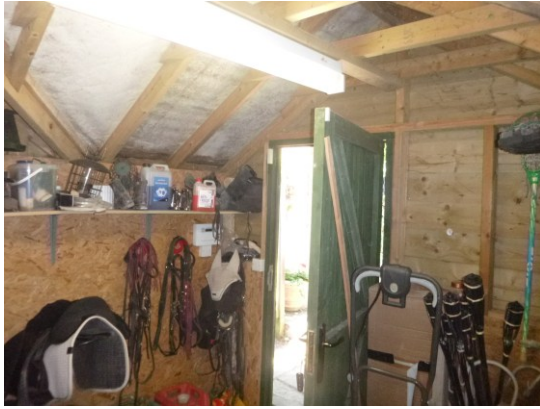
- 3.4.1 The interior of the shed (B1) was open from the ground to the roof and used to store gardening equipment and tools (**Photograph 9**). The roof was of 'cut and pitch' construction with an exposed ridge beam and rafters and was lined with a white breathable roofing membrane (**Photograph 10**). The walls were a single-skin of timber shed panels and the timbers at the gable ends were tight (**Photograph 11**). No evidence of bats was found in the shed.

9. Garden shed interior (B1).

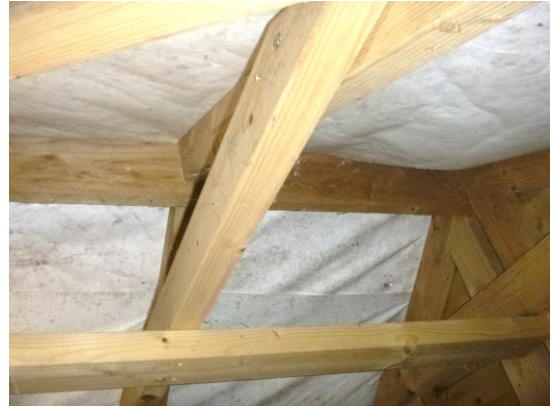
10. Breathable roofing membrane lining roof (B1).

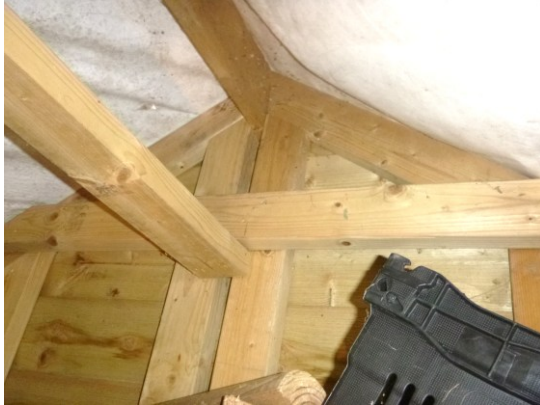
11. Single-skin shed panel walls with tight roof timbers at gable ends (B1).

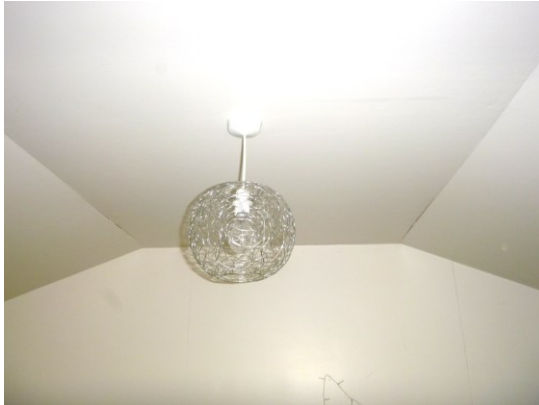
- 3.5.1 The summerhouse had plastered walls, and ceiling, and was furnished and therefore unsuitable for bats (**Photograph 12**).

12. Walls and ceiling plastered in summerhouse (B2).
