**10 Danywern Drive  
Winnersh  
Wokingham  
Berkshire  
RG41 5NR**

# **Preliminary Roost Assessment**

Report ref.: R2632\_PRA\_a

**March 2024**

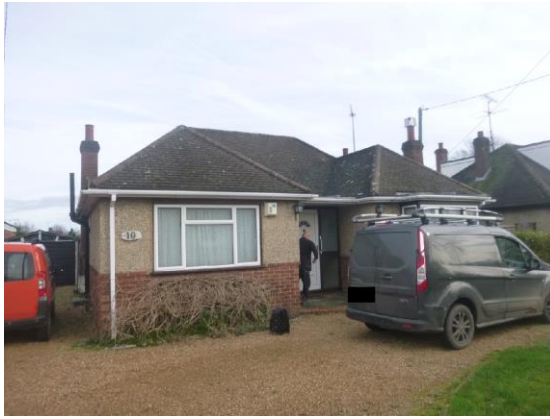
**5.2.2** The detached bungalow had a hipped roof with a flat roof section over the front porch and glass-roofed conservatory at the rear (**Photographs 1 & 2**).

*Photograph 1. Front of property viewed from southwest.*

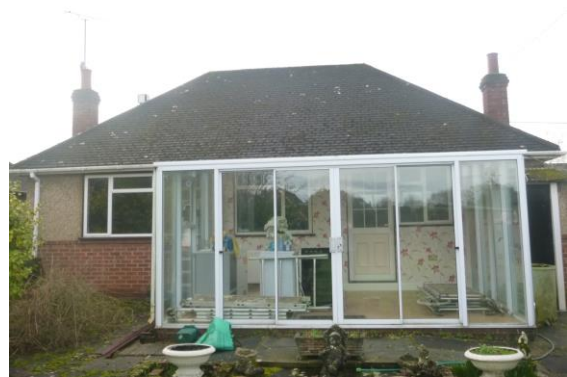
*Photograph 2. Rear of property viewed from northeast.*

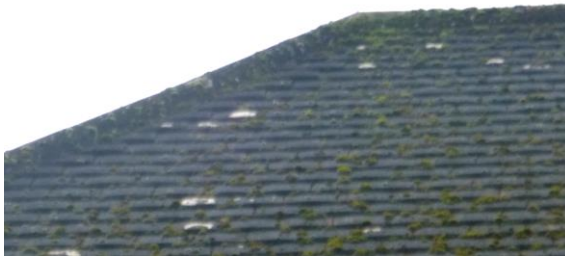
- 5.2.3** The hipped roof was covered in clay tiles that were mostly flat and intact other than occasional lifted tiles along the hip on the rear elevation and southwest elevation (**Photograph 3; Target note 1**). The ridge and hip mortar was intact on all elevations (**Photograph 4**).

*Photograph 3. Lifted clay roof tiles along the hips (rear elevation).*

- Lifted clay roof tiles along the rear hips of the property (**Target note 1**); and
- A gap between the uPVC soffit and brickwork on the front elevation (**Target note 2**).

- 8.1.2** A minimum of one dusk emergence survey visit should be undertaken in the period of May to August. This survey visit will form the roost characterisation necessary to inform an impact assessment and mitigation strategy.

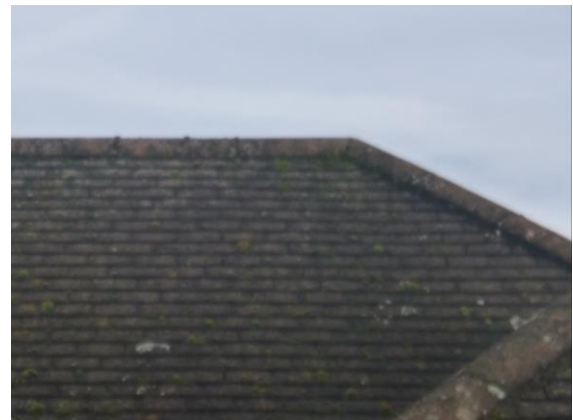
*Photograph 4. Ridge and hip mortar fully intact (front elevation).*

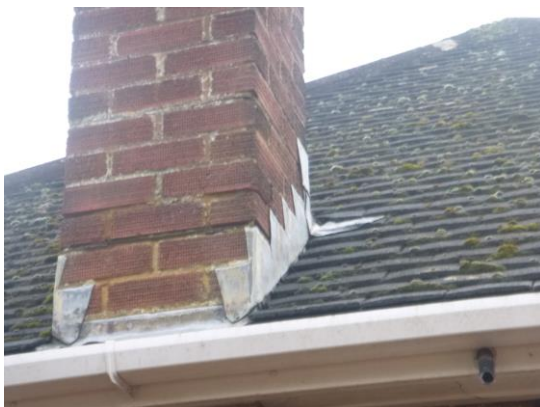
- 5.2.4** The lead flashing situated at the base of the chimneys was sealed to the clay roof tiles and brickwork (**Photographs 5 & 6**). The roof tiles were cut behind the western chimney and the gaps were closely inspected and confirmed to be superficial (**Photograph 7**).

*Photograph 5. Lead flashing sealed to brickwork and roof tiles (northwest elevation).*

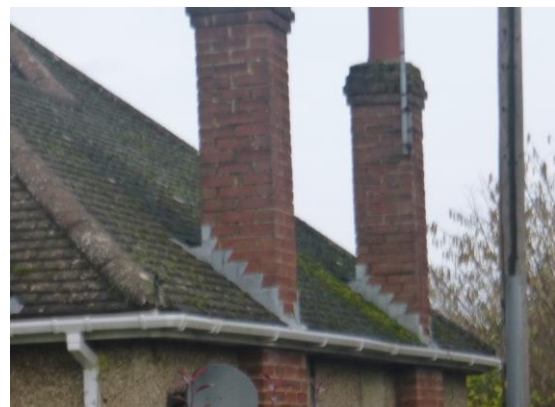
*Photograph 6. Lead flashing sealed to brickwork and roof tiles (southeast elevation).*

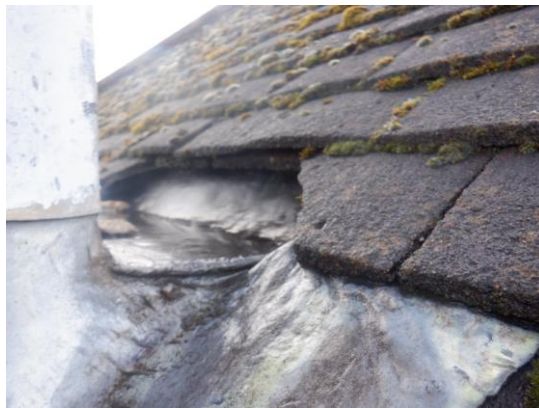
*Photograph 7. Superficial crevice beneath cut roof tile (northwest elevation).*

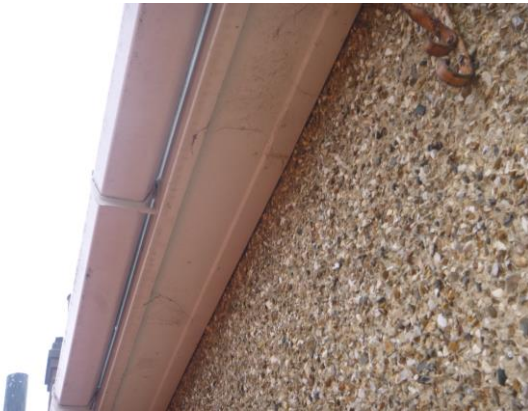
- 5.2.5** The uPVC soffit was sealed to the wall of the property, with a gap situated between the soffit and wall on the front elevation (**Photographs 8 & 9; Target note 2**).

*Photograph 8. uPVC soffit sealed to the rendered wall (northwest elevation).*

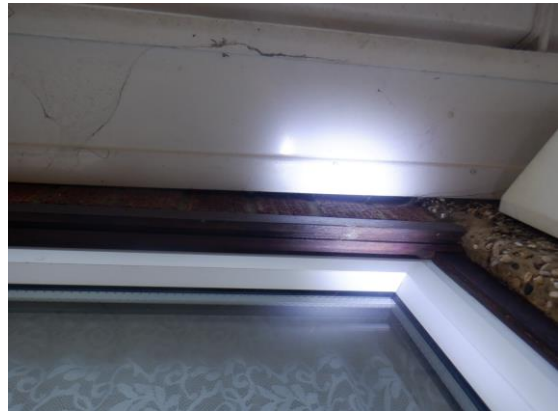
*Photograph 9. Gap between uPVC soffit & brickwork (front elevation).*

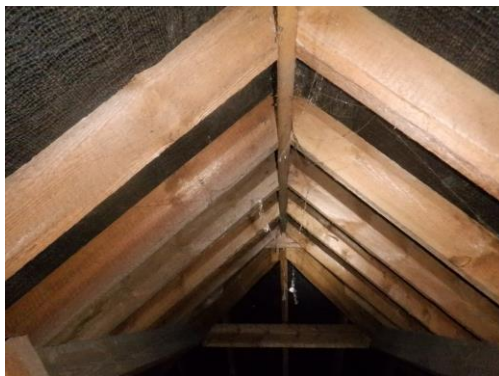
- 5.2.6** The roof void was of cut & pitch construction, accessible via a ladder and had an approximate floor-to-ridge height of 1.75 metres in which the ridge was cobwebbed throughout (**Photograph 10**).

*Photograph 10. Ridge cobwebbed throughout the void.*

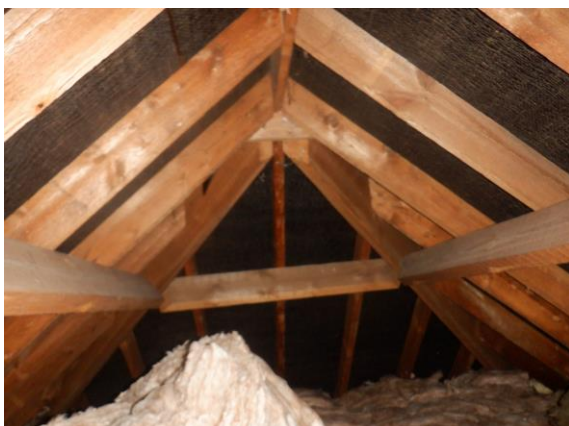
- 5.2.7** The roof was lined by a fully intact hessian-reinforced bitumen felt which was tight to the roof timbers and around the timbers of the chimney on the eastern elevation (**Photographs 11 & 12**).

*Photograph 11. Fully intact bitumen felt roof lining.*

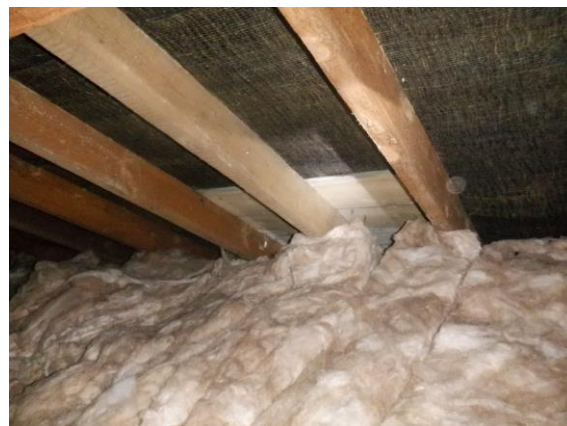
*Photograph 12. Bitumen felt tight to the chimney timbers.*

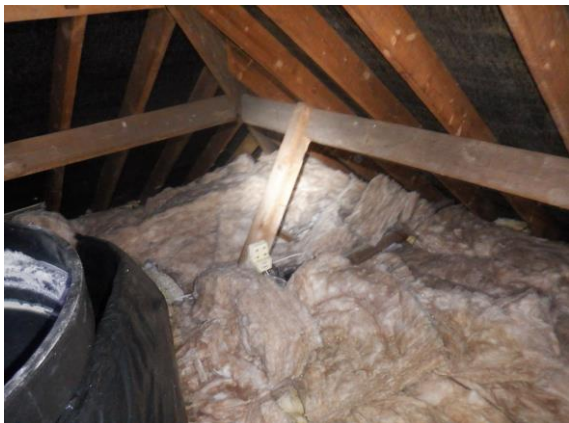
- 5.2.8** The floor was covered by fibreglass insulation that was installed in 2011 over a previously existing layer of vermiculite. The fibreglass filled the eaves, preventing access to the uPVC soffit (**Photograph 13**). A small, inactive wasp nest was situated within the southwest corner of the void (**Photograph 14**).

*Photograph 13. Eaves blocked by fibreglass insulation.*

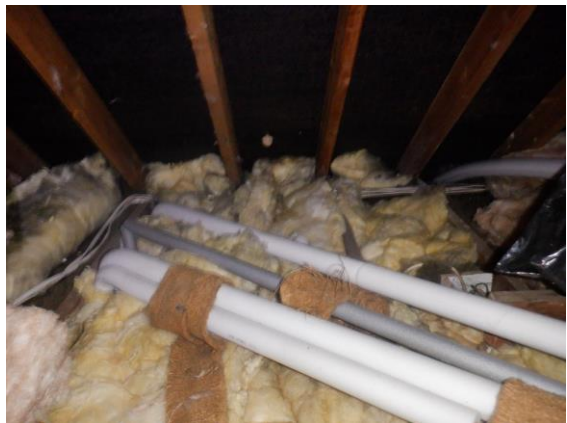
*Photograph 14. Small in-active wasp nest within southwest corner of the void.*
