**BS5837:2012 TREE SURVEY AND  
ARBORICULTURAL IMPACT ASSESSMENT:  
Cherrylands, New Mill Road, Finchampstead, RG40  
4QU**

Our reference: GHA/DS/160292:25

Location: Cherrylands, New Mill Road, Finchampstead, RG40 4QU

Date of Inspection: 30<sup>th</sup> July 2025

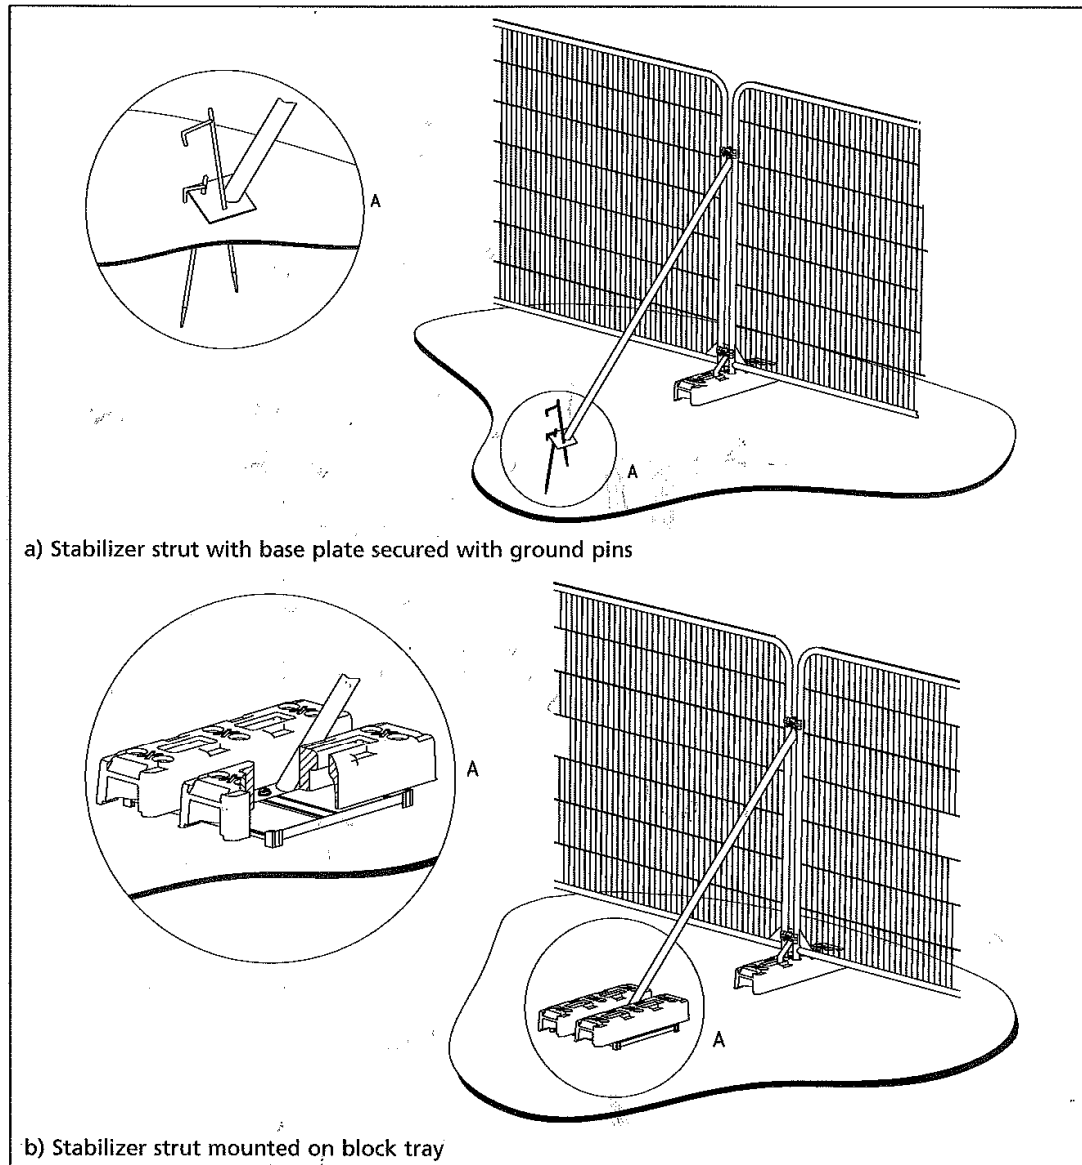
**Appendix C**  
**TREE FENCING DETAIL**

Figure 3 Examples of above-ground stabilizing systems

It is essential for the future health of the trees to be retained on site, that all development activity is undertaken outside the root protection zone of these trees. The position of the fence **MUST** be marked out with biodegradable marker paint on site and agreed with appropriate representatives from the LPA and contractor. The fencing **MUST** be erected **prior** to any works in the vicinity of the trees and removed only when all development activity is complete. The protective fencing **MUST** be as that shown in BS 5837 (see Appendix C). The herras panels **MUST** be joined together using a minimum of two anti-tamper couplers which **MUST** be installed so they can only be removed from the inside of the fence. The panels **MUST** supported by stabilizer struts, which **MUST** be installed on the inside and secured to the ground using pins or appropriate weights.
