# **Preliminary Roost Assessment**

**Castleman's Cottage, Bath Road, Knowl  
Hill, Reading RG10 9UT**

04 May 2025

**Reference Number:** Eco25-19

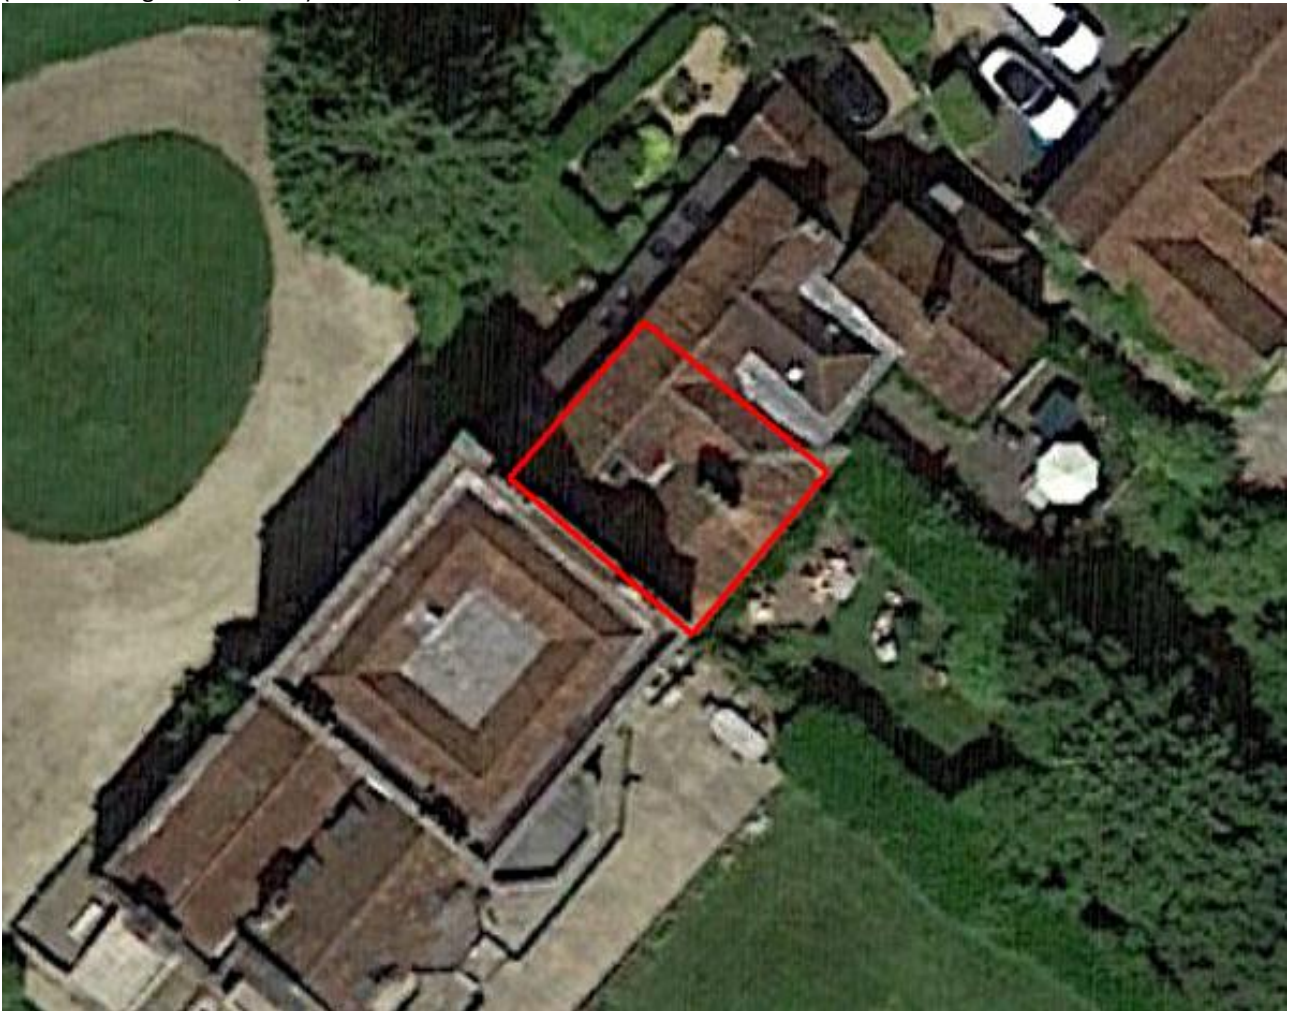
**Figure 1: The structures surveyed, B1 (red)**

Castleman's Cottage, located on Bath Road, Knowl Hill, Reading, RG10 9UT (hereafter referred to as "the site"), is centred at Ordnance Survey Grid Reference SU 81556 78496. The building considered for this report (B1), is a mid-terrace cottage that has recently undergone a roof strip, during which all roofing tiles were removed. The proposed works for B1 include the complete replacement of the roof structure.

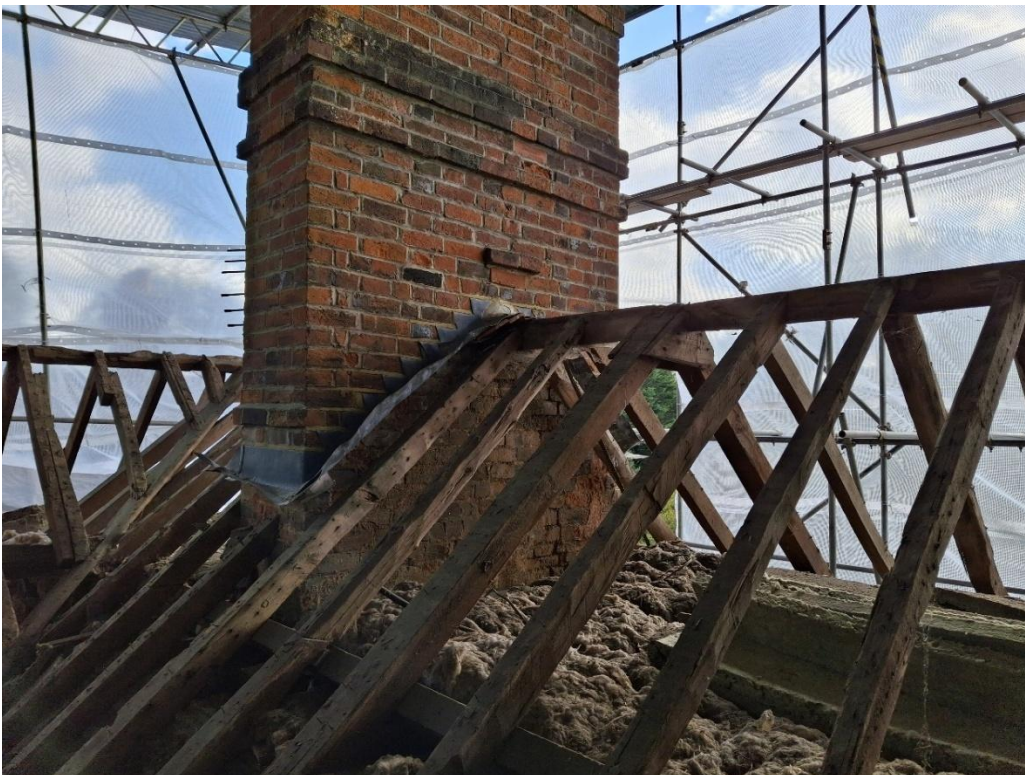
**Figure 3: Exposed roof beams and remaining chimney**

that forms an overall square-shaped footprint when viewed from above. This configuration creates multiple rooflines and junctions. All parts of the roof have been stripped of tiles, and the timber frames are exposed. The chimney remains in-situ, along the ridge of the southernmost roof pitch. Scaffolding and plastic sheeting currently provide a cover to the remaining roof structure.

The insulation within the roof void has been significantly disturbed because of the roofing works. However, inspections were conducted where feasible, focusing on any remaining debris. Particular attention was paid to the area surrounding the chimney base, as these locations often provide potential roosting niches. During the inspection, several small fragments were recovered, which were suspected to be remnants of bat droppings and were collected for further analysis.

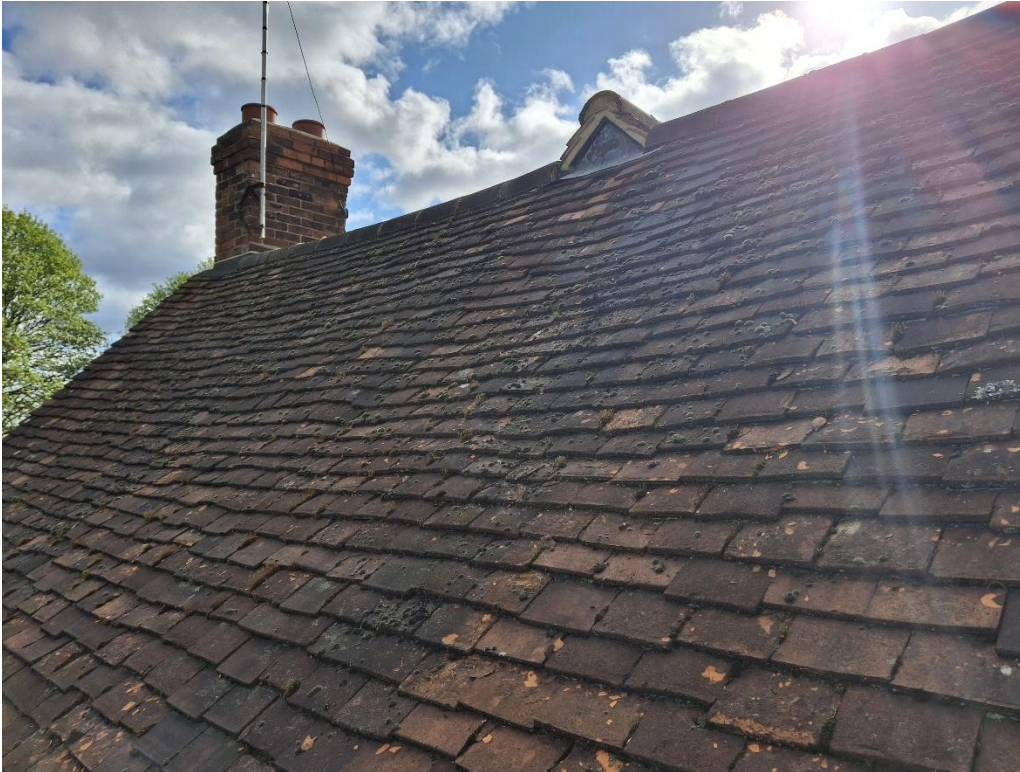
**Figure 4: The northwest roof of B2, as seen from scaffolding**

B1 is located on the southwest side of a semi-detached property. The roof of Building B2 remains intact, with the tiles securely in place. A limited survey conducted from the scaffolding on the northwest side of B1 revealed that the tiles on B2 are in moderate condition, with some areas

showing gaps where tiles have lifted. Additional gaps were also noted beneath the lead flashing near the ridge.
