## Preliminary bat roost assessment

| Site Location | 43, NINE MILE RIDE, RG40 4ND |
| Document reference | CE4705 |

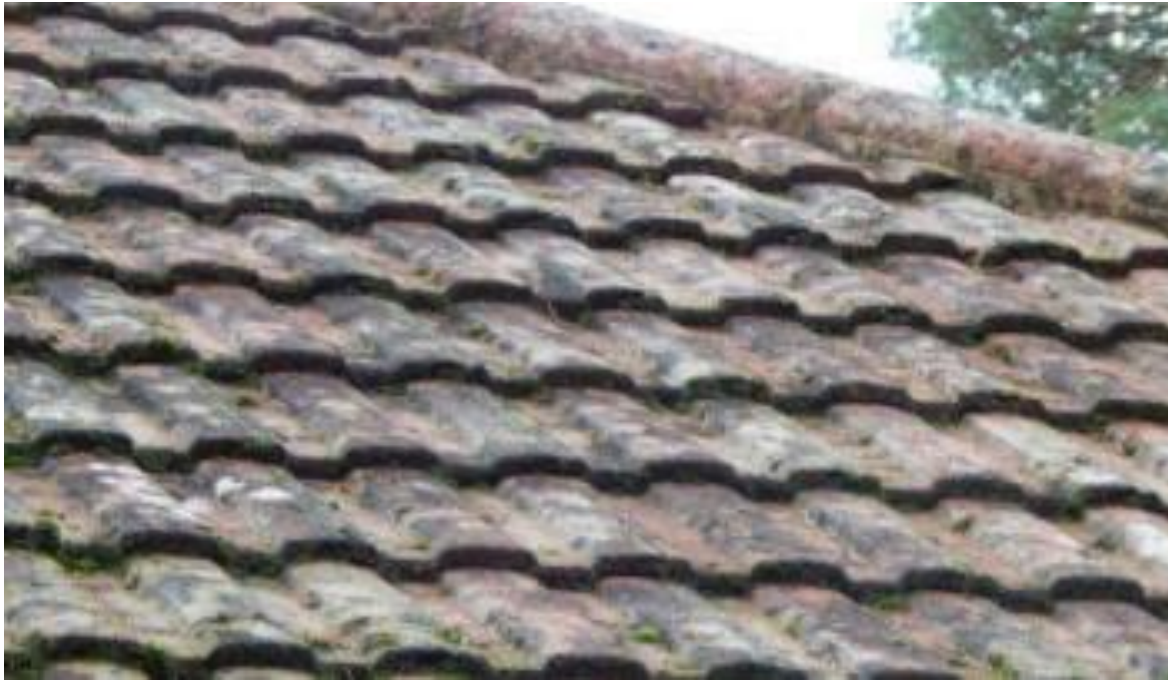
Image 5 – Close view of the main upper roof coverings to the main dwelling where no suitable features of value to bats were identified

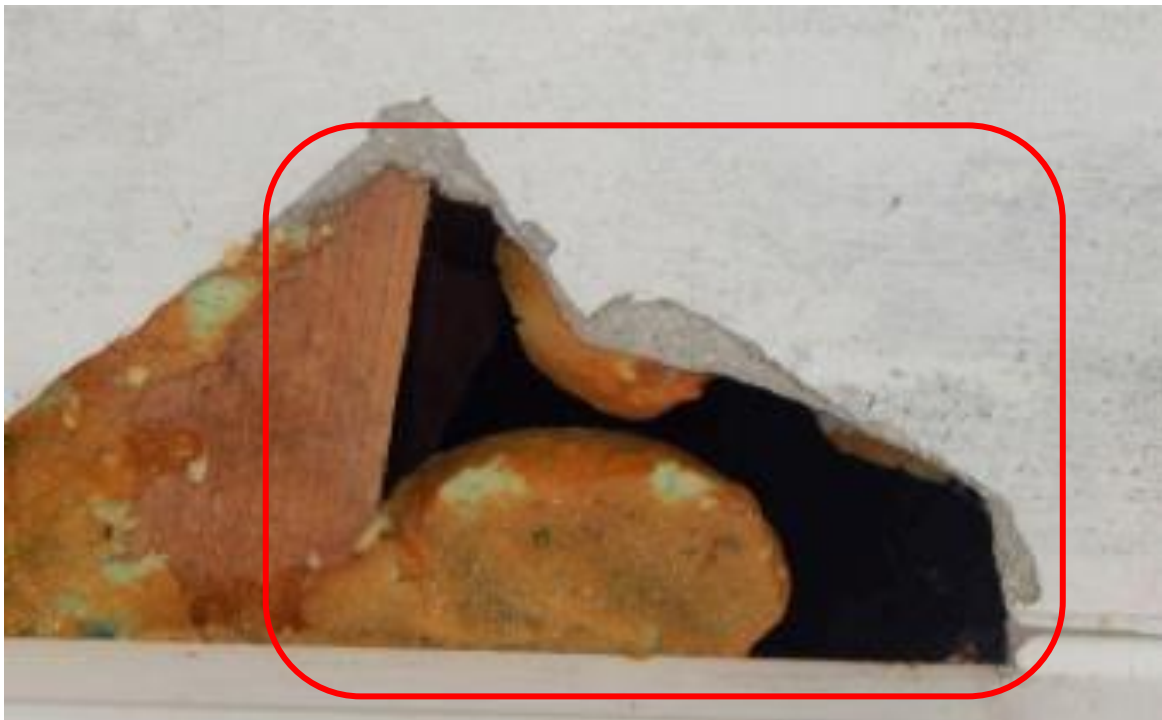
| External | Features of value to bats | Notes |
|---|---|---|
| Eaves coverings | Yes | The eaves coverings to the main dwelling have demonstrated gaps of adequate proportions to offer access for bats and nesting birds into the main roof void spaces.<br><br>The fascia coverings to the detached garage demonstrated no visible features of value. |

Image 6 – Gaps to the eaves coverings of the front and rear areas of the property of adequate proportions to offer access opportunities for bats and nesting birds within

- 6.4 The main dwelling has evidenced roosting features of value within the eaves coverings which offer access and availability to both void & crevice dwelling bats and could not be fully ruled out during the Preliminary Roost Assessment without causing disturbance to materials which in effect may cause disturbance to possible bat roosts within.

- 6.7 In line with best practice survey guidelines, a structure that has demonstrated activity from bats must have a further three emergence surveys to confirm activity from bats along with species, volume and roost type. These survey should be carried out within the recommended survey season from May to September with at least two of these visits during the optimal time of May to August. It is also recommended that during the above required surveys the detached garage is also viewed to confirm or rule out activity.

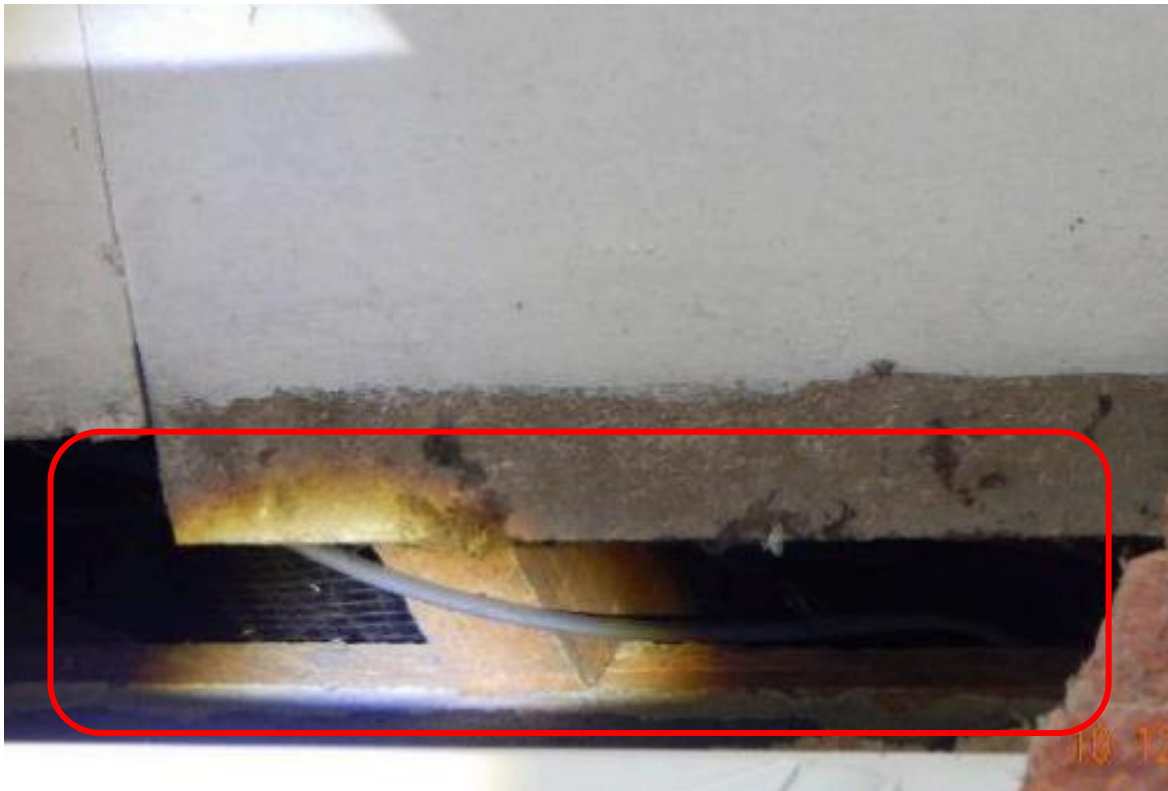
Image 7 – Further gaps to the eaves coverings offering adequate access opportunities into the main roof void spaces of the main dwelling

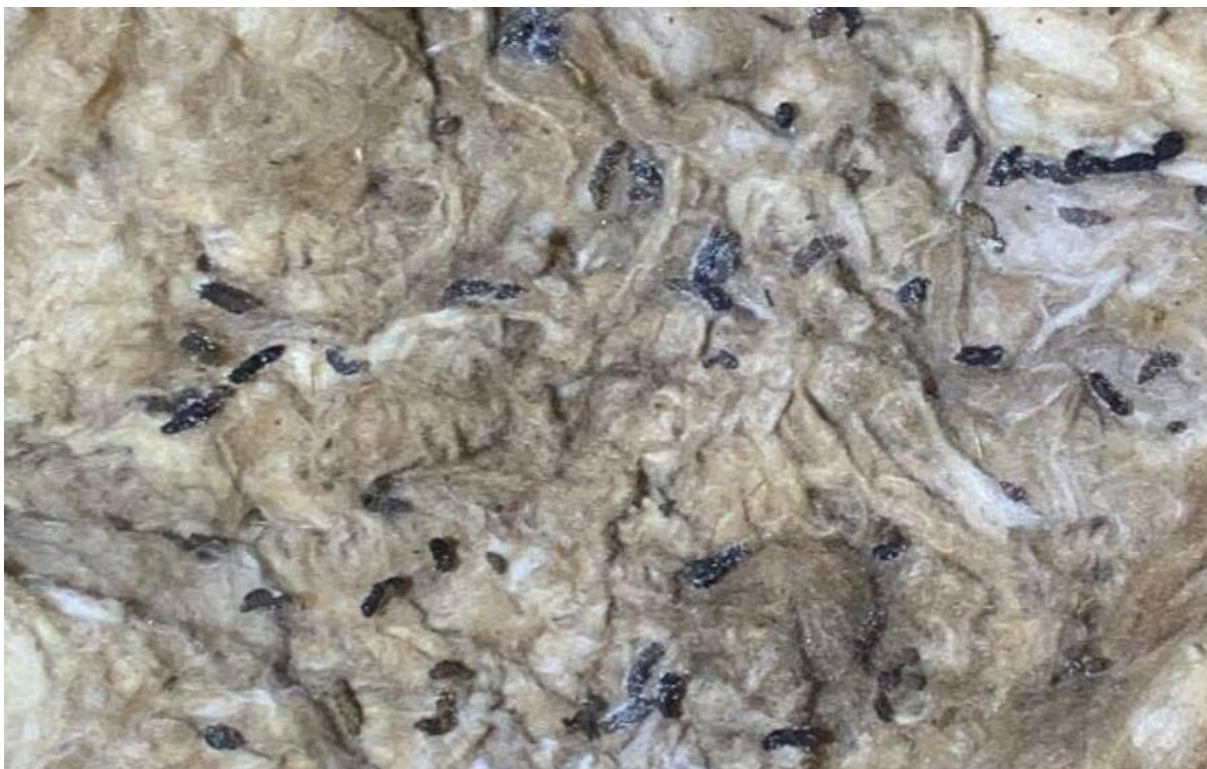
Image 10 – Evidence from bats in the form of 100+ bat droppings across the floor areas to the main roof void spaces of the dwelling

- 6.5 Internally, 100+ bat droppings were observed across the insulated floor coverings within the roof void spaces which confirms roosting activity from bats.

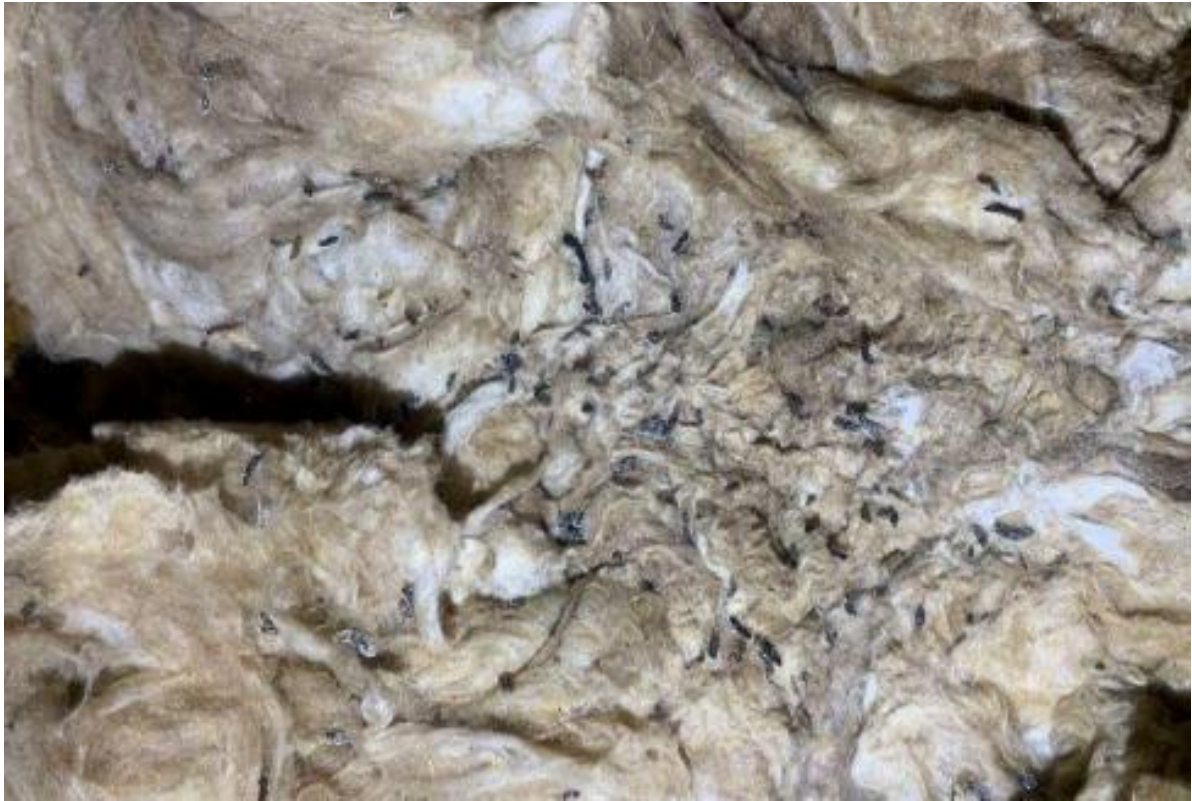
Image 11 – Evidence from bats in the form of 100+ bat droppings across the floor areas to the main roof void spaces of the dwelling

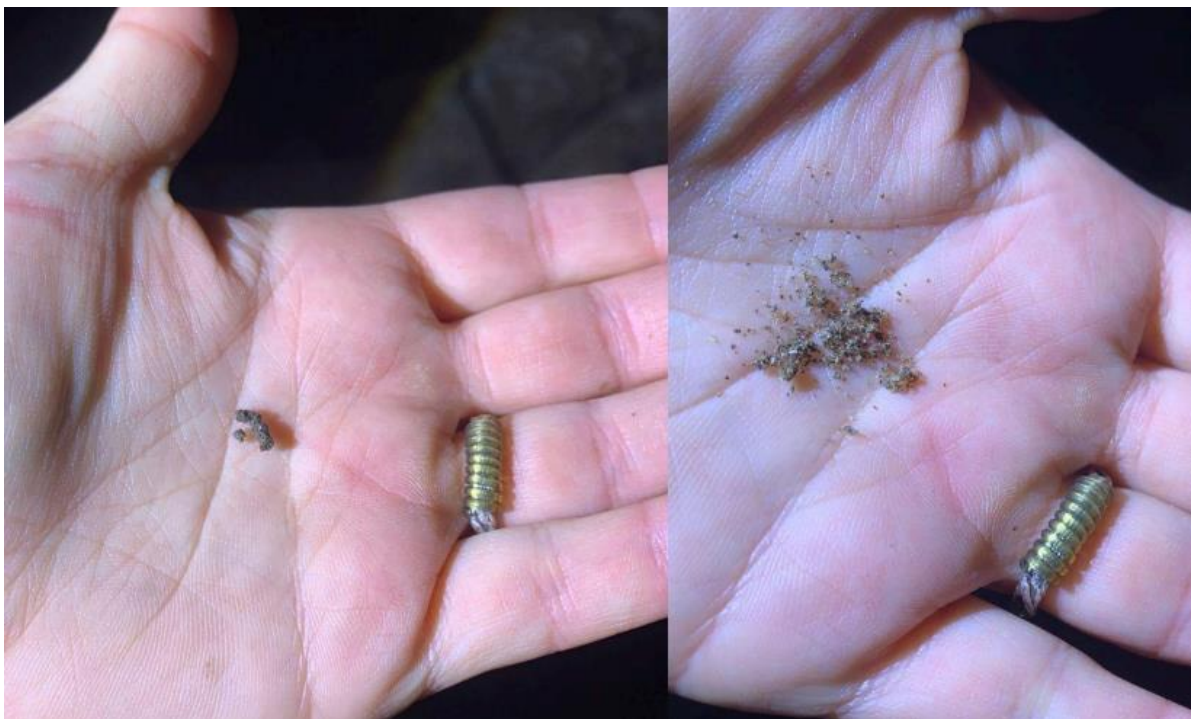
Image 11 – Evidence from bats in the form of 100+ bat droppings across the floor areas to the main roof void spaces of the dwelling

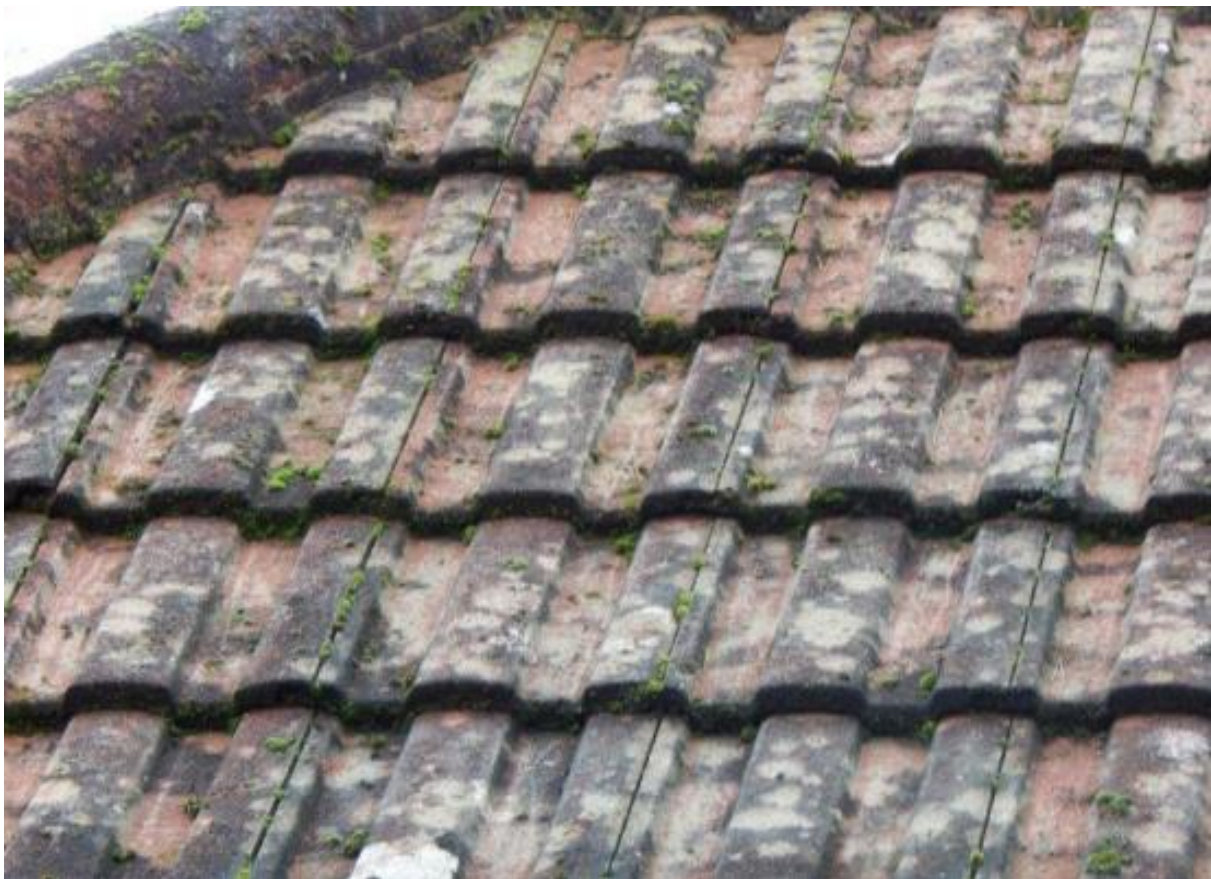
Image 13 – View of the roof coverings to the detached garage structure which has demonstrated no features of value to bats

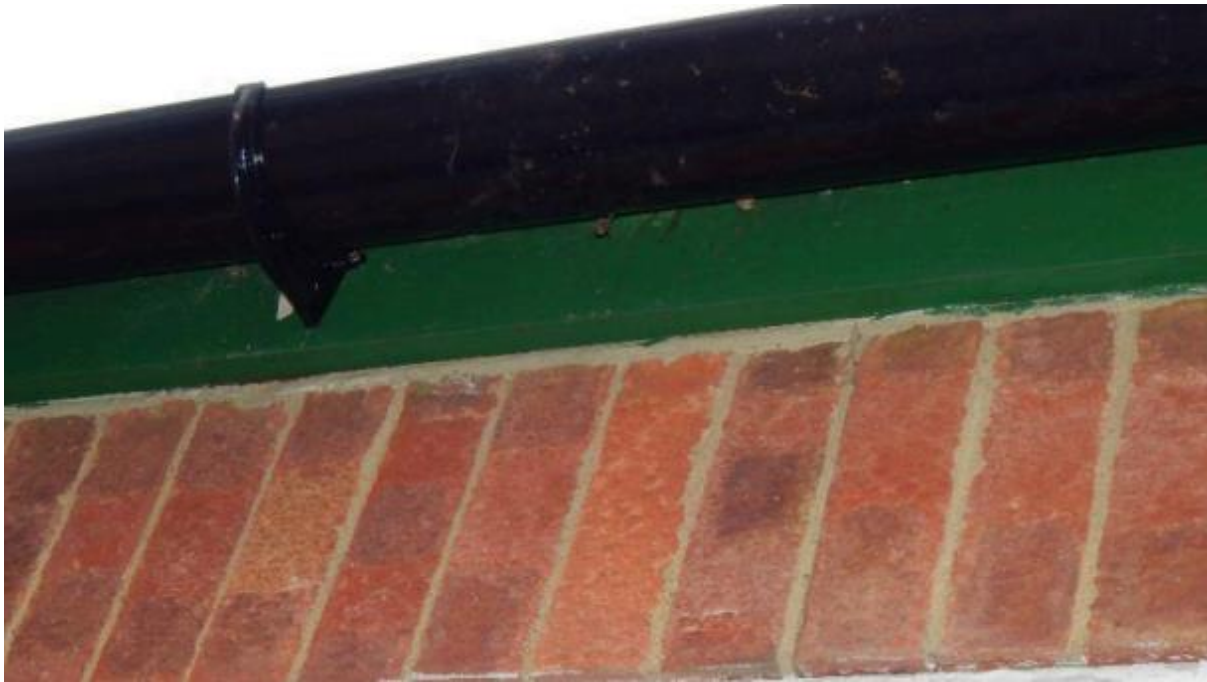
Image 14 – Facia coverings to the detached garage structure where no gaps or features of value to bats were observed

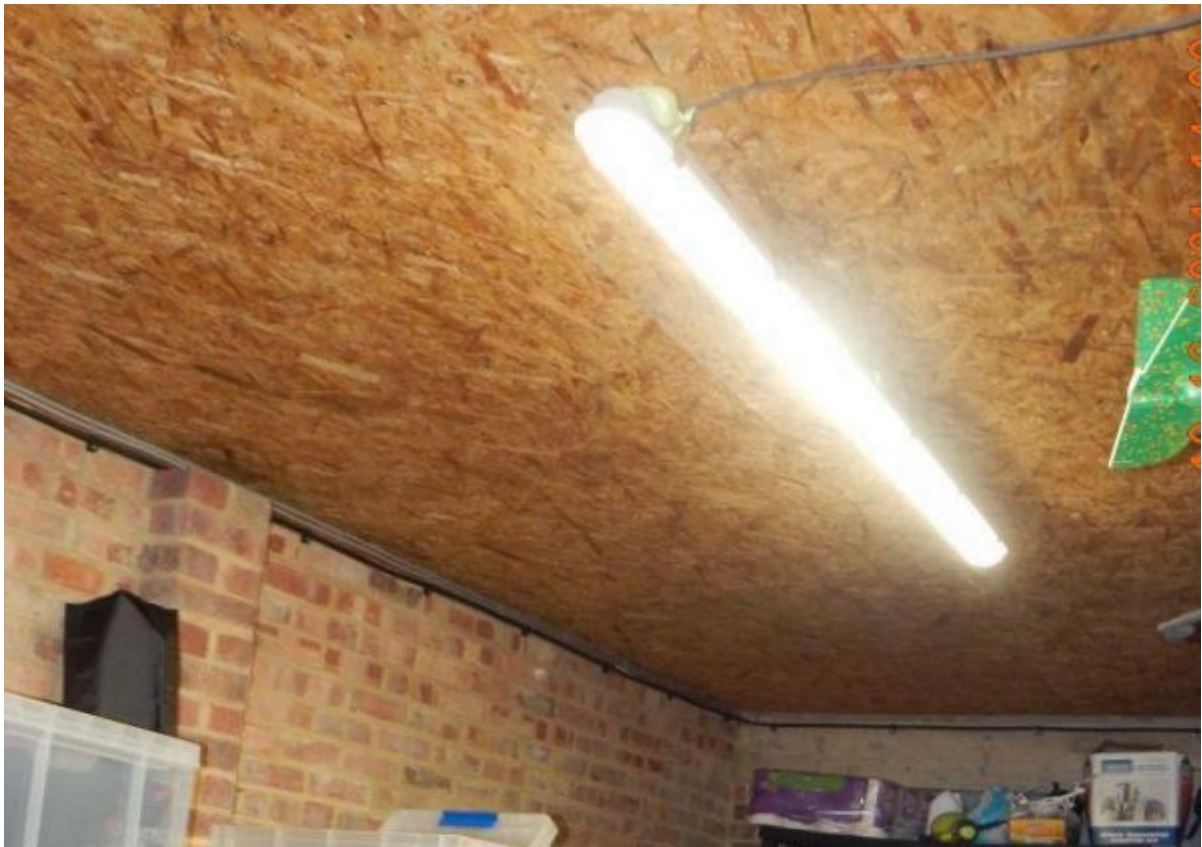
Image 15 – Internal view from below the roof coverings to the detached garage. No access available into the roof void spaces

- 6.6 The detached garage structure has demonstrated no visible features of value to bats. However, we were not able to assess the roof void spaces of this structure as it have been boarded out below. The roof void may offer a suitable roosting habitat and although no visible features were observed externally there is a likelihood that bats may also use this structure as with those using the main dwelling.

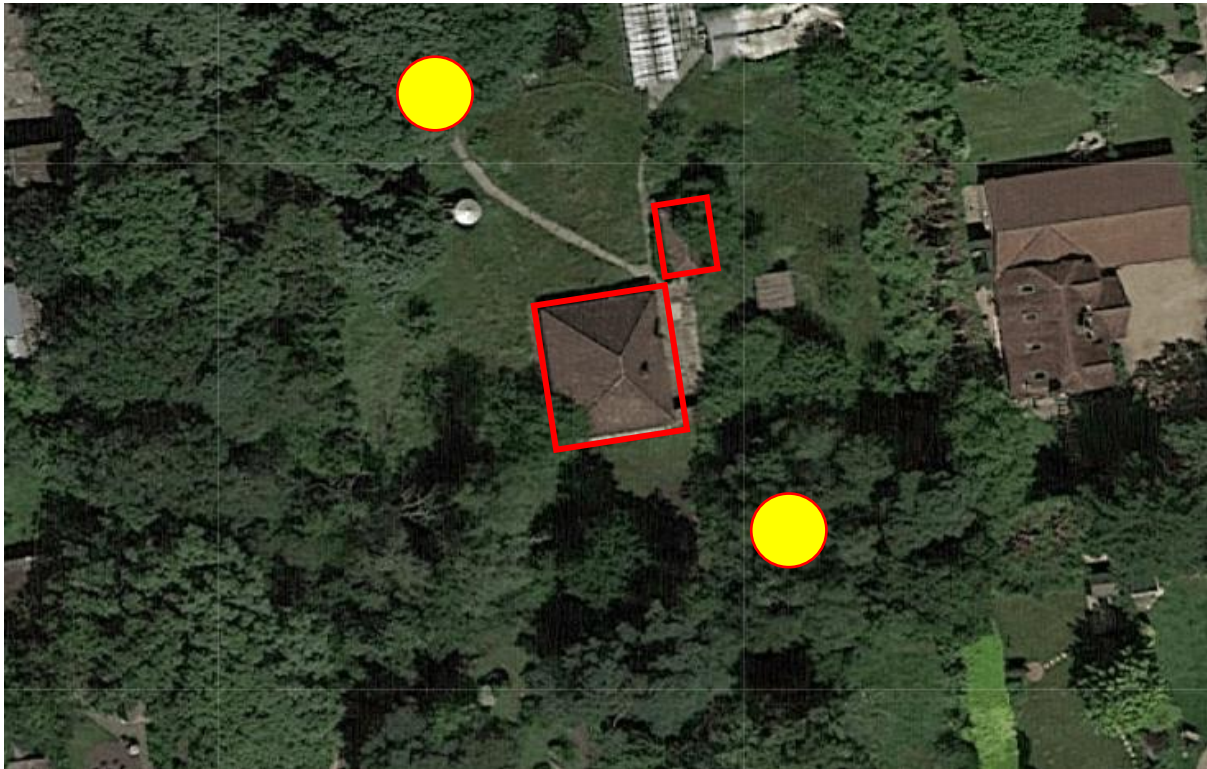
#### Appendix 4: Emergence Survey Location Points

Below site view to show suitable surveyor location points during each emergence survey to maintain visibility of the property.

In line with best practice survey guidelines, a total of two surveyors will be required to visually cover all elevations of the structure during each emergence survey.
